Geotechnical and Structural Field Observations from Christchurch, February 2011 Earthquake, in New Zealand

Research Report

September 2011

National Technical University of Athens, Greece

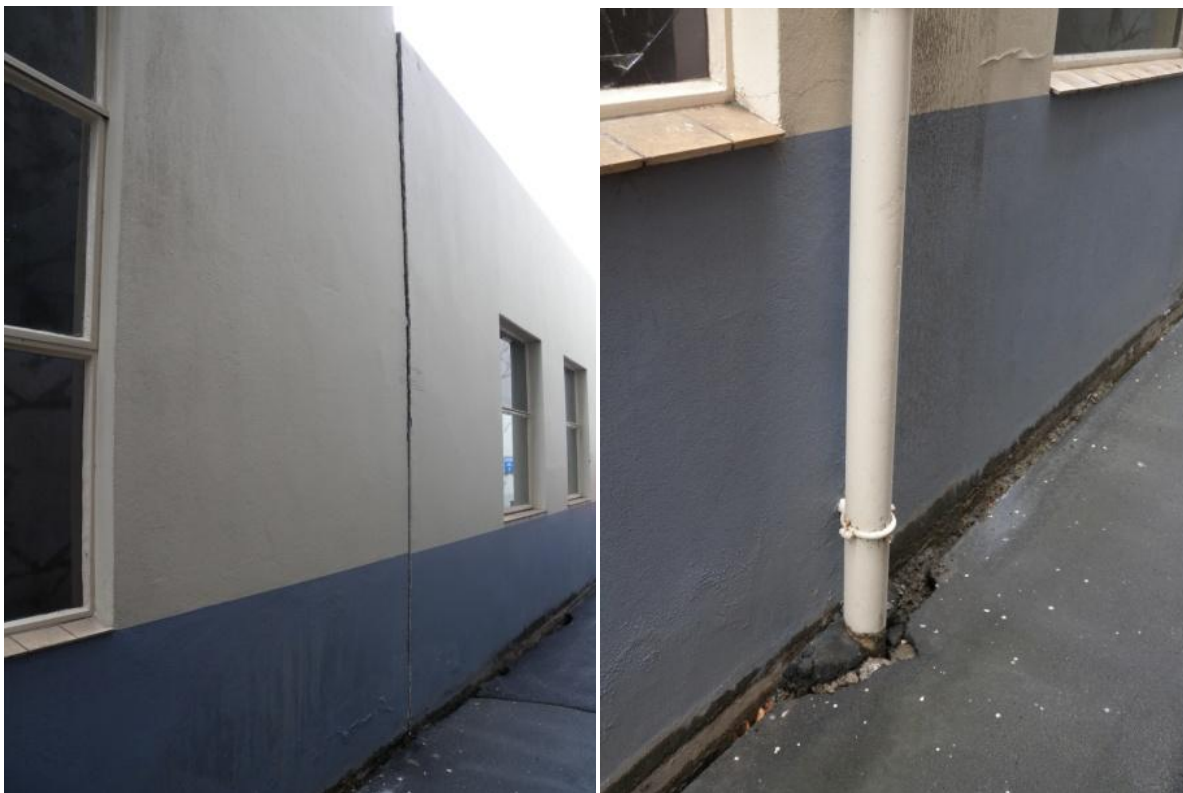
The concrete building accommodating the station did not sustain major damage apart from gap opening between the front and the rear section in the order of 4 cm at the top and a 1 cm out of plane displacement (Figure 2.15). A crack between the building and the asphalt has been developed in the perimeter of the building allowing the liquefied sand emerge on the ground surface. The soil underneath the station mainly consists of sand (borelog of Figure 2.13), justifying the large amount of ejected sand.

Figure 2.15. Gap opening between the front and rear section of CHHC seismic station building (left). Crack between the building and the asphalt due to ejected sand (right).

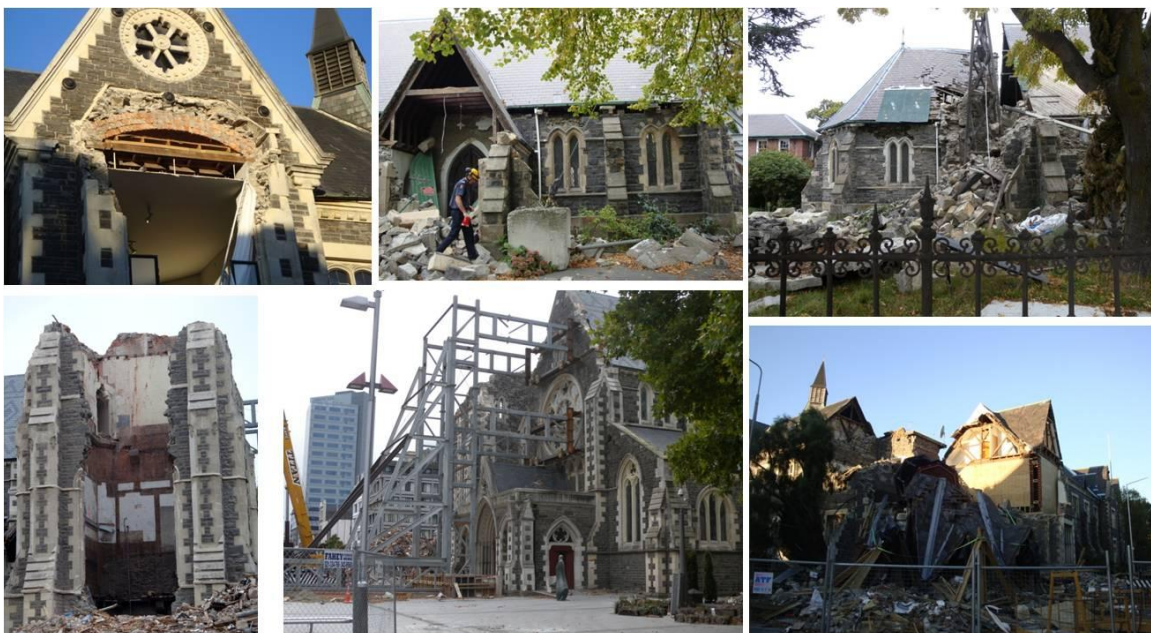
Figure 3. 20. Several historical masonry buildings, including the Cathedral, with significant damage.

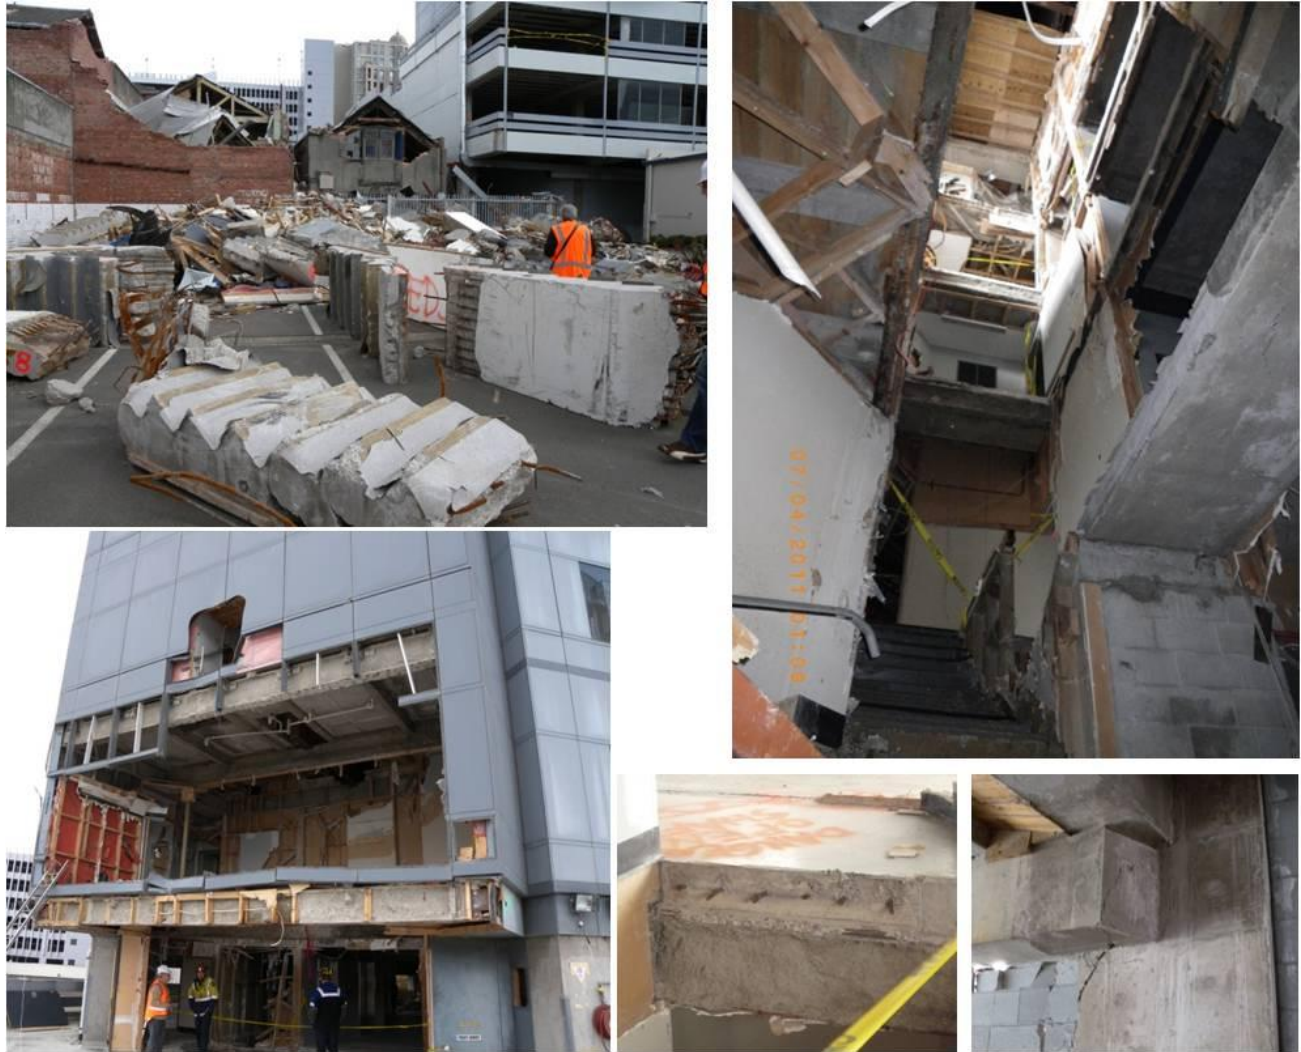
Figure 3. 30. Damage in the Forsyth Barr Building and its collapsed stairs.

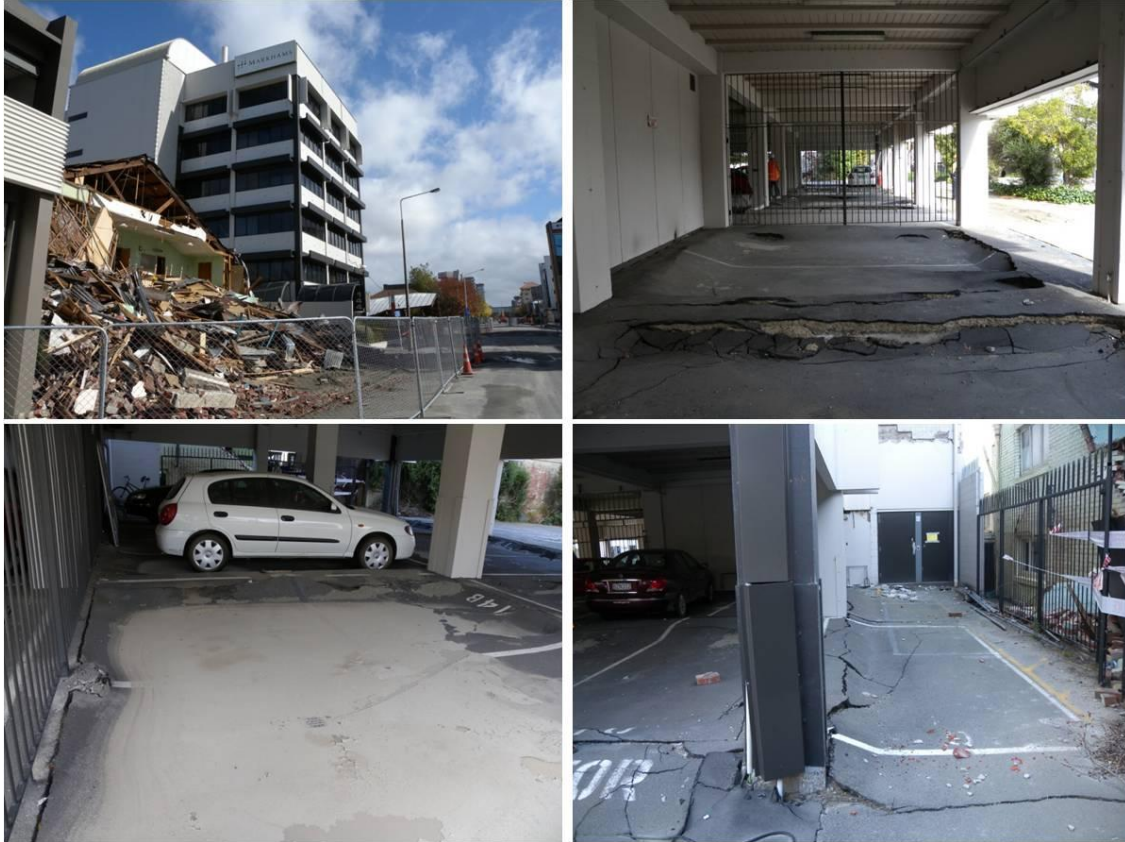
Figure 3. 35. A RC building on piles (B33) with large soil settlements and insignificant damage.

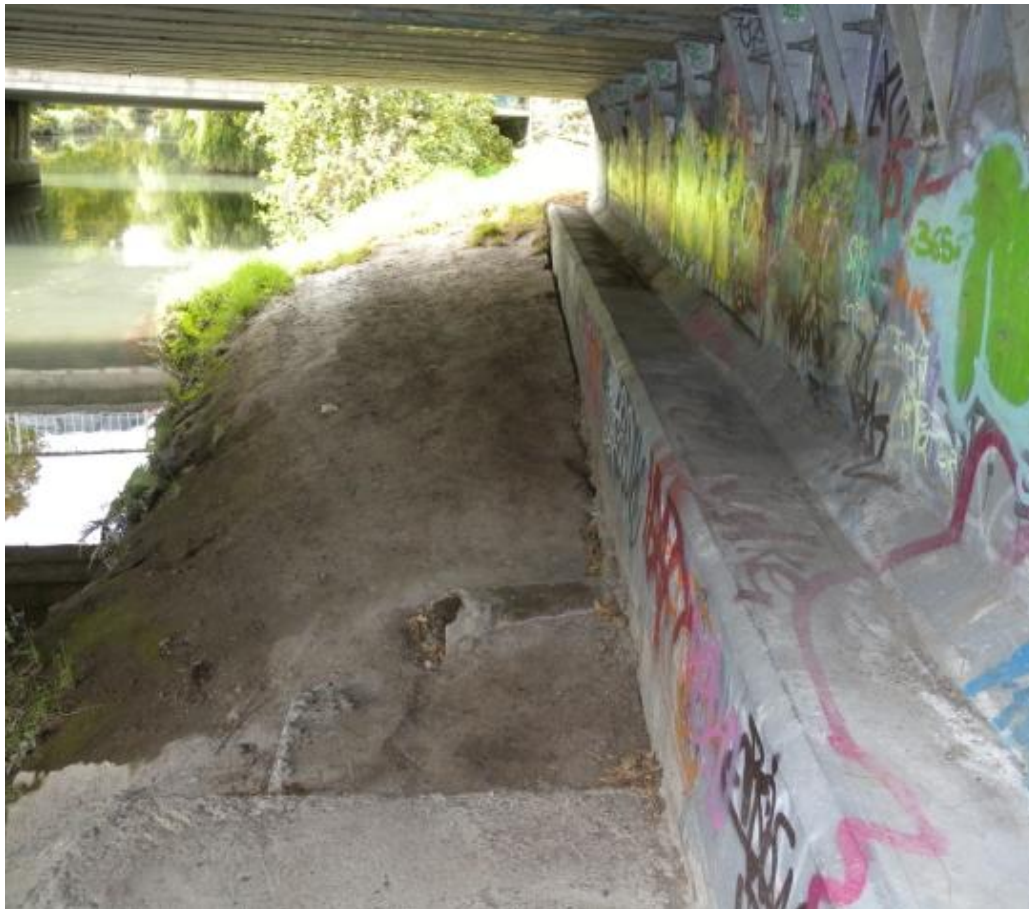
Figure 5.2. Fitzgerald Bridge (B1 on map of Figure 5.1). Performance of southern abutment after ChCh earthquake. No signs of lateral ground deformation occurred at the southern abutments of the twin bridges. The soil is still attached to the abutment.

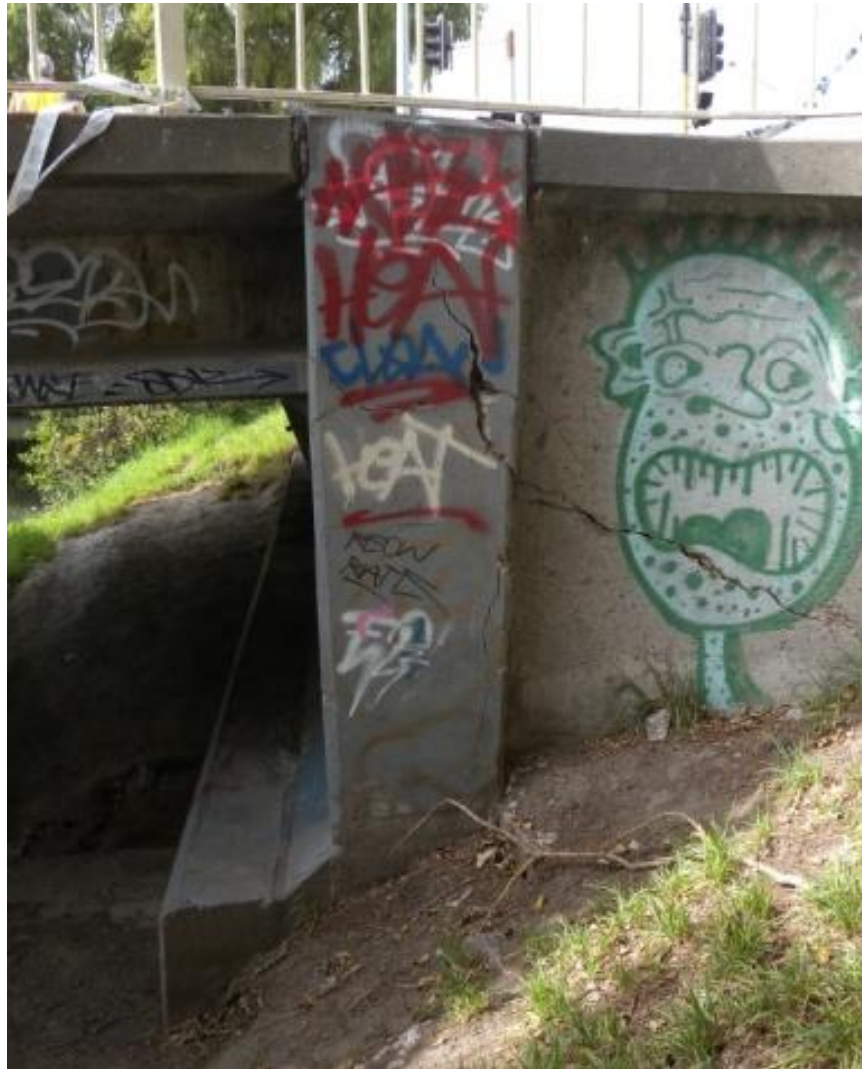
Figure 5.3. Fitzgerald Bridge (B1 on map of Figure 5.1). Performance of southern abutment after ChCh earthquake. No lateral ground deformation occurred at the southern abutments of the twin bridges. Thus, there was no rotation of the abutment. However, the southern abutment suffered moderate cracks due to seismic and inertial load.

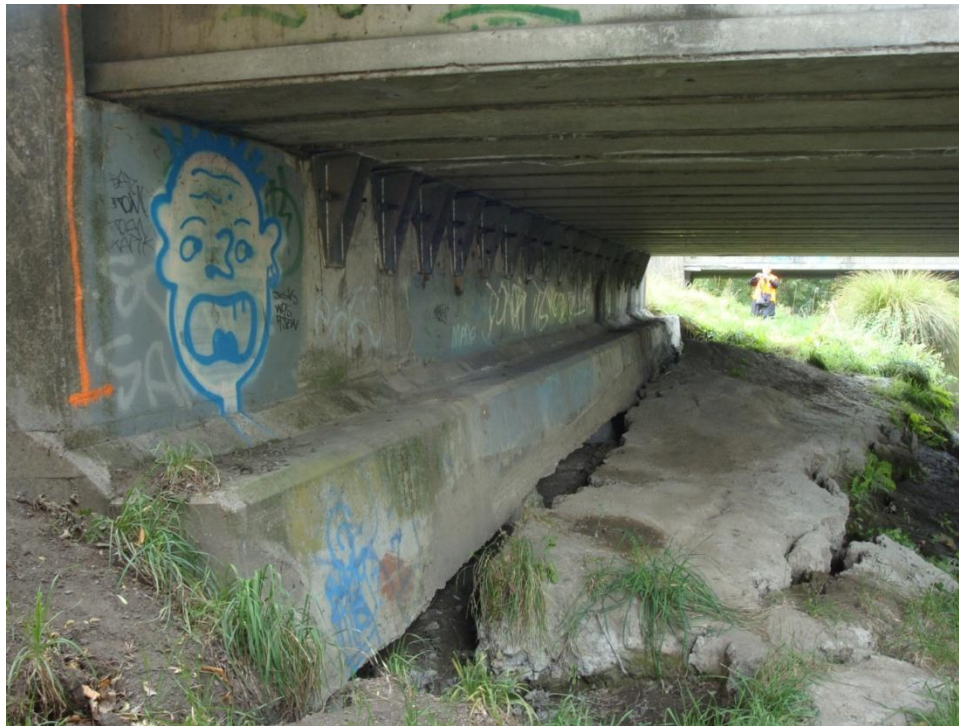
Figure 5.4. Fitzgerald Bridge (B1 on map of Figure 5.1). Performance of northern abutment after ChCh earthquake. Lateral spreading of the ground has exposed the pile heads.

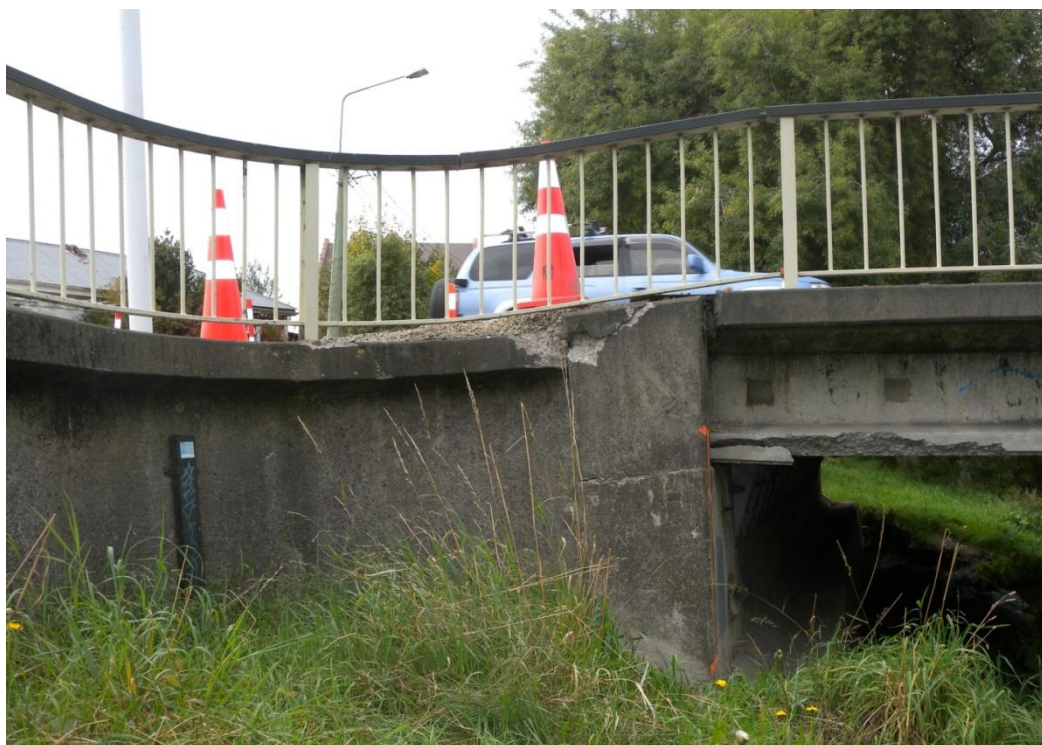
Figure 5.7. Fitzgerald Bridge (B1 on map of Figure 5.1). Performance of northern abutment of the twin bridge after ChCh earthquake. Rotation of abutment and slump of the backfill took place. Concrete spalling of the deck developed close to the abutment-seat.

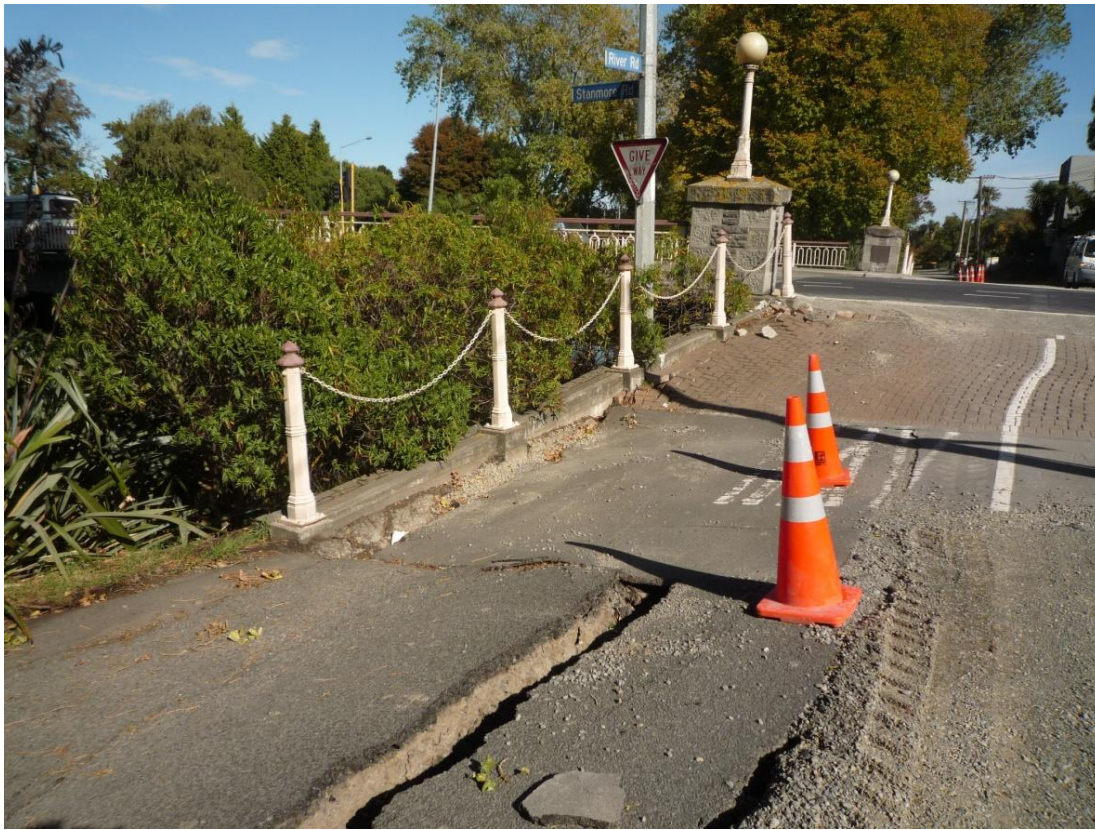
Figure 5.11. Stanmore Bridge (B2 on map of Figure 5.1). Rotation of the abutment around the deck. The street lighting column next to the abutment has rotated riverwards, following the lateral deformation of the ground, while the light column seated on the abutment indicates that the abutment has back rotated due to the deck constraint. Slump of the approach fill is not visible because at the time of our visit, the cracked asphalt between the two abutments had been replaced by new. However the large cracks in the road parallel to Avon river (in the order of 40 cm) due to lateral spreading were still there.

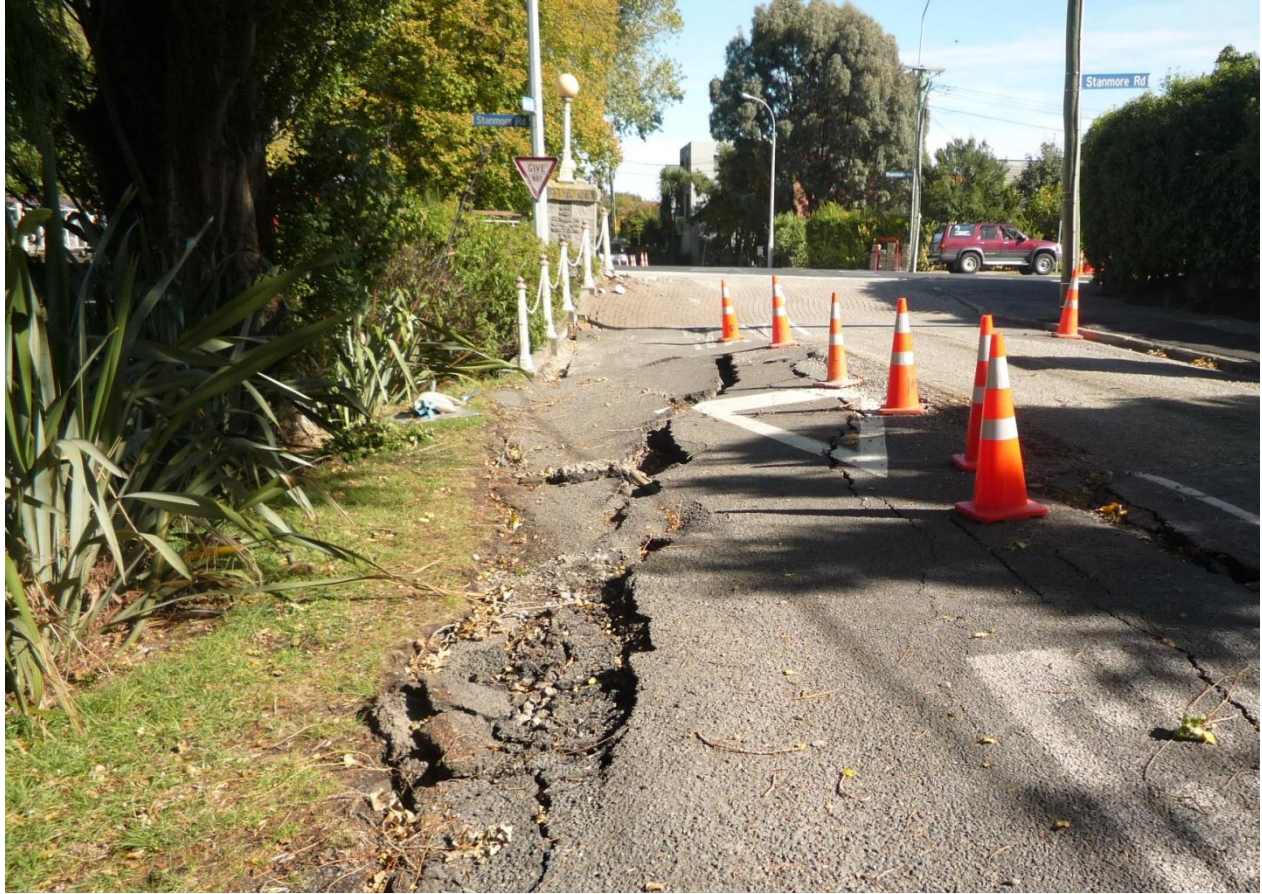
Figure 5.12. Stanmore Bridge (B2 on map of Figure 5.1). Large cracks in the asphalt due to significant lateral spreading in the free field (away from the bridge). The cracks tend to decrease towards the bridge, as the axial stiffness of the deck combined with the bending stiffness of piles limits the lateral ground deformation.

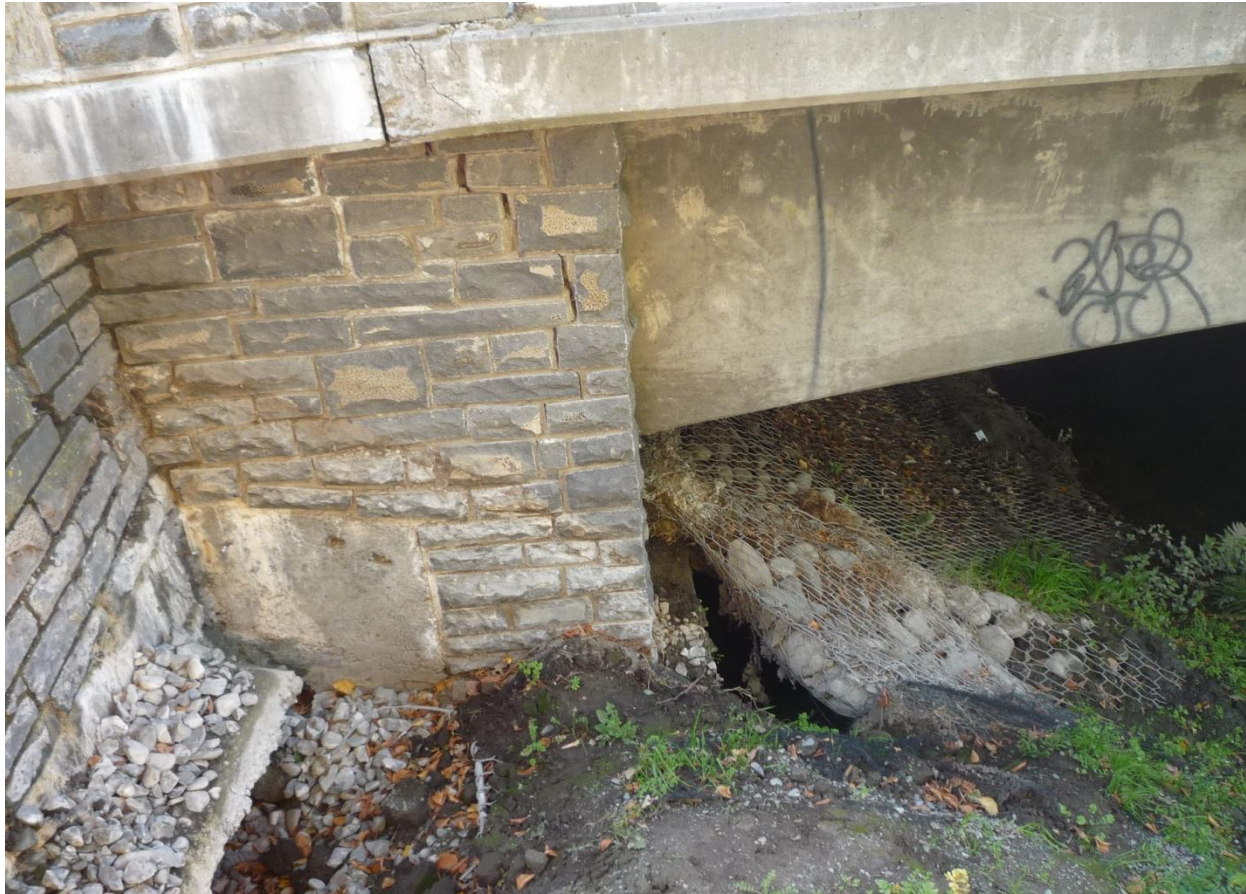
Figure 5.13. Stanmore Bridge (B2 on map of Figure 5.1). Cracks in the abutment and concrete spalling close to the joint with the deck. Gap opening between the abutment and the soil, tending to expose the foundation.

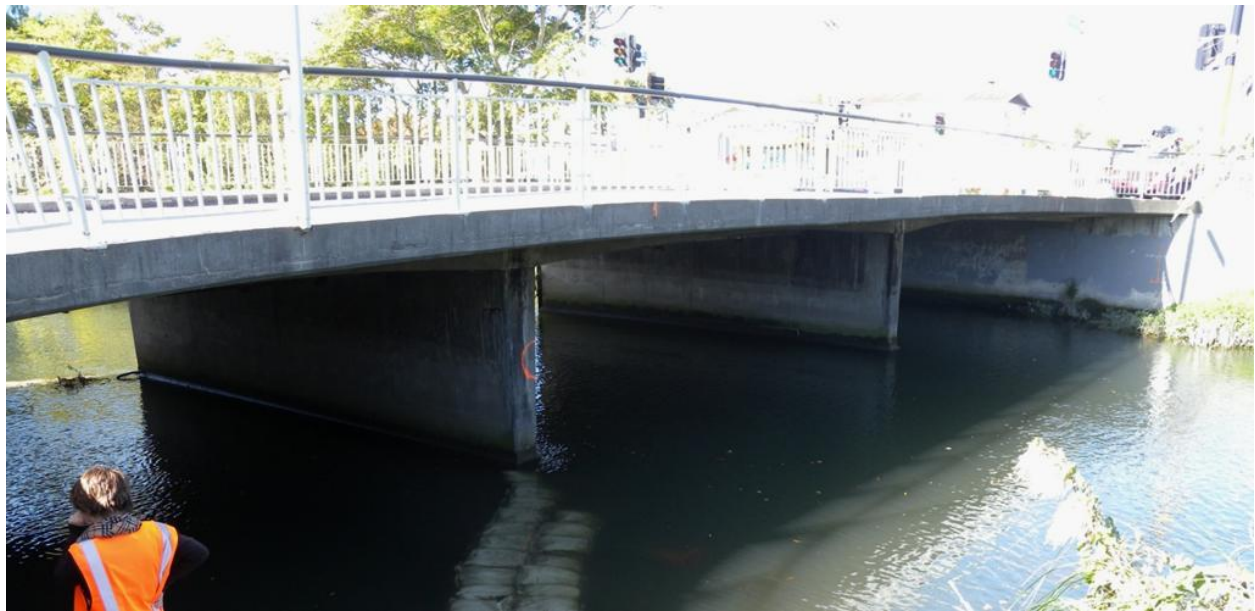
Figure 5.15. Gayhurst Bridge (B4 on map of Figure 5.1) after Christchurch earthquake. The southern abutment appears practically undamaged on the right side of the photo.

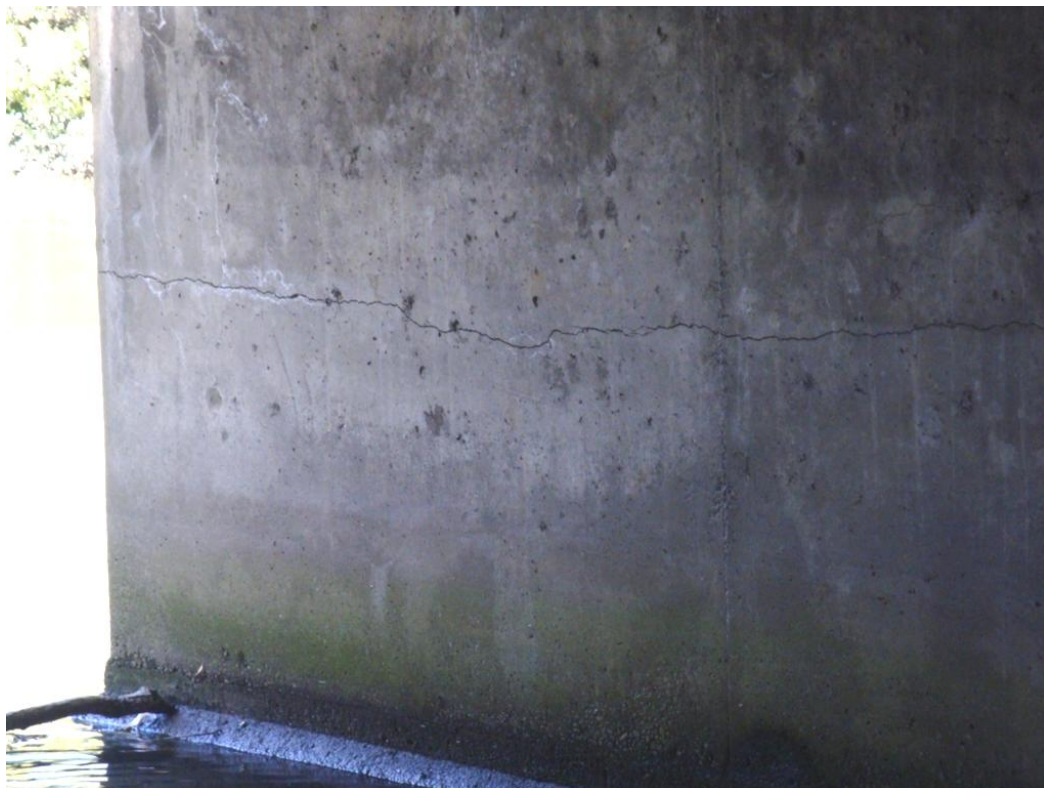
Figure 5.16. Gayhurst Bridge (B4 on map of Figure 5.1) The pier wall close to the northern abutment developed horizontal tension cracks, about 1 m below the deck due to intense shaking and lateral spreading.

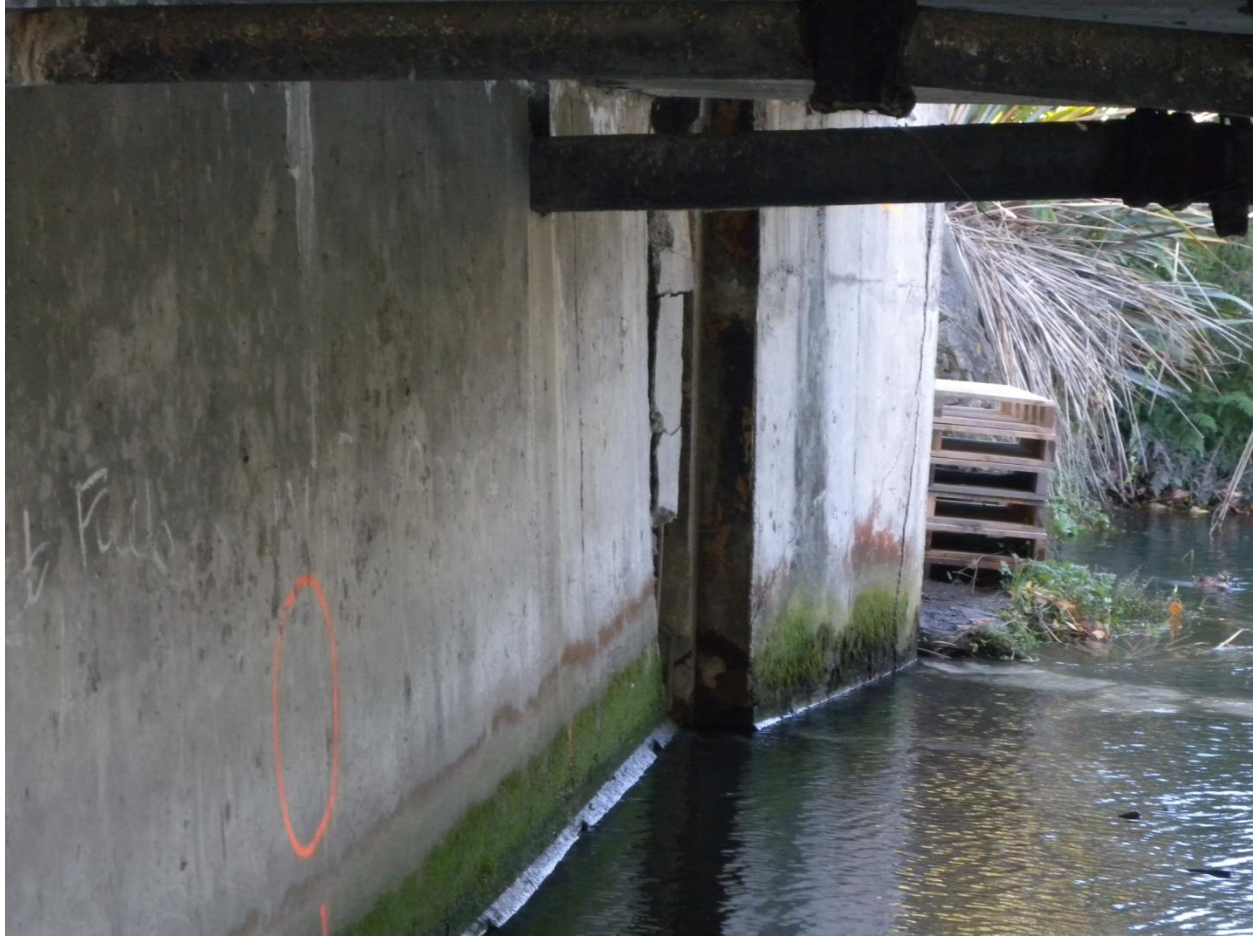
Figure 5.17. Northern abutment of Gayhurst Bridge (B4 on map of Figure 5.1). Rotation and differential riverward displacement (in the order of 70 cm and more) of the eastern wingwall relative to the abutment caused concrete spalling and cracking at the joint of the abutment with the wingwall.

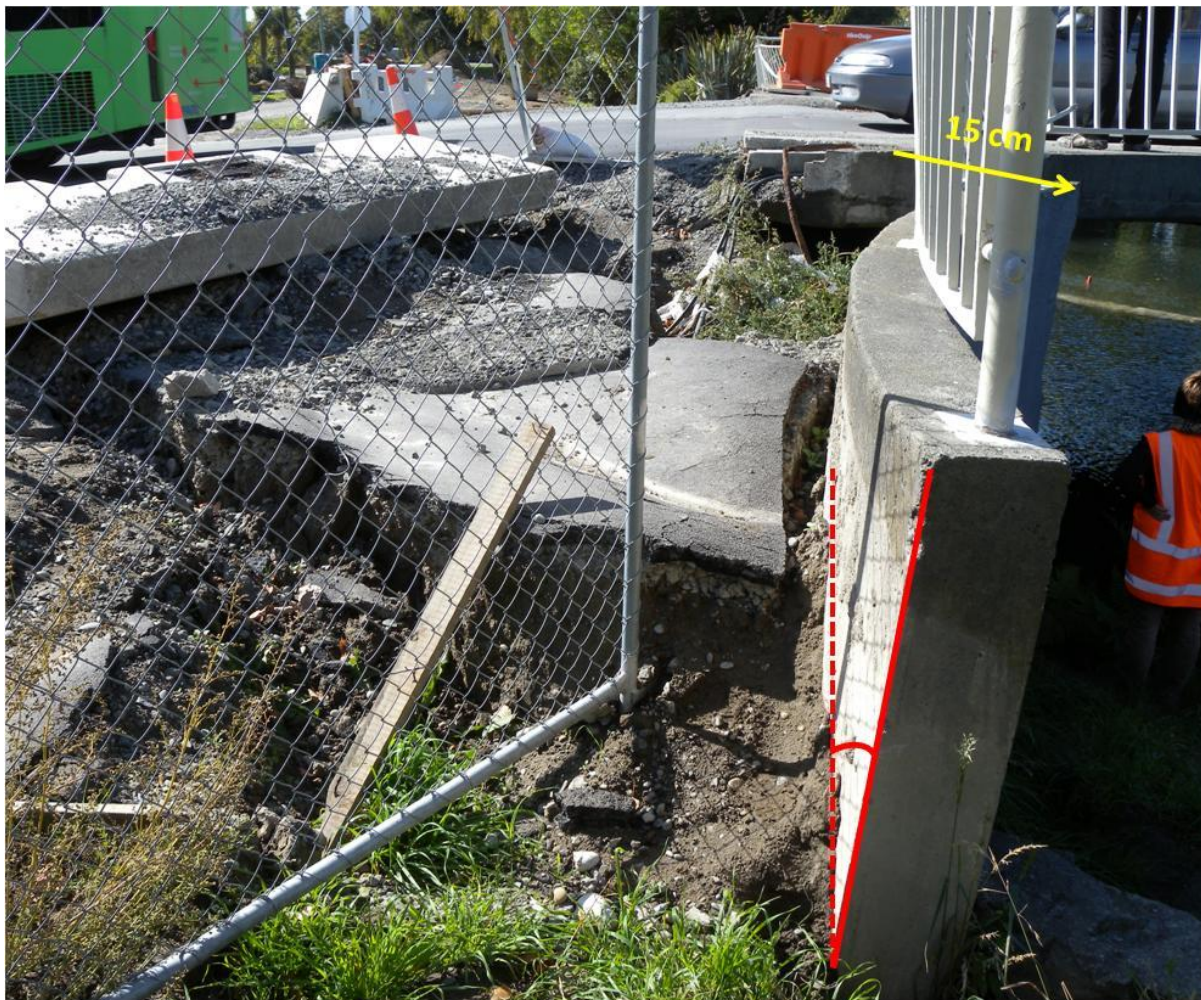
Figure 5.18. Northern abutment of Gayhurst Bridge (B4 on map of Figure 5.1). Rotation and displacement of the western wingwall not only riverwards but also away from the abutment (15 cm approximately at the top) perpendicular to the deck.

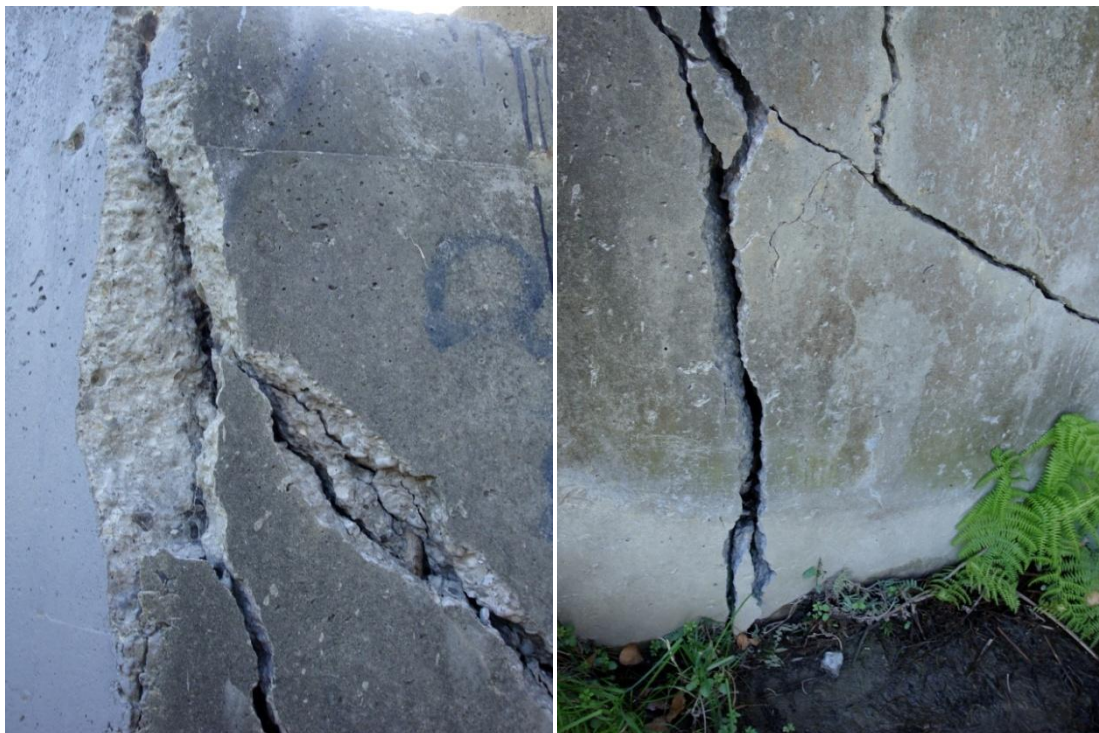
Figure 5.20. Closer look on the cracks of the western wingwall at the north of Gayhurst Bridge (B4 on map of Figure 5.1). The cracks have widened and deepened, while concrete spalling has occurred during Christchurch earthquake.

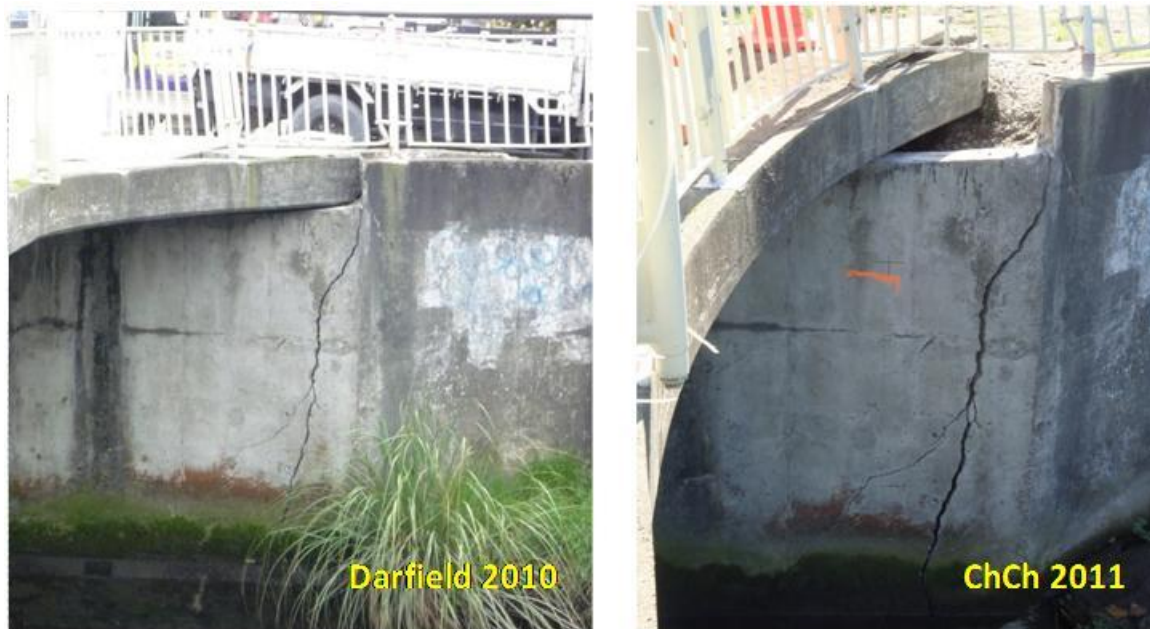
Figure 5.21 Eastern side of the northern abutment of Gayhurst Bridge (B4 on map of Figure 5.1). Comparison of damage between Darfield and Christchurch shaking events. The cracks have widened and the differential lateral riverward displacement of the abutment and wingwalls relative to the deck has increased after Christchurch earthquake. SOURCE.

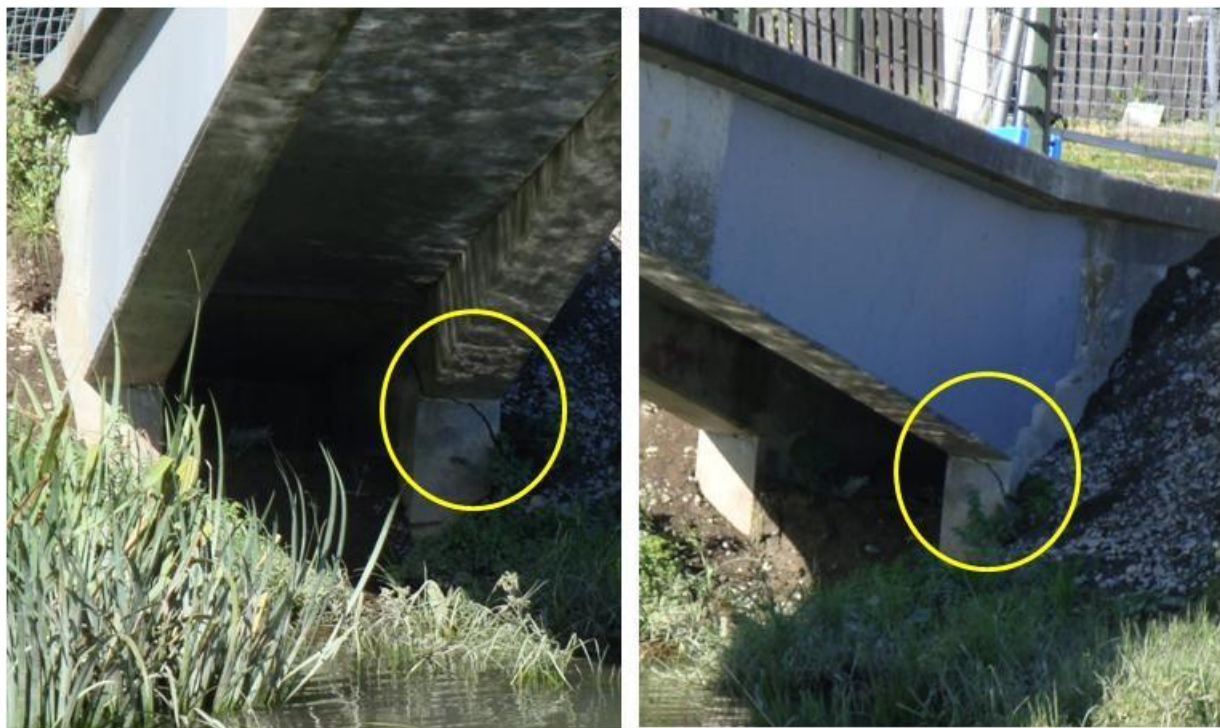
Figure 5.22. Snell Footbridge (B5 on map of Figure 5.1) after Christchurch earthquake. Cracks in the abutments.

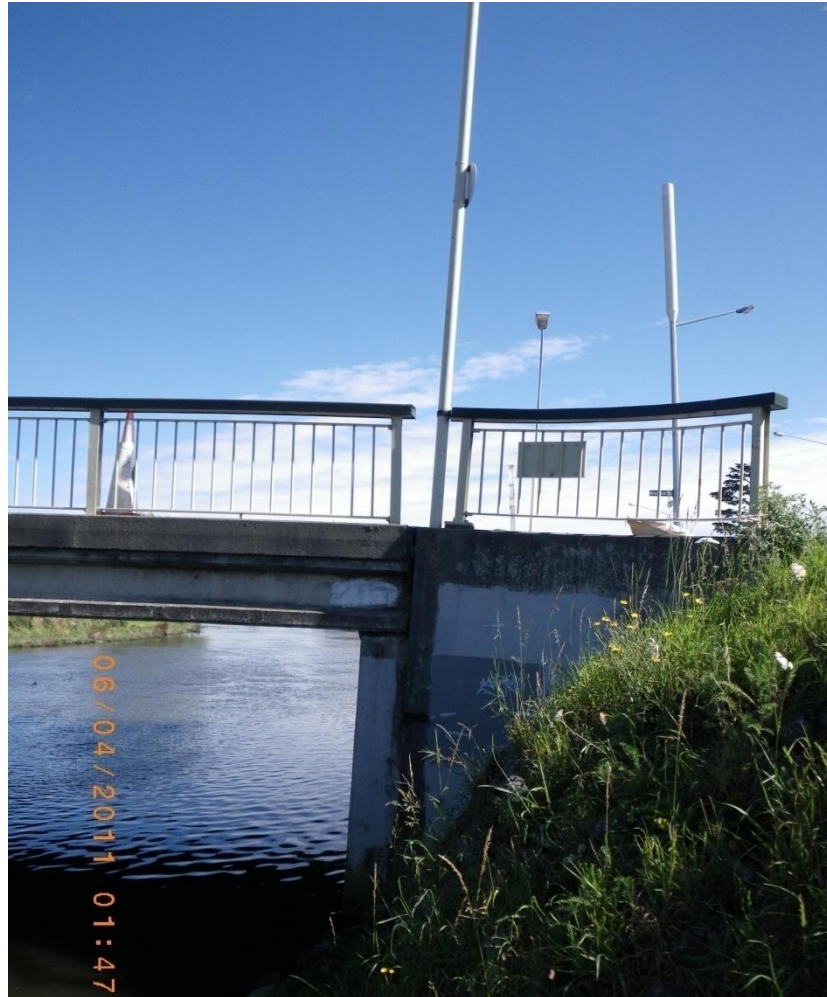
Figure 5.28. Northern abutment of Avondale Bridge (B6 on map of Figure 5.1) after Christchurch earthquake. Moderate back rotation (4 degrees) with only slight settlement of the backfill.

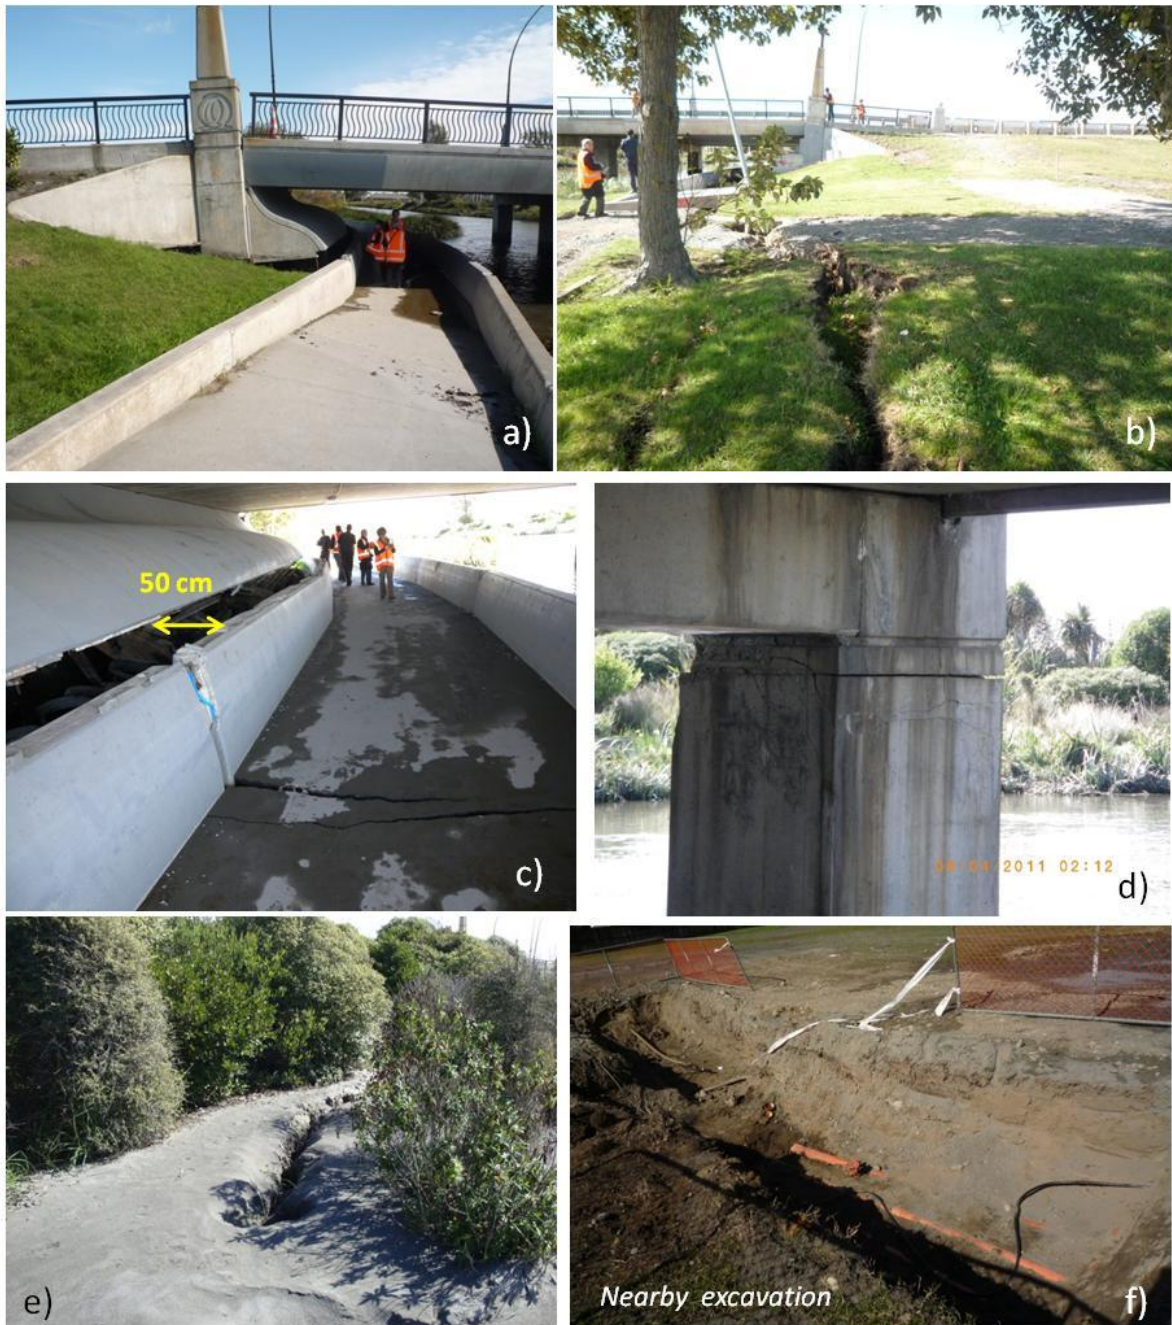
Figure 5.29. Avondale Bridge (B7 on map of Figure 5.1) after Christchurch earthquake. a) Back rotation of the abutments and slump of the approach fill, b) Large lateral spreading cracks in the ground parallel to Avon river coast extending in a great distance from the abutments indicating horizontal ground displacement more than 1, c) Riverward ground displacement in front of the abutments forms a gap of 50 cm exposing the top of the piles, d) Concrete spalling and cracks at the top of the pier-column due to intense shaking and lateral spreading, e) Significant quantity of sand ejecta close to the bridge, f) Nearby shallow excavation shows a top crust of clay containing thin beds of sand.

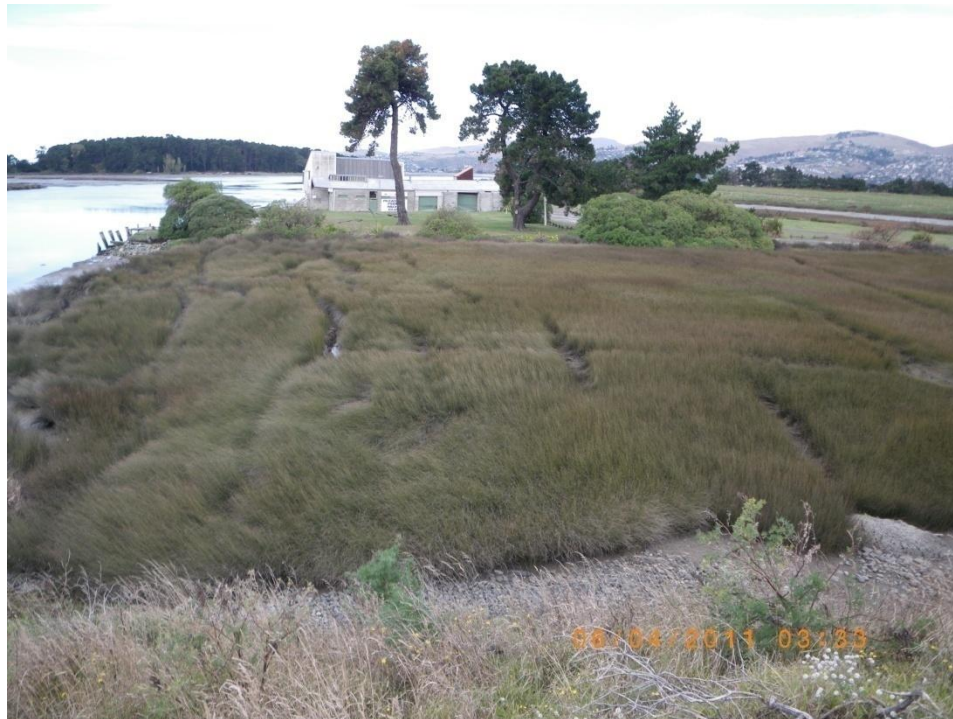
Figure 5.32. South Bridge Road Bridge (B8 on map of Figure 5.1) after Christchurch earthquake. Large lateral spreading cracks in the ground parallel to the coast and adjacent to the abutments extending at a great distance inland.

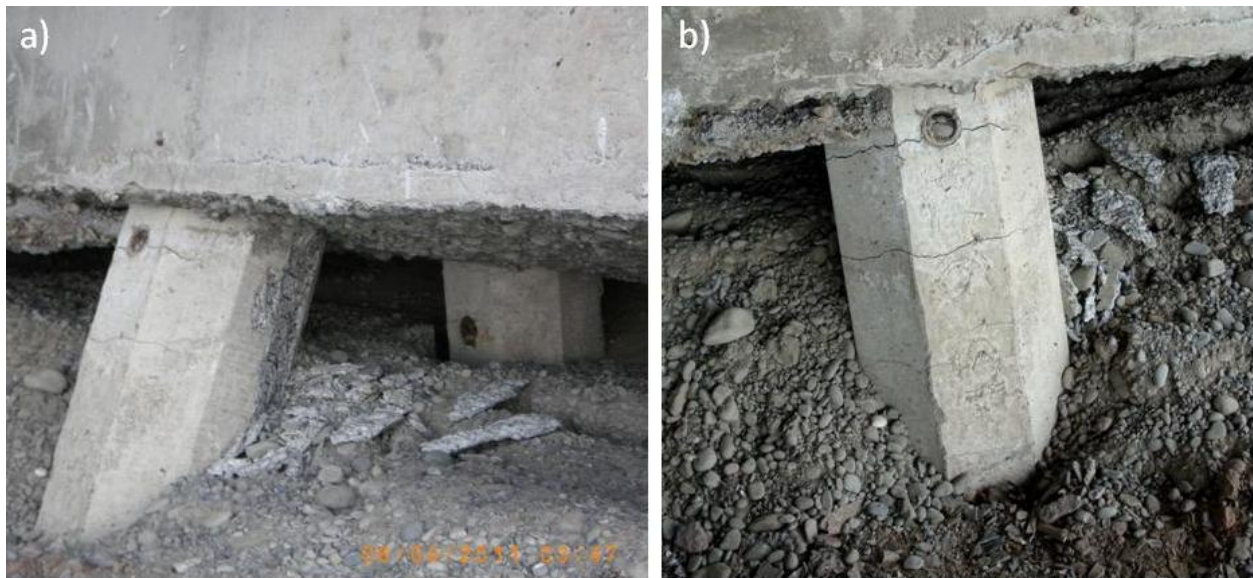
Figure 5.35. Western abutment of South Bridge Road Bridge (B8 on map of Figure 5.1) after Christchurch earthquake. a) Concrete spalling exposing the pile reinforcement, b) Flexural cracks developed at the top of the piles indicating plastic hinging.
