Geotechnical and Structural Field Observations from Christchurch, February 2011 Earthquake, in New Zealand

Research Report

September 2011

National Technical University of Athens, Greece

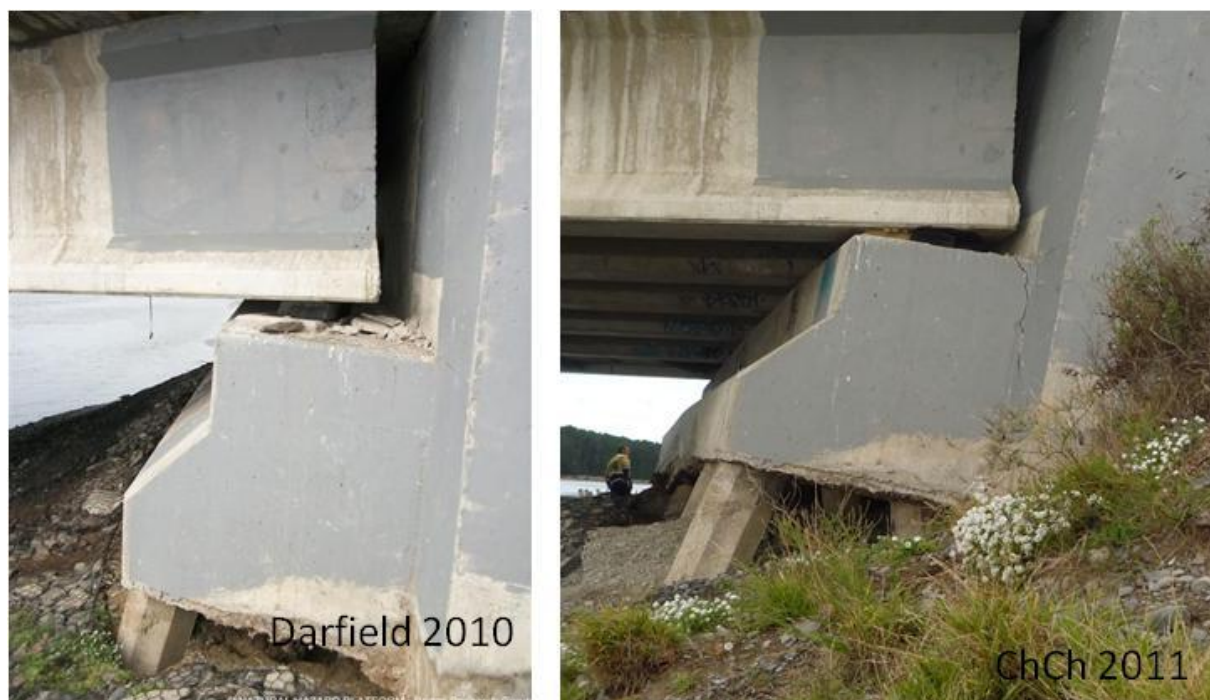
Figure 5.39. Western abutment of South Bridge Road Bridge (B8 on map of Figure 5.1). Differences between Darfield and Christchurch shaking events. After Christchurch earthquake the piles have been more exposed due to greater lateral spreading of the soil and some cracks have been developed in the abutment. Source: NHP- Bridge Research Group.

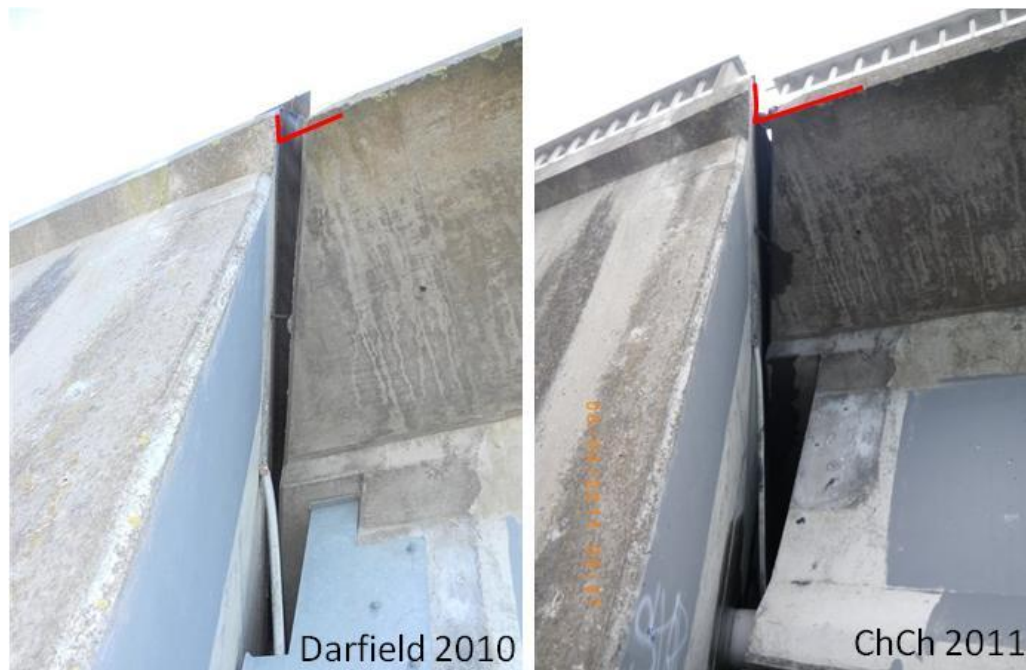
Figure 5.40. Western abutment of South Bridge Road Bridge (B8 on map of Figure 5.1). Slight differences between Darfield and Christchurch shaking events in terms of differential displacement of the abutment relative to the deck in the skew line direction. Source: NHP-Bridge Research Group.

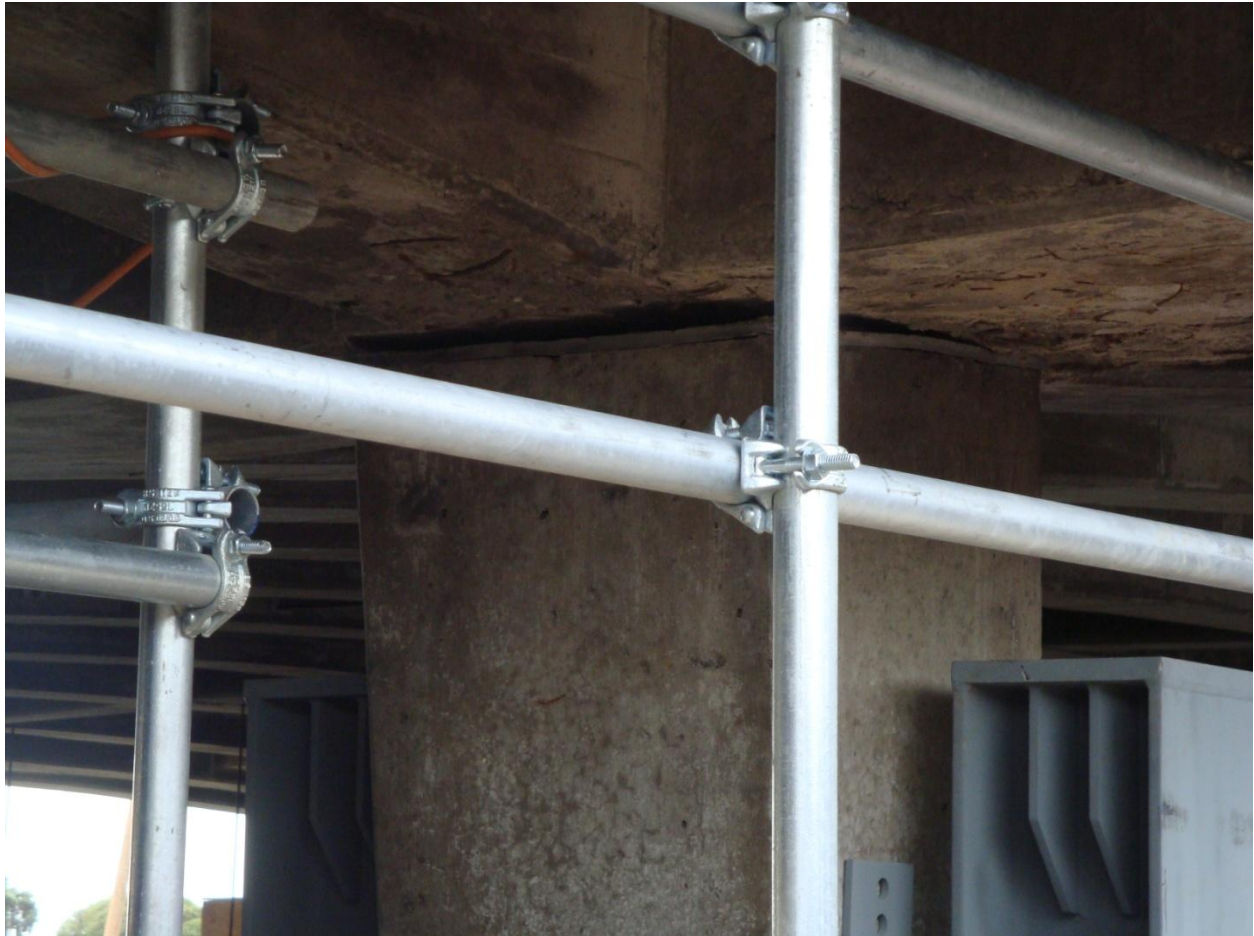
Figure 5.49. West pier of Ferrymead Bridge after Christchurch earthquake (B8 on map of Figure 5.1). The gap opening between the top of the pier and the deck was caused by the inward movement of the pier.

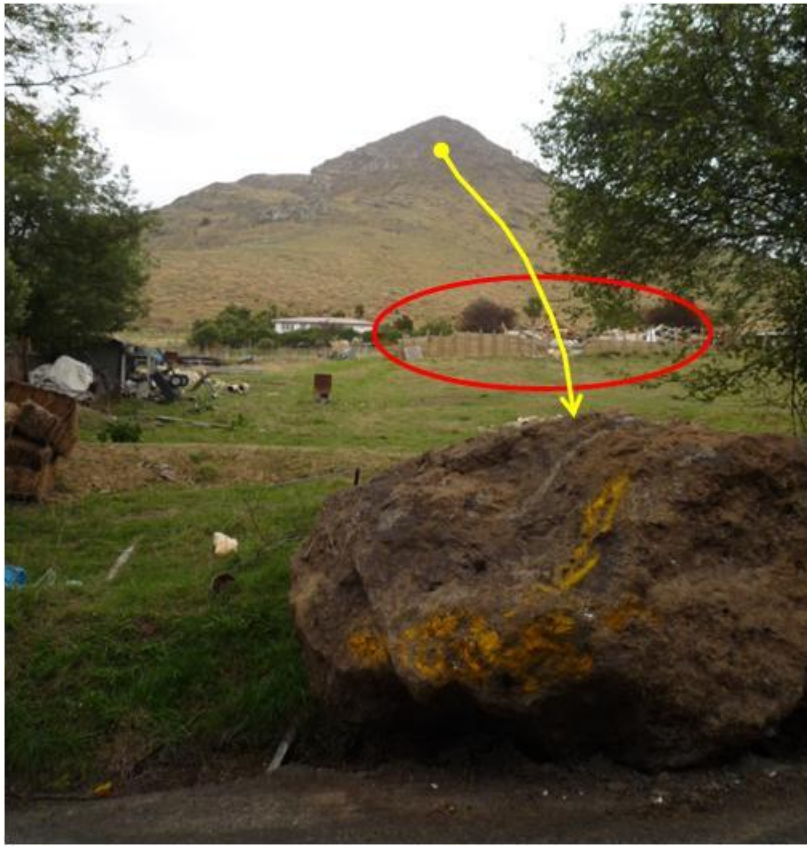
Figure 5.2. Boulder struck through a house at 241 Governors Bay Road in Rapaki (site S1 in the map of Figure 5.1).

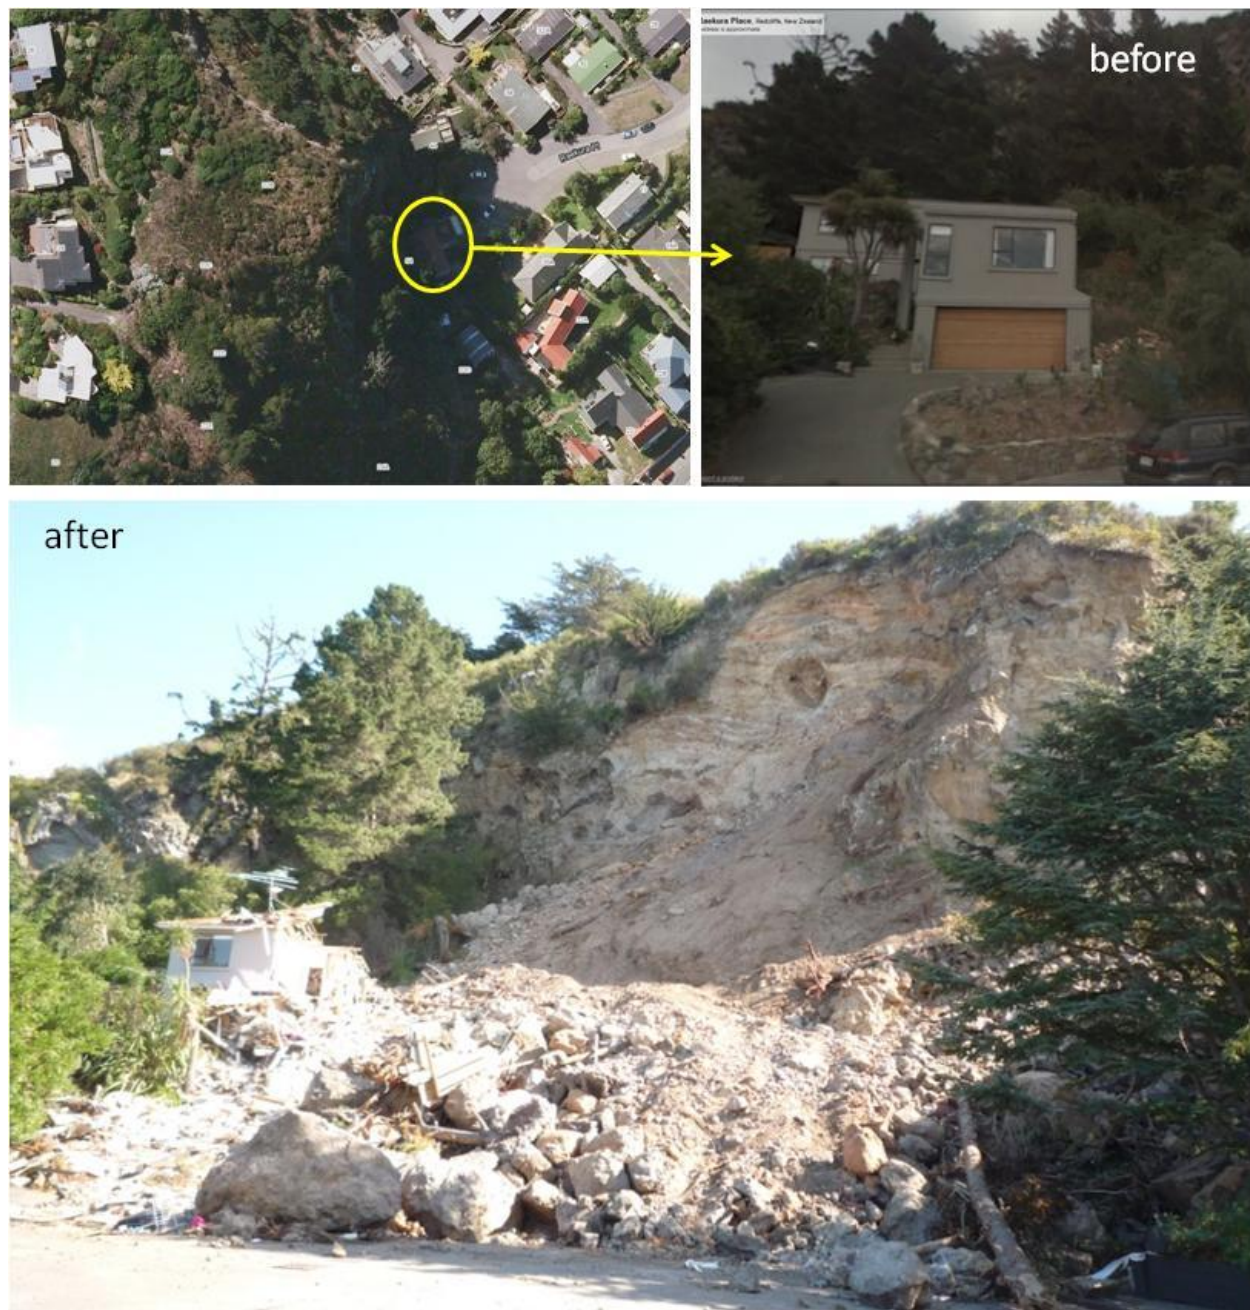
Figure 5.3. House collapsed by rock fall at Reakura Pl. in Redcliffs (site S2 in the map of Figure 5.1).

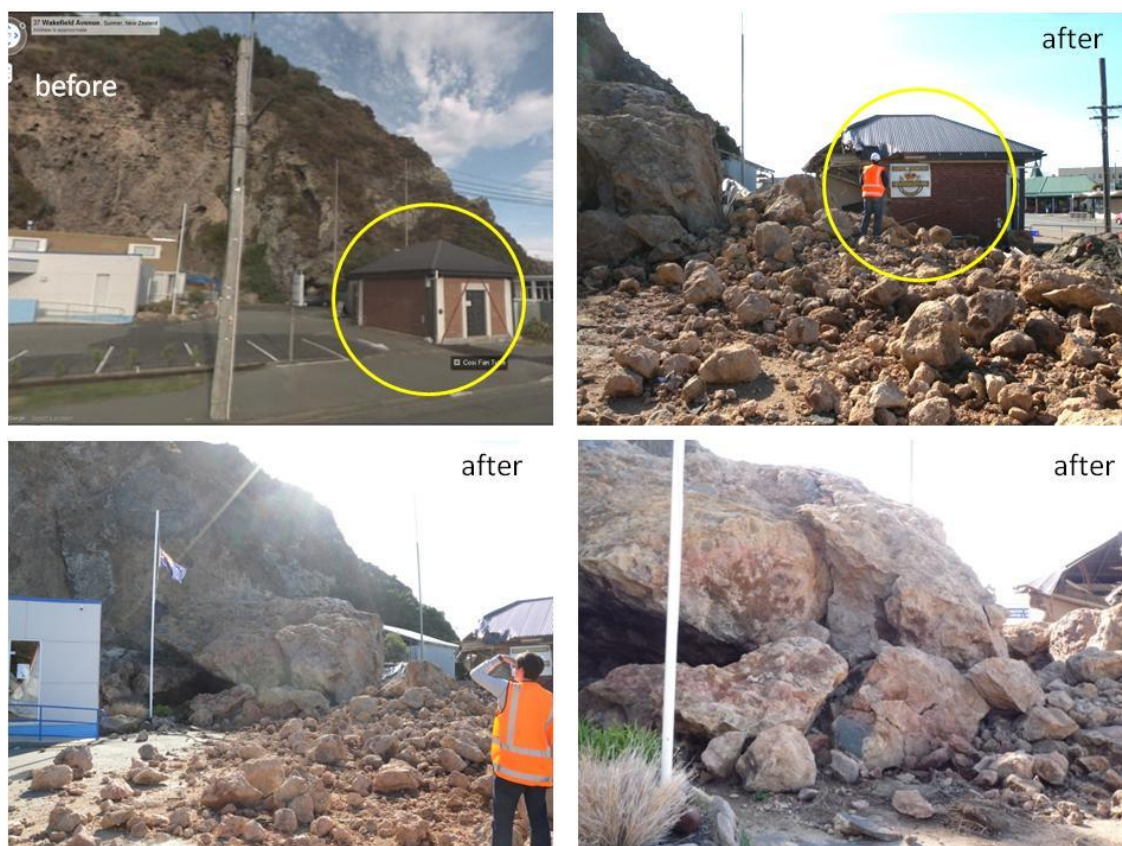
Figure 5.5. Extensive rock fall behind the RSA building at 34 Wakefield Ave, in Sumner (site S4 in the map of Figure 5.1).

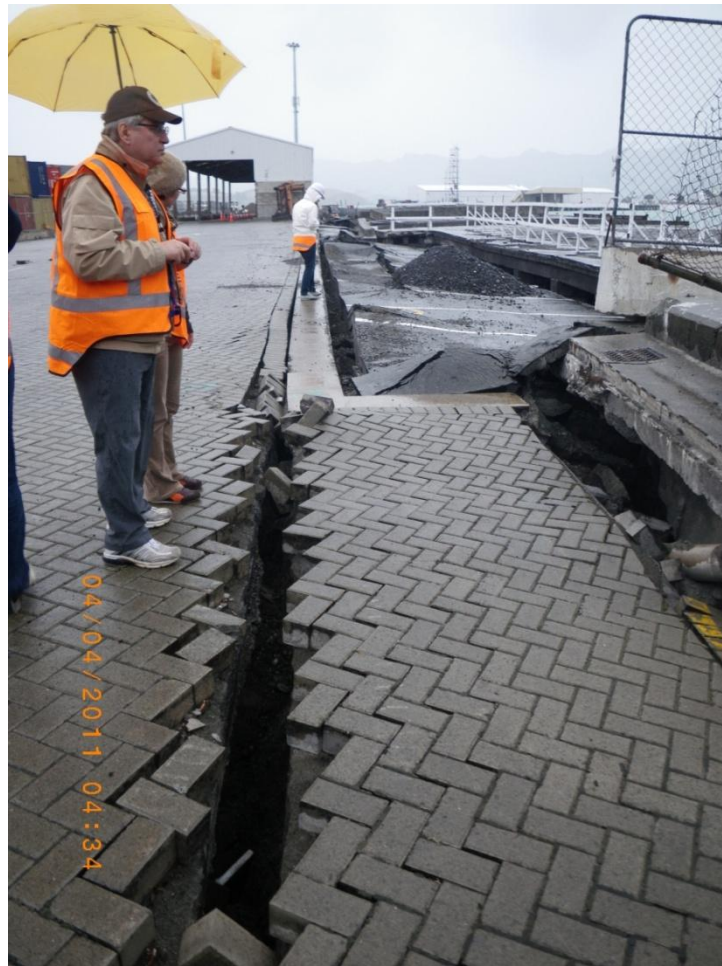
Figure 5.15. Huge cracks in the pavement in the order of 50 cm due to outward lateral movement of the quay (site W2 pointed in the map of Figure 5.6).

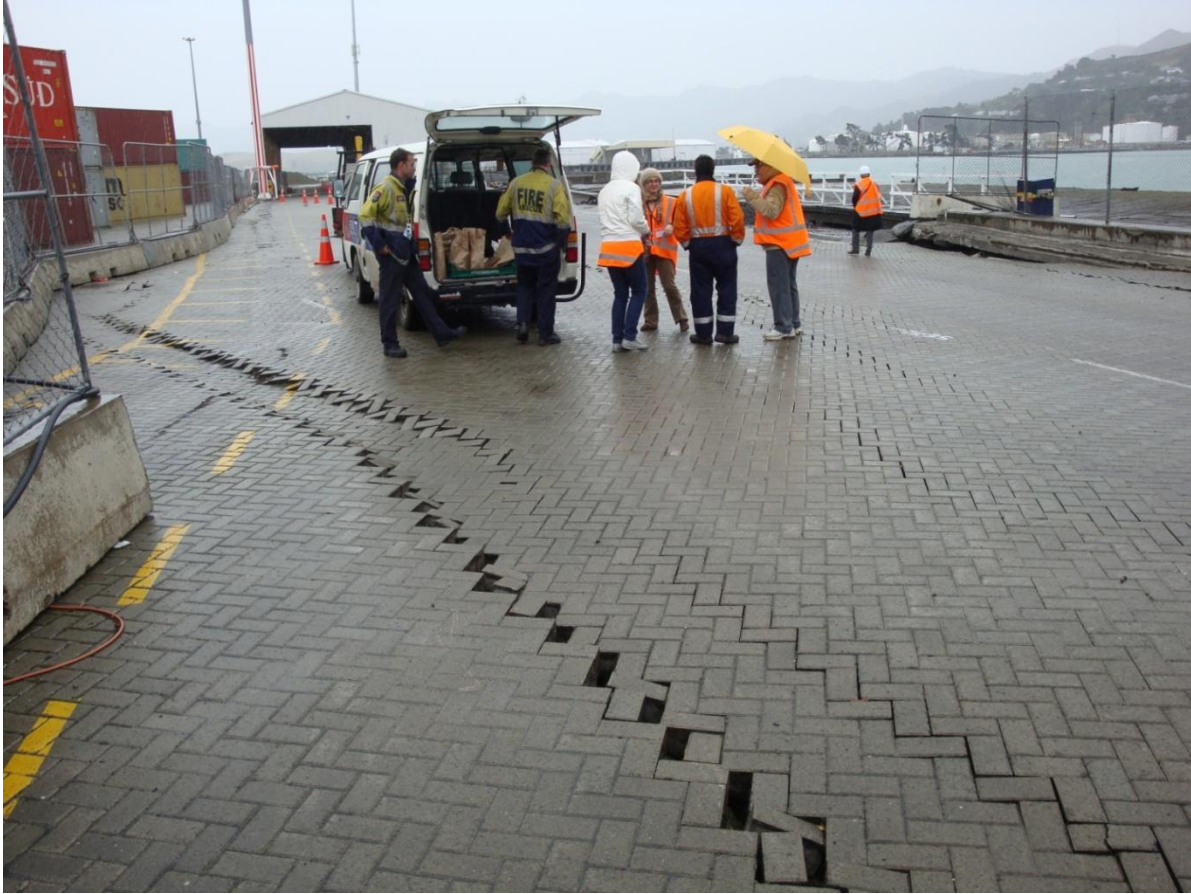
Figure 5.16. Cracks in the pavement due to lateral spreading continue to develop several meters behind the quay (site W2 pointed in the map of Figure 5.6).

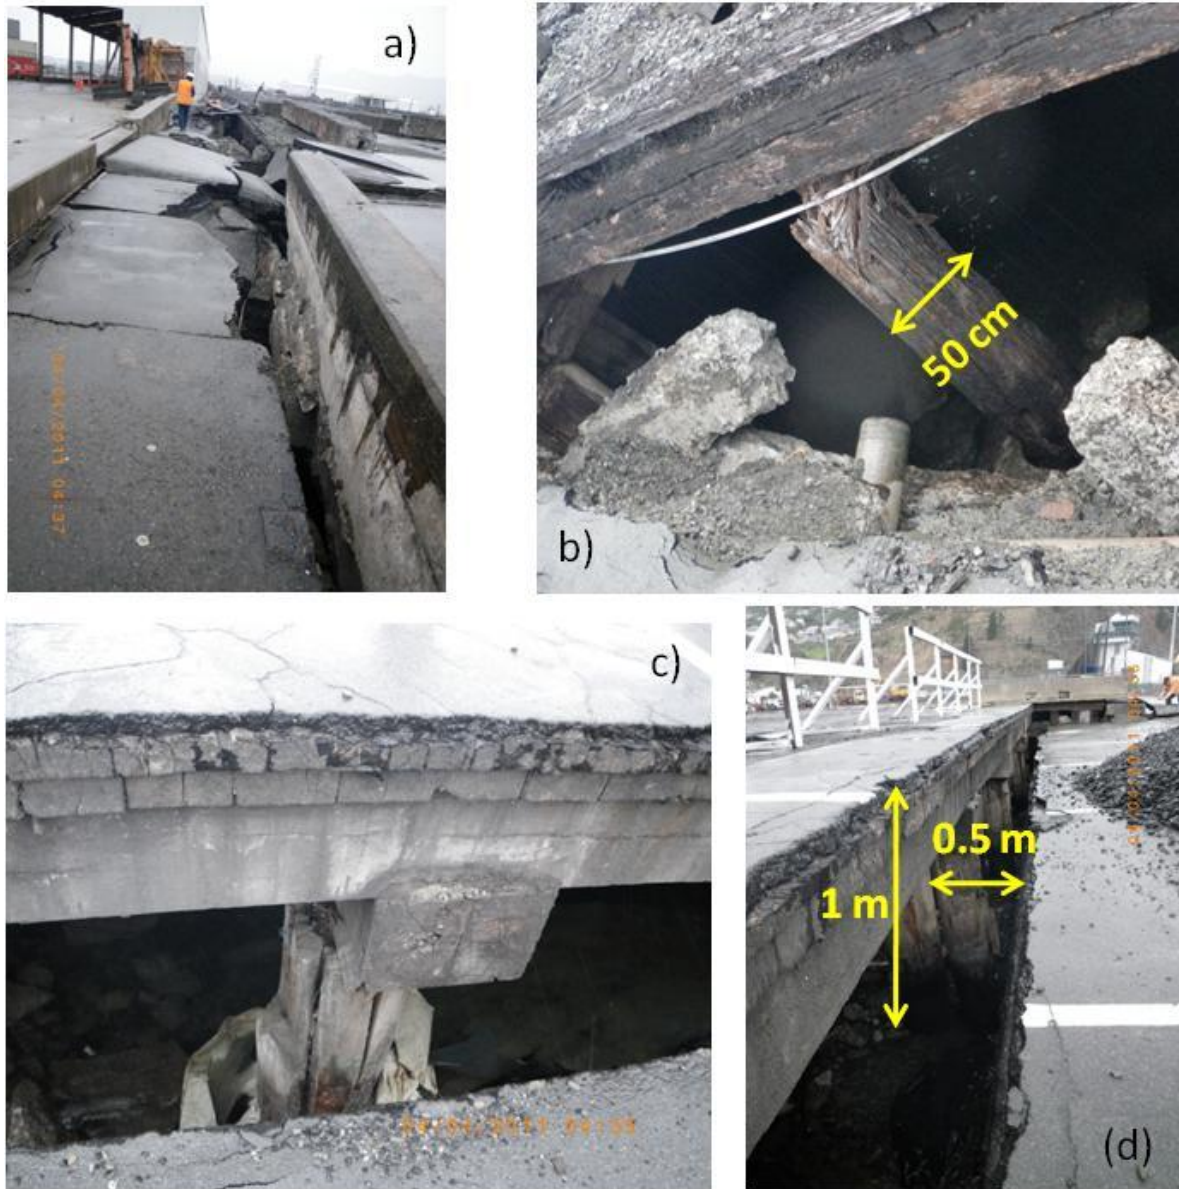
Figure 5.17. Damage of the container terminal quay (site W2 pointed in the map of Figure 5.6):
a) Crack opening and distortion of the asphalt connecting the terminal with the wharves, b) Plastic hinging at the top of a timber pile of 50 cm diameter, c) Relative movement of the deck to the pile, d) Separation of the wharf to the backfill due to 1 m settlement of the backfill and outward movement of the wharf up to 50 cm.

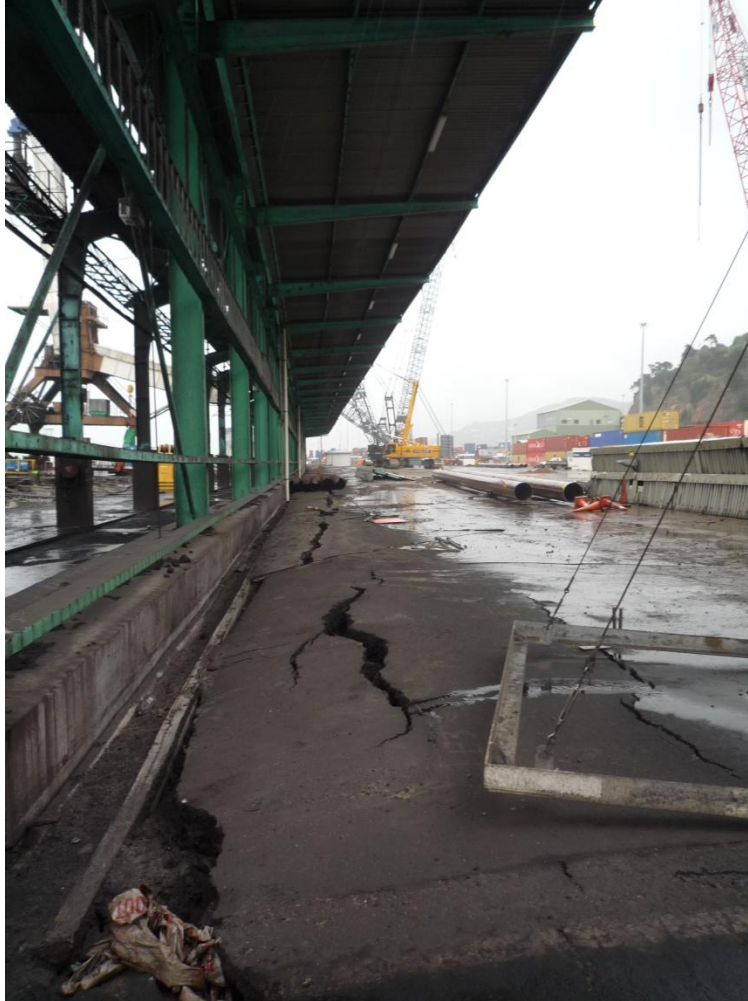
Figure 5.18. Large uniform settlement under the heavy load of the structure. Cracks in the asphalt due to heaving of the ground at right side of the steel structure (site W2 in the map of Figure 5.6)

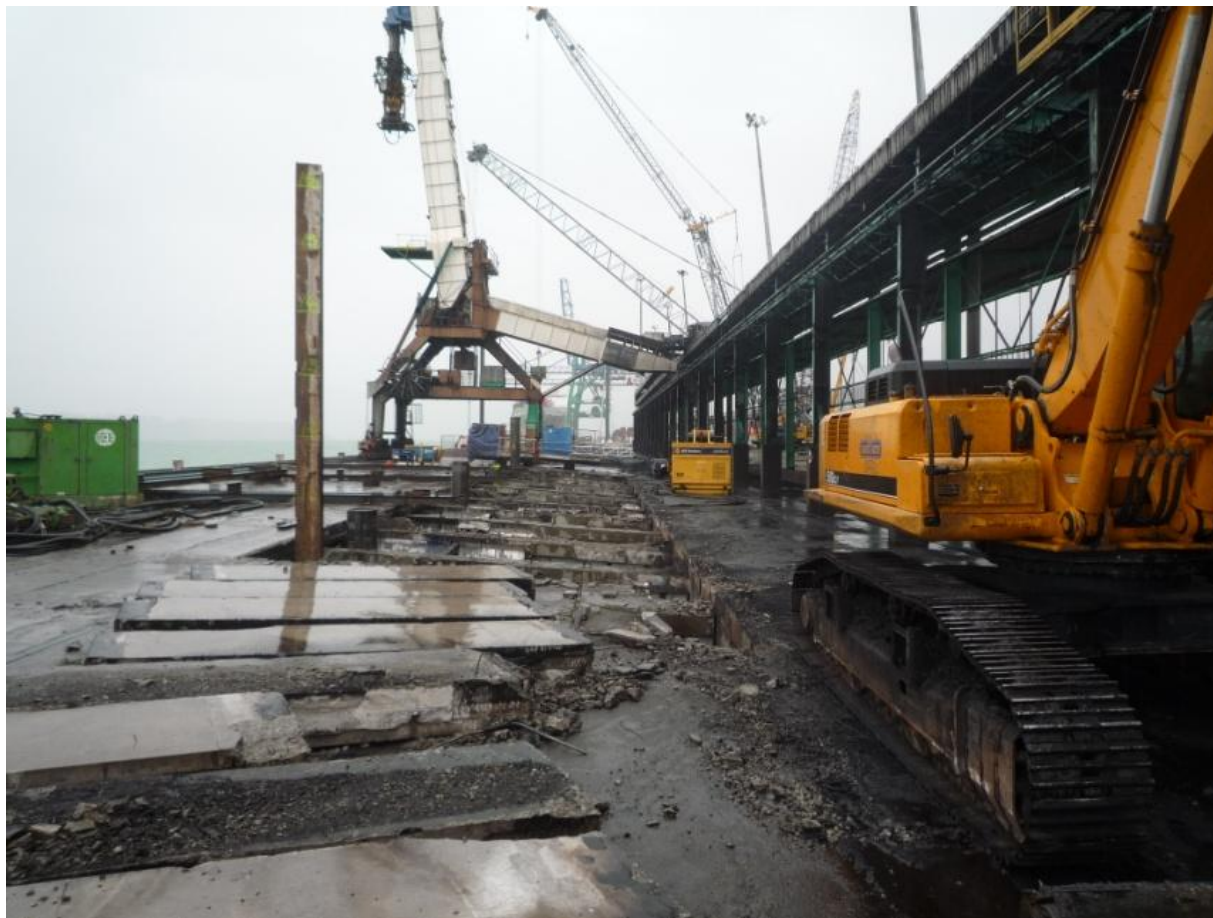
Figure 5.19. Detachment of the slabs of the platform due to differential settlement (site W2 in the map of Figure 5.6). Now the slabs have been removed from their initial place.

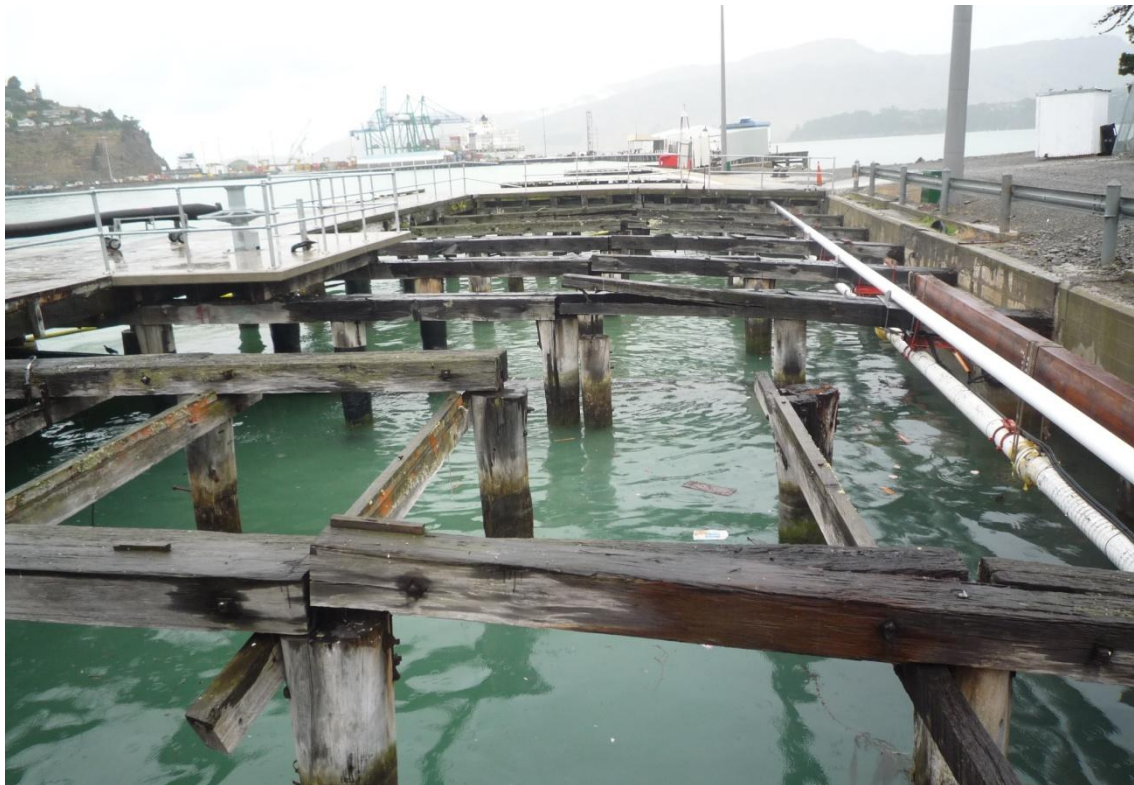
Figure 5.20. Settlement of the backfill caused detachment of the wooden beams from the pile heads (site W3 in the map of Figure 5.6).

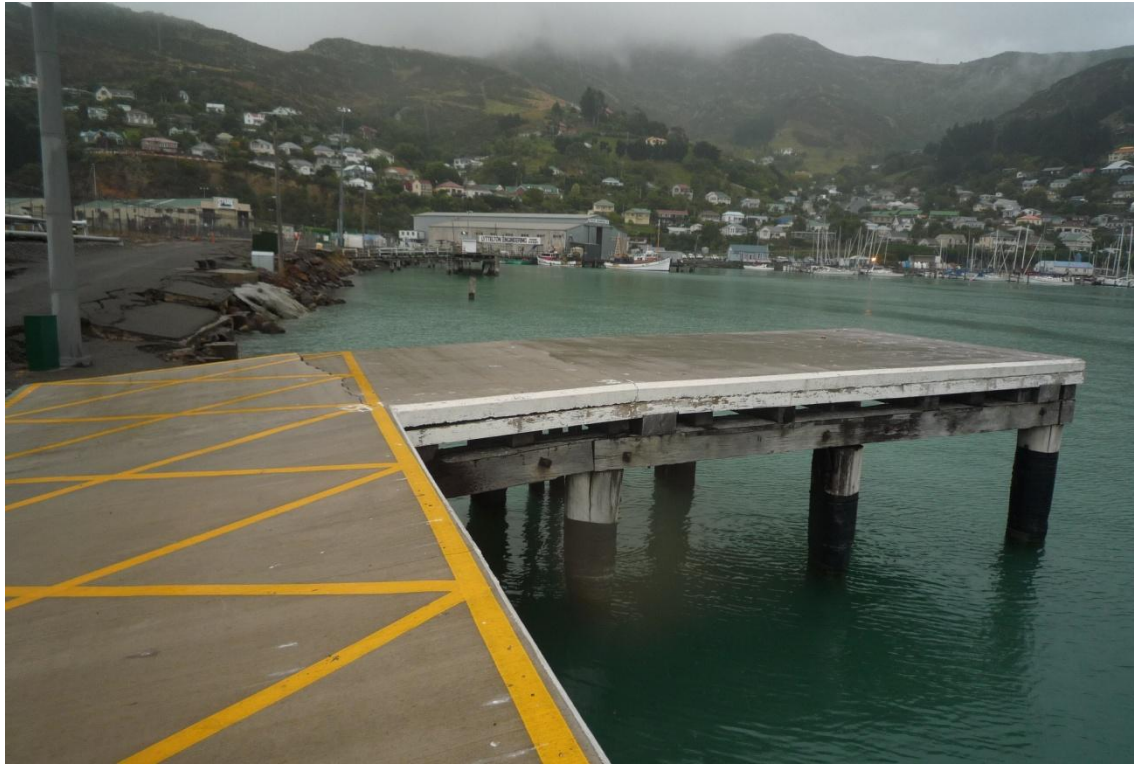
Figure 5.21. One typical pile configuration (site W3 in the map of Figure 5.6). The timber piles have cracked at the top.

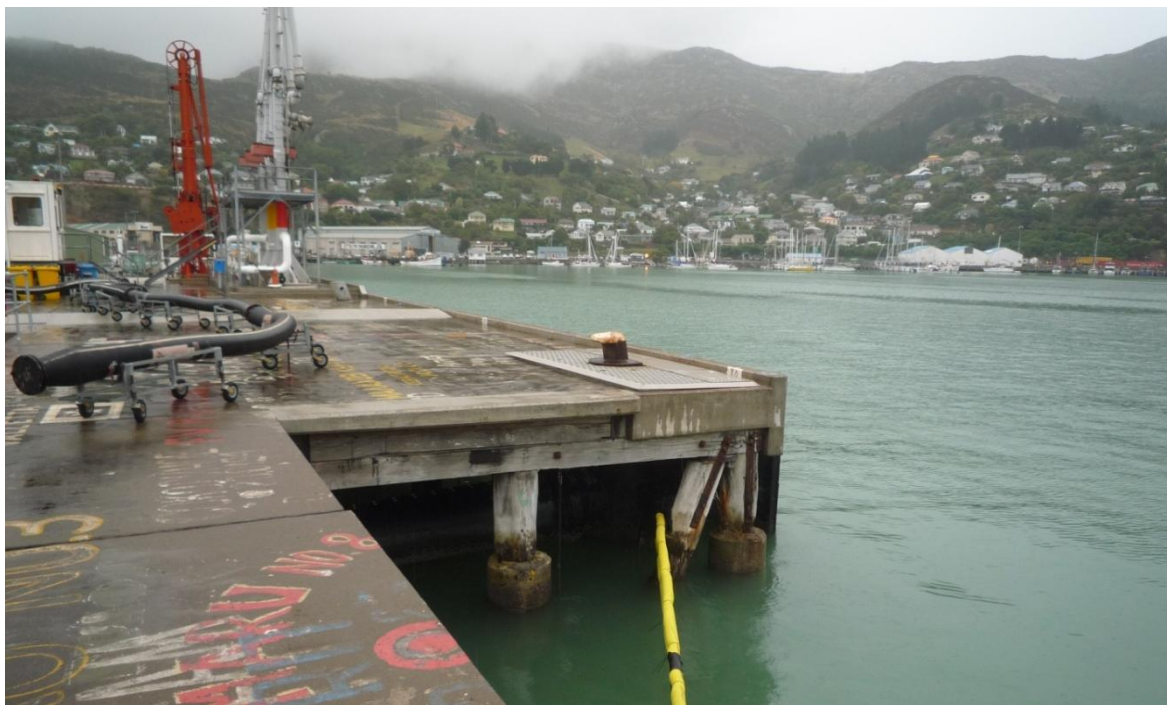
Figure 5.22. Another typical pile configuration (site W3 in the map of Figure 5.6). The concrete piles performed quite well.

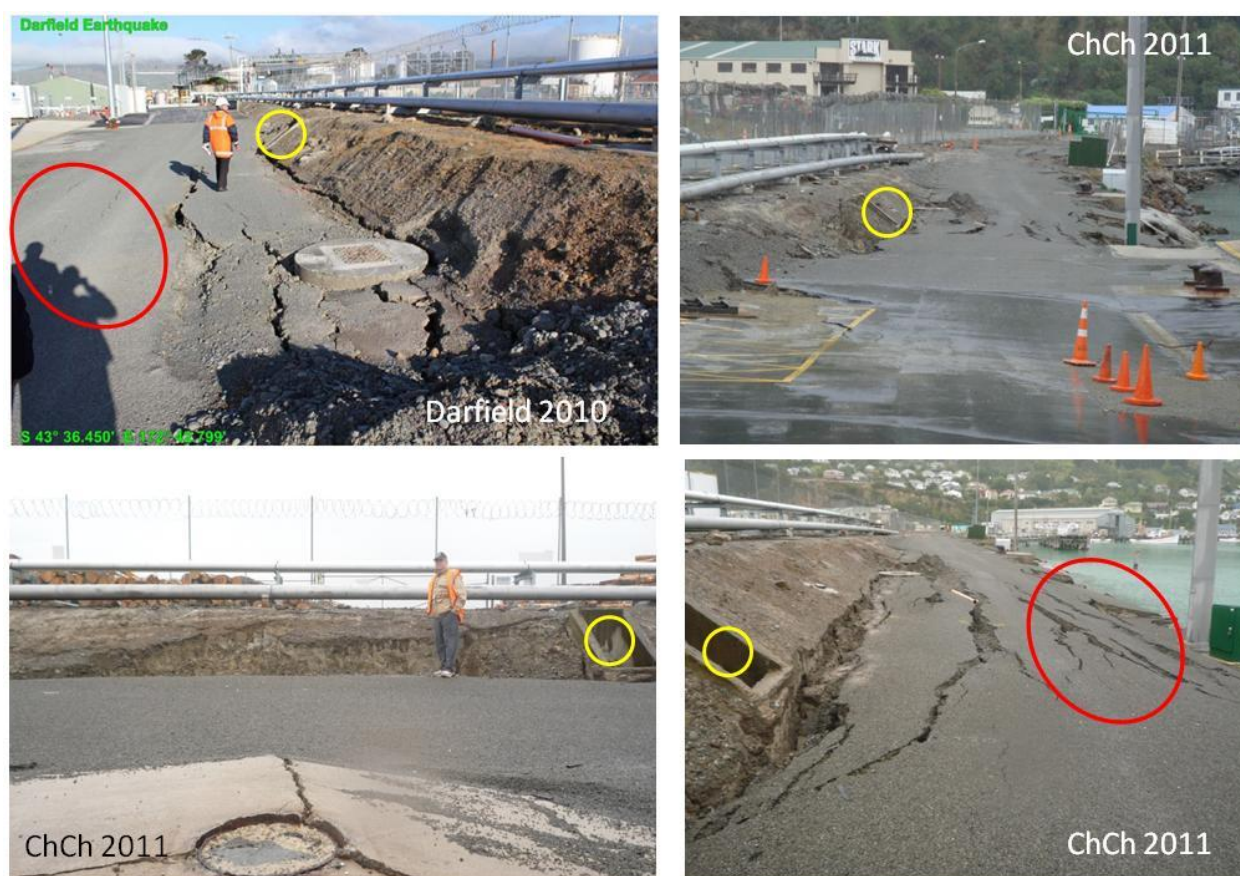
Figure 5.26. Comparison of the damage of site W3 in the map of Figure 5.6 between Darfield and Christchurch earthquakes. The yellow and red circles are the common point of references in all photos. Photo from Darfield earthquake can be found in Cubrinovsky et al. (2010).
