Foundation–structure systems over a rupturing normal fault: Part I. Observations after the Kocaeli 1999 earthquake

Ioannis Anastasopoulos · George Gazetas

3 The “natural experiment” of Denizevler: Overview

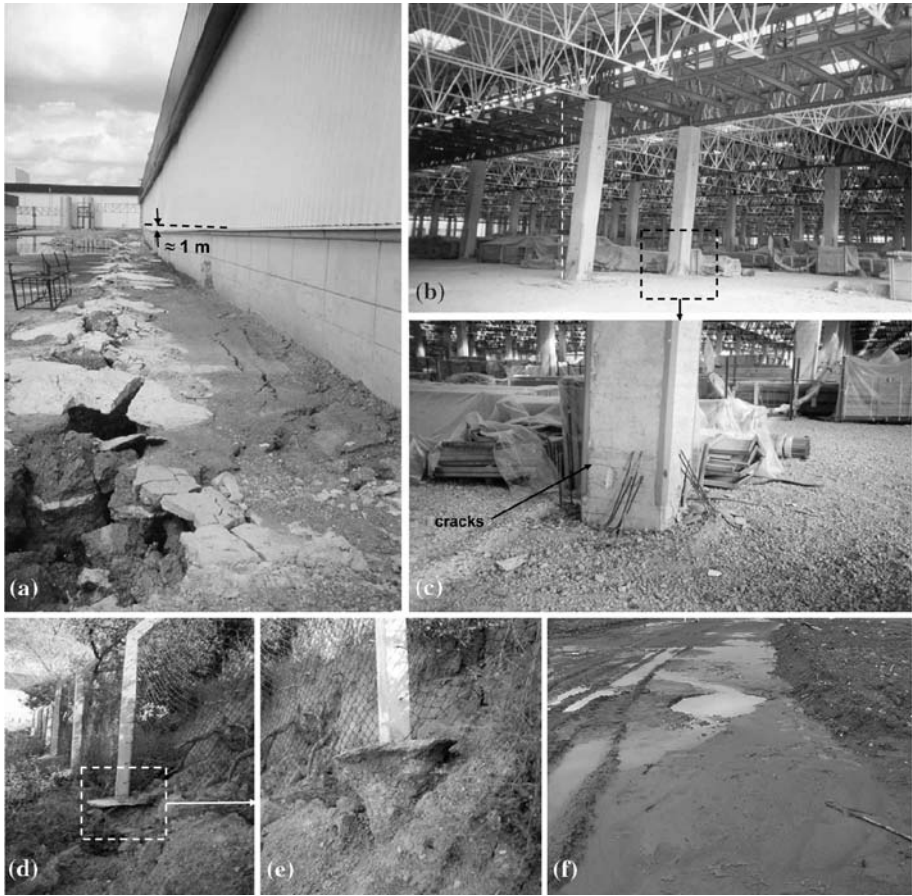
impressive (even though perhaps merely fortuitous) success was that of a high-voltage electricity pylon : crossed by the fault rupture, the pylon did not collapse, sustaining only minor damage despite the “loss” of two of its four supports. Then, a major building of an under-construction car factory of Ford also survived the faulting, but with damage (Fig. 3a, b, c). While parts of it were later demolished and reconstructed, it is interesting to note that the main dislocation practically went around the factory complex, emerging along its fence. Consequently, some portion of the fence bases were pulled out (Fig. 3d, e). Outside the factory, some traces of liquefaction (silty sand boils) were evident (Fig. 3f).

Fig. 3 Ford factory: (a) differential settlement of about 1 m, (b) tilting of concrete columns, (c) cracking at the base of the columns, (d) fault rupture right through the fence, (e) fence footing pulled out, (f) traces of liquefaction north of the building

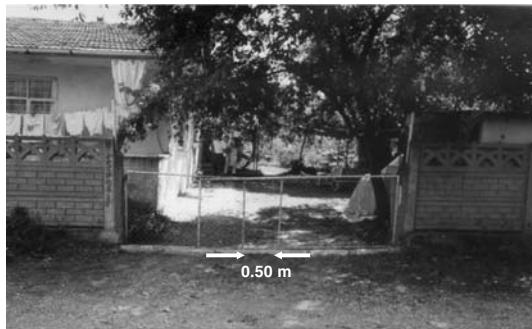
Fig. 4 Garden gate subjected to shrinking of about 0.5 m: indication of horizontal compression at a 50 m distance from the fault scarp

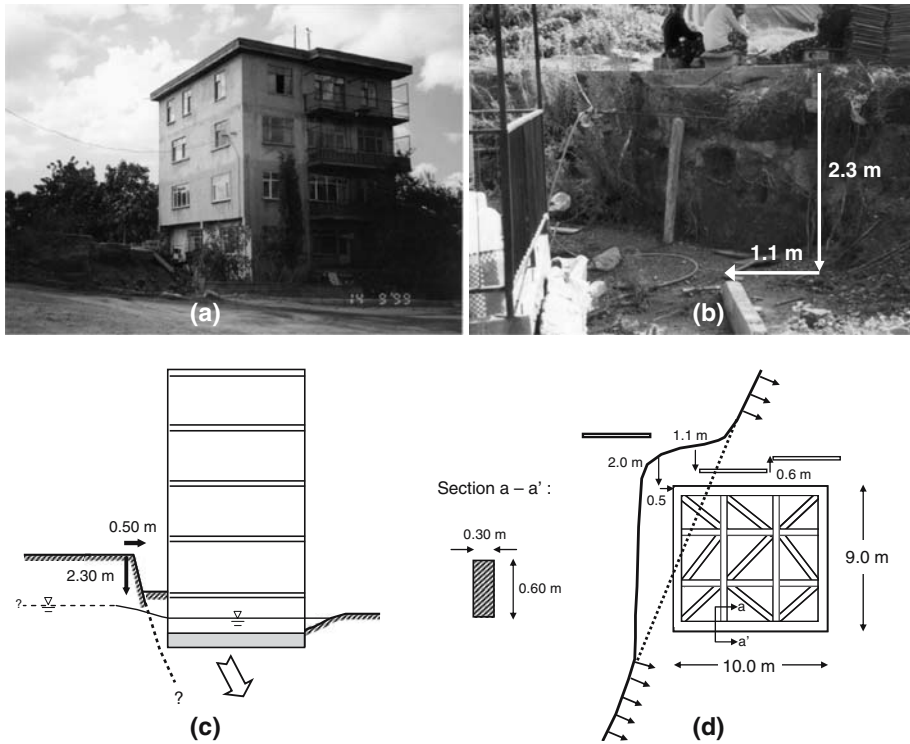
4.1 Building 1

Fig. 5 Building 1, four stories plus basement; Minor Damage: (a) photograph of the building showing the fault trace directed towards the building, before being diverted, (b) photograph showing the vertical displacement reaching 2.3 m, along with a horizontal component of 1.1 m measured on the torn apart fence of the building, (c) cross-section of the building, and (d) plan view of the foundation (box-type foundation with cross tie beams), along with the horizontal displacements measured around the building

Building 1 is a 4-story reinforced-concrete structure with basement. As depicted in Fig. 5a the surface rupture diverted and just avoided the structure, leaving it unharmed. The downward settlement (dislocation) reached 2.3 m, being accompanied by a horizontal displacement of 1.1 m (Fig. 5b). The only apparent damage to the building was the flooding of its basement, due to local modification of the water table (Fig. 5c). One year after the seismic event the basement was still filled with water, showing that the water table had changed permanently. Since the basement was flooded with about 1 m of water, and the vertical displacement was 2.3 m, it was concluded that the water table should be at a depth of about 1.5 m.

Figure 5d sketches a plan view of the fault scarp that formed around the building, as well as the consequences of differential displacement to the fence of the building. It is interesting to note that the maximum horizontal displacement occurred at the point where the rupture was re-aligned with its original path, after diverting due to the presence of the structure. This curving of the dislocation must have apparently produced the horizontal (strike component) displacement vector measured on the fence. According to the owner, who was inside the house during the earthquake, no vertical falling was felt, despite the fact that the building was on the “downthrown” hanging-wall. Instead, they only felt a torsional motion, something that agrees with the geometry of the observed dislocations and horizontal displacements around the building. Evidently, the vertical displacement should have been of quasi-static nature.

Figure 5d depicts the main characteristics of the foundation of this building. Its plan dimensions are approximately 9 m × 10 m, and it consists of strip footings approximately 0.60 m × 0.30 m (height × width) transversely connected through tie beams of similar dimensions. Interestingly, the owners of this building had detailed knowledge of the foundation (they had actually built it themselves).

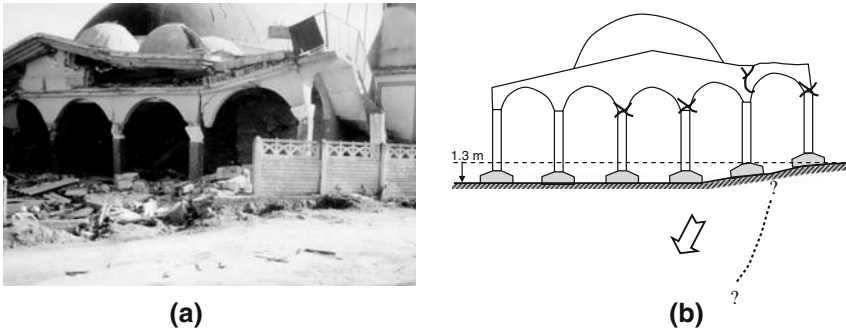
4.2 The Mosque

As shown in Fig. 6, in the area of the Mosque (less than 150 m west of Building 1) the rupture did not create a visible fault scarp. On the contrary, the dislocation appeared at the surface as a widespread differential settlement, not easily observable. Despite this seemingly “favourable” situation, the Mosque partially collapsed, and was fully demolished later. The superstructure of the mosque was also of reinforced concrete, but its foundation comprised several isolated footings, apparently without any connection between them. No shear walls or stiff tie beams existed between the columns. In conjunction with its rather “heavy” arched roof, its structural system was less stiff than that of Building 1. Its foundation is, obviously, discontinuous and thus quite flexible. Hence, the differential settlements were transmitted to the superstructure practically unaltered. We have to exclude the intensity of ground shaking from being a principal cause of the collapse, since the observed damage and cracking did not indicate horizontal shear failure. The minaret of the mosque confirms this hypothesis: in most of the regions where ground shaking was the main cause of damage, the minarets of the Mosques were quite susceptible to collapse. In this case, the minaret did not collapse.

Fig. 6 Mosque; Collapse: (a) photograph of the Mosque showing the differential settlement of the un-scarped ground surface and the distress of its superstructure, and (b) sketch of its cross section and foundation (separate footings)

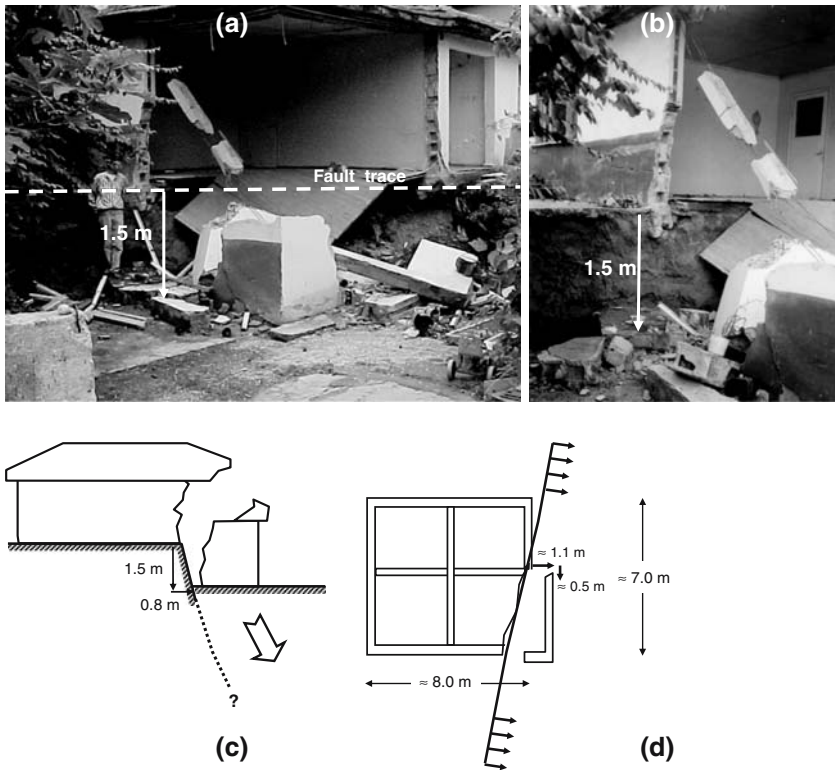
4.3 Building 2

Building 2 was a simple poorly-constructed 1-story structure. Its wooden tile-covered roof was supported directly on cinder block walls. Between the roof and the walls, poorly-reinforced concrete beams had been cast, presumably to tie the walls together.

The walls were practically founded directly on the soil, without the interference of foundation. This poor building would *not* have been expected to perform well in an imposed differential displacement of the order of 1.5 m, and indeed it was torn apart by the rupture as depicted in Fig. 7a and b. However, it did not collapse completely, and its partial collapse did not cause fatalities. The rupture crossed its north-east corner tearing it apart from the rest (Fig. 7c and d). Given the limited tensile resistance of the cinder-block walls, the structure was unable to resist the rupturing significantly, leaving the rest of it almost un-harmed.

Compared to the adjacent Mosque, this building can be seen to have behaved a little better: a part of it collapsed, but the rest was left intact. We believe that one could attribute the partial survival of this modest building to its “compliance”, in terms of strength. On the other hand, the Mosque, a better-built structure, offered more resistance to the differential settlement (this is attested by its deformation), but was obviously not strong enough to completely sustain it. A small, yet possibly important difference between the two, is the geometry of rupture crossing : Building 2 was crossed by the rupture very close to the corner (at ~ 2 m distance), while the Mosque was traversed at ~ 4 m from its northern corner. Furthermore, while the Mosque was subjected to widespread differential settlement, Building 2 was forced to endure a distinct fault scarp. Although, such a situation would seem to be favourable for the Mosque, this was not the case here. Apart from these differences, the two structures were quite similar in the discontinuity and flexibility of their foundation. Both were significantly different in this respect from Buildings 1 and 3, which both rested on rigid and continuous foundations.

Fig. 7 Building 2, single story; Partial Collapse: (a) photo of the fault trace passing through the building (adapted from Youd et al. 2000), (b) photo of the rupture-produced cross section of the building (cinder-block walls directly founded on the ground), (c) schematic cross-section of the building, and (d) plan view of the foundation and the measured offset displacements

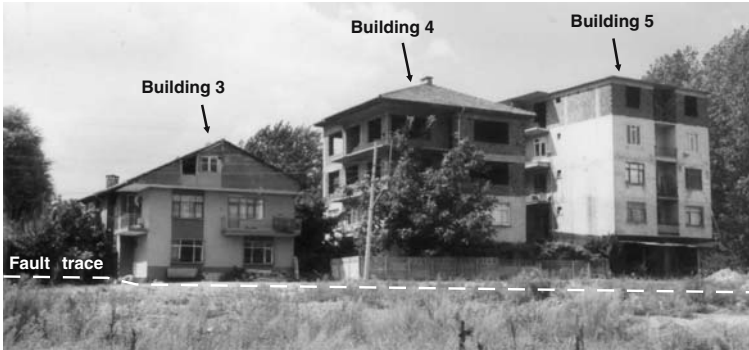
Fig. 8 Panoramic photo of Buildings 3, 4, and 5: all of them survived the dislocation with only minor damage. Most interesting is the case of Building 3, in which case the fault rupture was effectively diverted.

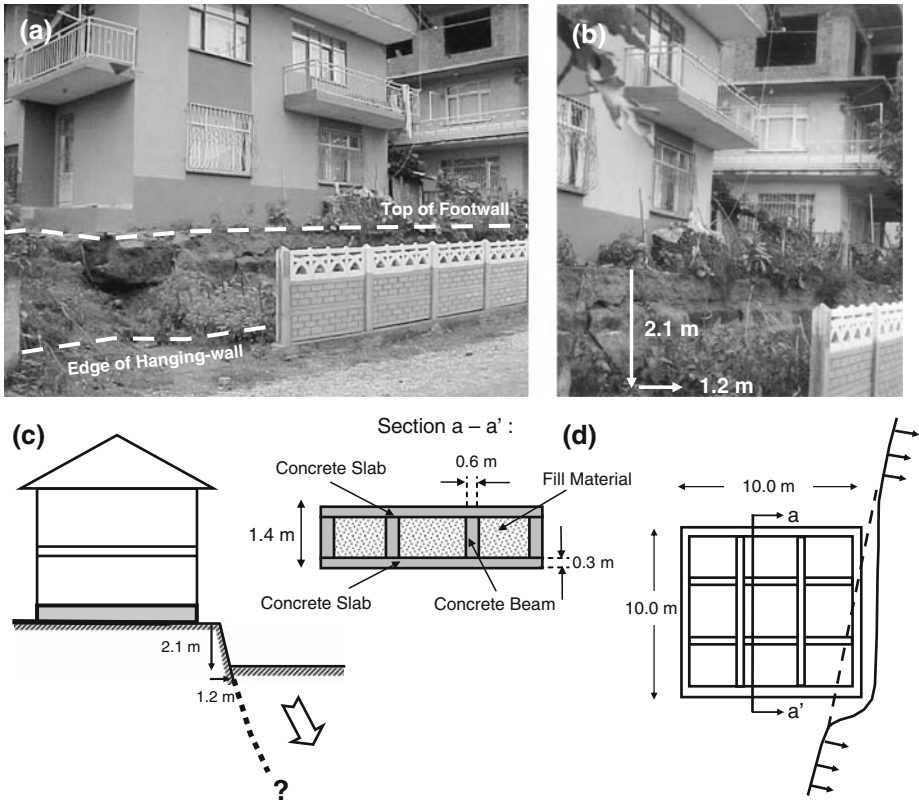
4.4 Building 3

Building 3, along with Buildings 4 and 5 (Fig. 8) managed to survive the tectonic dislocation without any externally visible damage other than a hairline crack on one of their brick walls. Most importantly, it seems to have effectively diverted the rupture, as was the case with Building 1. But whereas Building 1 is founded on the hanging-wall, managing to divert the rupture to the South (towards the footwall), Building 3 is founded on the footwall, and the rupture was slightly diverted to the North, towards the hanging-wall (Fig. 9a). The vertical displacement in this case reached 2.1 m (Fig. 9b

and c). The reinforced concrete building comprises 2 stories and an attic. As depicted in Fig. 9d its box-type foundation system is quite rigid, comprising stiff concrete beams “sandwiched” between a mat and a top slab. The voids between the concrete beams and the slabs are filled with gravelly soil. The slabs are about 0.3 m thick, and the concrete beams 0.5–0.6 m wide, while the thickness of the whole box reaches ~ 1.4 m.

It appears that rigid box-type foundation is quite common in the provincial regions of Turkey with poor soil conditions. The box-type foundation is considered as a relatively inexpensive but rigid foundation system. Obviously, the constructors (usually the owners themselves) did not have in mind resistance to faulting-induced differential settlements. Their aim was to secure their inexpensive, and therefore vulnerable, superstructures from excessive differential settlements due to soil compliance. This type of foundation is also widely used in Adapazari, where most of the failures were of the bearing capacity type (Gazetas et al. 2003). In Adapazari, although many buildings had even toppled, the foundation and superstructure remained structurally un-harmed. This offers additional confirmation of the ability of rigid and continuous box-type foundations to safeguard vulnerable superstructures.

Fig. 9 Building 3, two stories plus attic; Minor Damage: (a) photo of the building, showing the fault scarp right next to the building (adapted from Youd et al. 2000), (b) photo of the rupture scarp in front of the building, showing the measured vertical and horizontal displacement, (c) schematic cross-section of the building, and (d) plan view of its box-type foundation along with a representation of the diverted rupture.

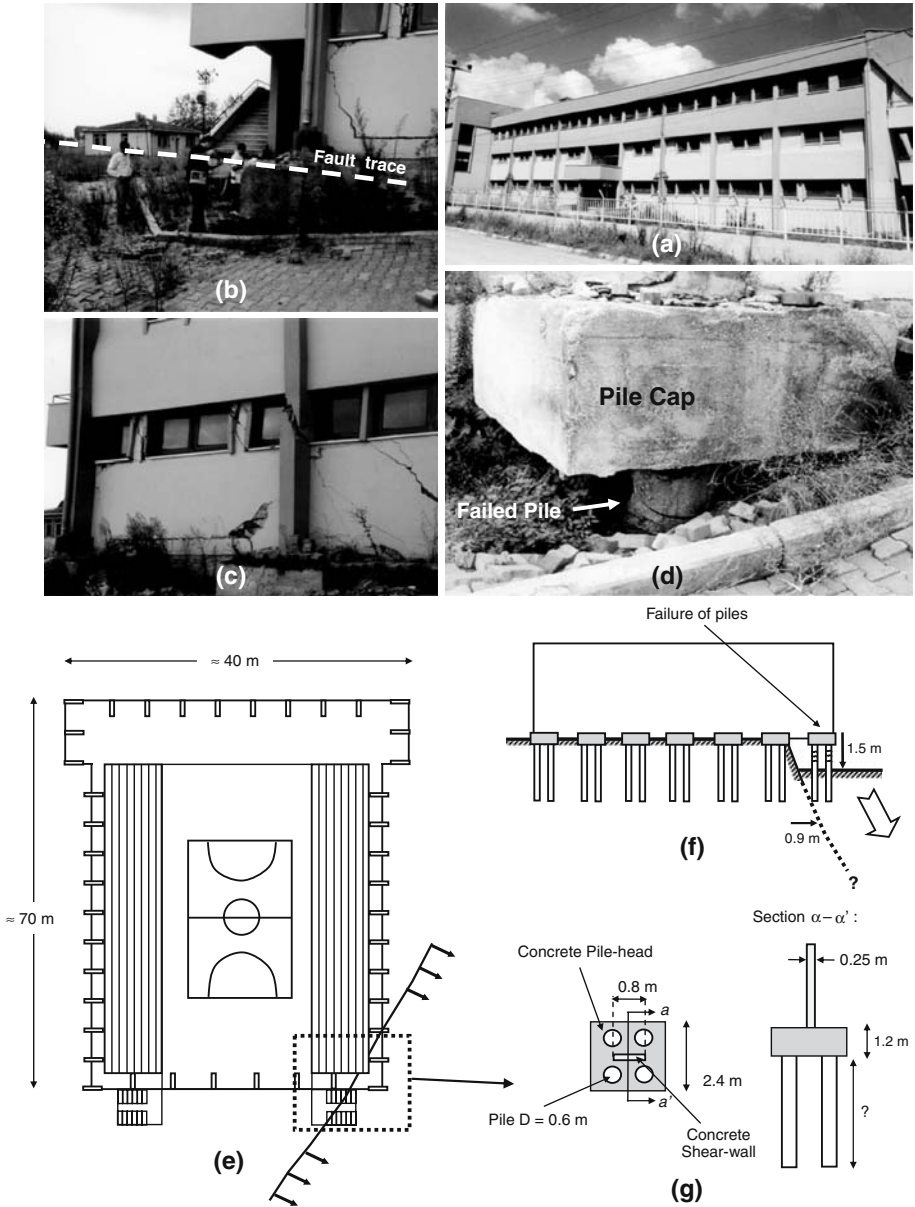
4.5 The “Attatürk” basketball court

The Basketball Court, named “Attaturk”, had just been constructed when the 1999 earthquake struck. As shown in Fig. 10a the rupture crossed its northeastern corner causing significant local damage to its reinforced concrete superstructure. Figure 10b shows the southern part of the building, which sustained practically no damage. Again, the damage can be attributed solely to differential tectonic displacement and not strong seismic shaking. Figure 10c depicts the extent of damage suffered by the northeastern part of the building, near the corner struck by the dislocation. Several of its concrete shear walls failed, while its non-bearing brick walls were diagonally cracked, indicating tensile failure at 45° due to differential settlement. Figure 10d depicts the damage to the piled foundation. The pile at the photo had been pulled downward and outward, and tensile cracking was easily observable. Its adjacent pile (not seen in the photo) had failed in tension completely, and was totally detached from the pile cap.

The plan view of the Basketball Court is sketched in Fig. 10e. Its structural system comprised shear-wall type columns $0.25\text{ m} \times 0.80\text{ m}$ in plan, positioned along the perimeter. As depicted in Fig. 10f, each column is founded through a 2×2 pile group. The piles are 0.6 m in diameter, connected together through a 2.4 m-square pile cap, 1.2 m in thickness. Although the building survived the induced differential displacement, the extent of damage was quite significant; the structure was deemed as “beyond the limit of repair” (BLR). It will be argued in the companion paper (Anastasopoulos and Gazetas 2007), that this constitutes a case where the piled foundation possibly contributed to the damage, by forcing the superstructure to follow the imposed displacement. In fact, if the piles had not failed (in tension), the situation might have been even worse.

Fig. 10 Basketball Court; Severe Local Damage: (a) panoramic photo of the building, (b) photo of the building’s corner crossed by the fault trace, (c) shear damage due to the imposed differential settlement, (d) tensile failure of the piled foundation, (e) schematic plan view of the building, along with the rupture trace, (f) cross-section showing the fault displacement and the damage to the (pulled-down) piles, and (g) detail of the foundation

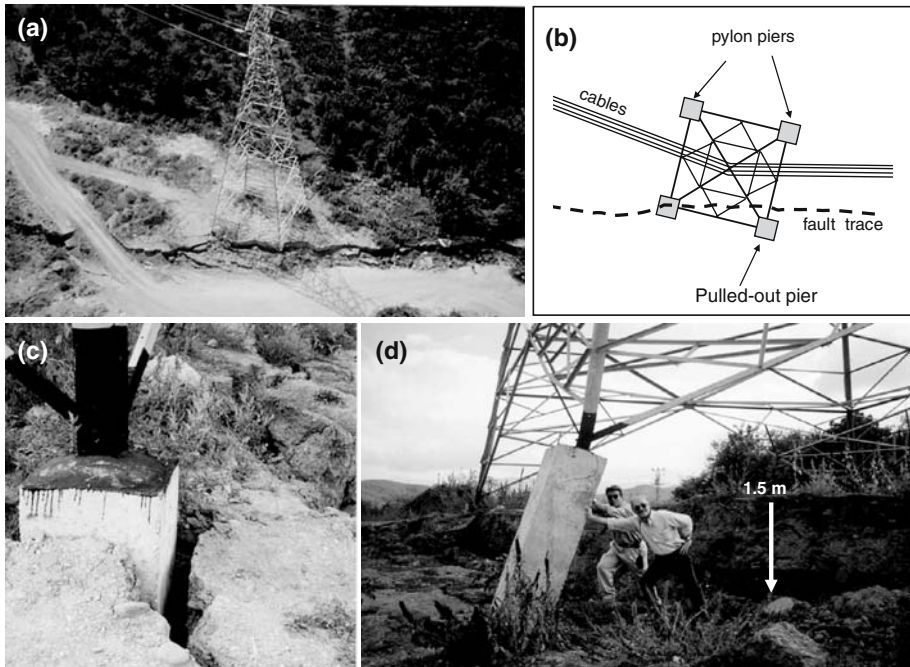
4.6 High-voltage electricity pylon

Figure 11a shows an aerial photo of the high-voltage pylon, east of the FORD factory, crossed by the fault rupture. The vertical displacement in this case reached about 1.5 m (Fig. 11b) with a relatively minor horizontal component. The pylon superstructure was a typical metal space-frame, while the foundation comprised four small concrete piers, $1\text{ m} \times 1\text{ m}$ in cross section, and 2.5 m deep. The rupture crossed its northeast corner, forcing two of the piers to follow the downward displacement of the hanging-wall, while the other two remained attached to the footwall. One of the two foundation piers founded on the hanging-wall was completely pulled-out, while the other was just “crossed” by the dislocation and remained attached. Surprisingly, not only the pylon did not collapse, but it actually suffered only minor local damage. The question that logically arises is how the pylon succeeded in carrying its dead load while supported on only 2 of its 4 foundation points. We identify two plausible explanations: (a) the pylon was in fact still supported on at least three foundation points, i.e. assuming that the pier directly “hit” by the rupture remained more- or less in place; and (b) the “favourable” orientation of the cables permitted development of the necessary horizontal force to counter-balance the eccentric vertical reaction of the two remaining foundation points. Naturally, both (a) and (b) may have contributed to its survival.

Fig. 11 High Voltage Pylon; Minor Damage: (a) aerial photo (adapted from Youd et al. 2000), (b) plan-view sketch of the pylon and the fault rupture, (c) photo of the directly-hit left foundation pier, and (d) photo of the pulled-out right foundation pier
