Fault rupture–foundation interaction: selected case histories

E. Faccioli · I. Anastasopoulos · G. Gazetas ·
A. Callerio · R. Paolucci

Keywords Fault rupture propagation · Soil–structure interaction · Kocaeli · Düzce-Bolu · Chi–Chi · Mount Etna

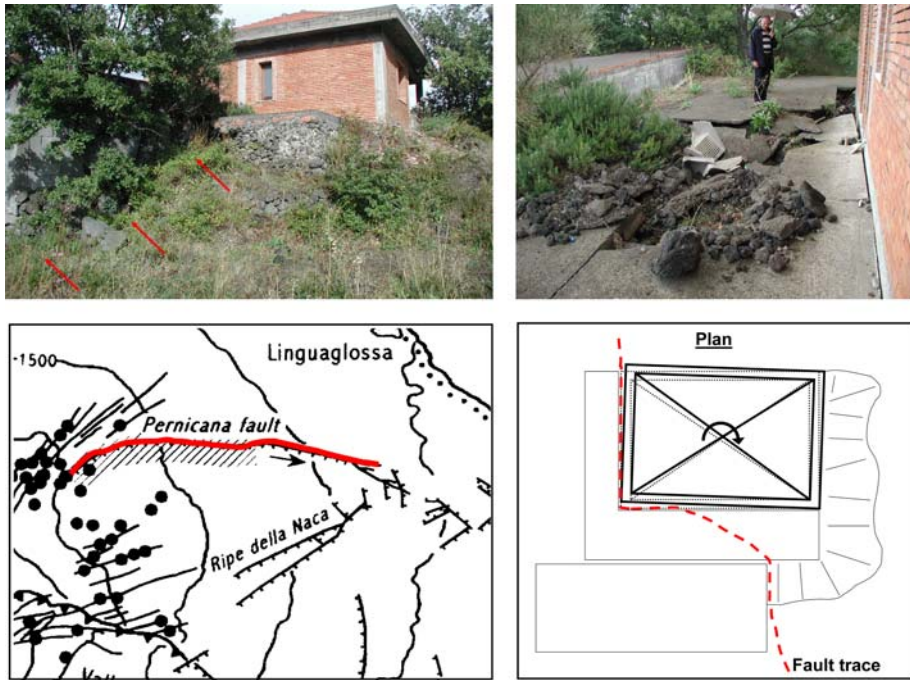
Fig. 4 Mt. Etna—Pernicana strike-slip fault: 1-story building resting on a rigid raft foundation. The continuity and stiffness of the foundation forced the surface fault rupture to divert away from the structure, leaving it almost completely unscathed, but with some rigid-body torsion around its vertical axis

a rigid and continuous raft foundation with reinforcing ring beams at the perimeter. During an earthquake sequence that lasted from 1981 to 1988, the structure was crossed by the surface trace of the strike-slip Pernicana fault almost diagonally. But the greatest amount of the imposed deformation was most likely caused by continuous “aseismic” creep over the years. Interestingly, the fault rupture did not cause significant structural damage to this modern but modest structure. In fact, the continuity and stiffness of its foundation (mainly provided by RC ring beams as shown in Fig. 5), seems to have forced the surface fault rupture to divert, leaving the building largely unscathed, but causing visible rigid-body torsion around its vertical axis. Severe non-structural damage, in the form of cracking of partition walls, occurred at a lower level on the side of the building opposite to that shown in Fig. 4. The similarities with Banco Central de Nicaragua (Duncan and Lefebvre 1973) are notable, despite the differences in the foundation system (slab, instead of a vault).

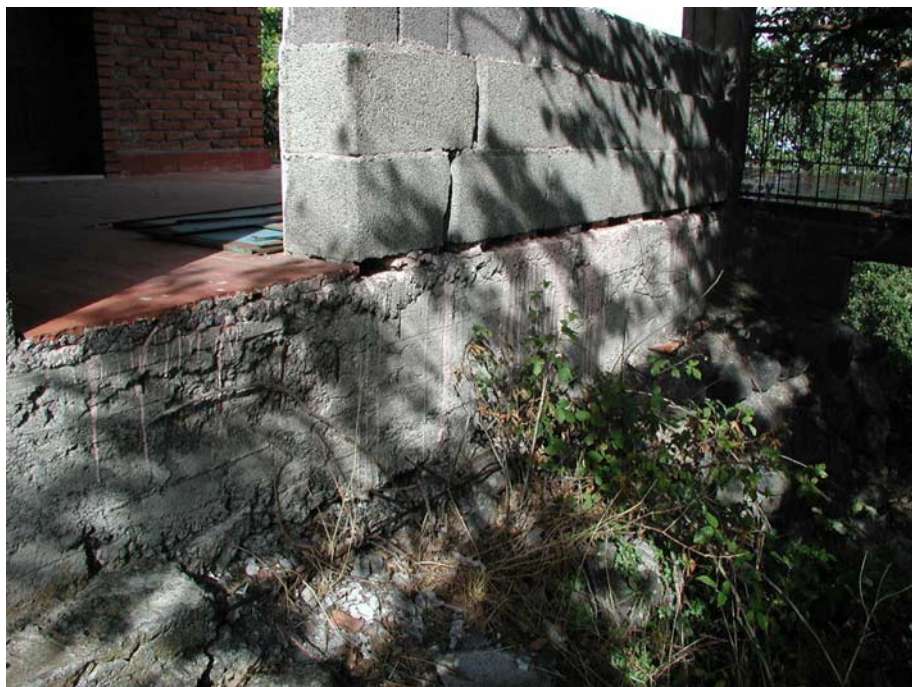
Fig. 5 Mt. Etna—1-story building of Fig. 4. Detail of the reinforced concrete ring beam around the raft foundation

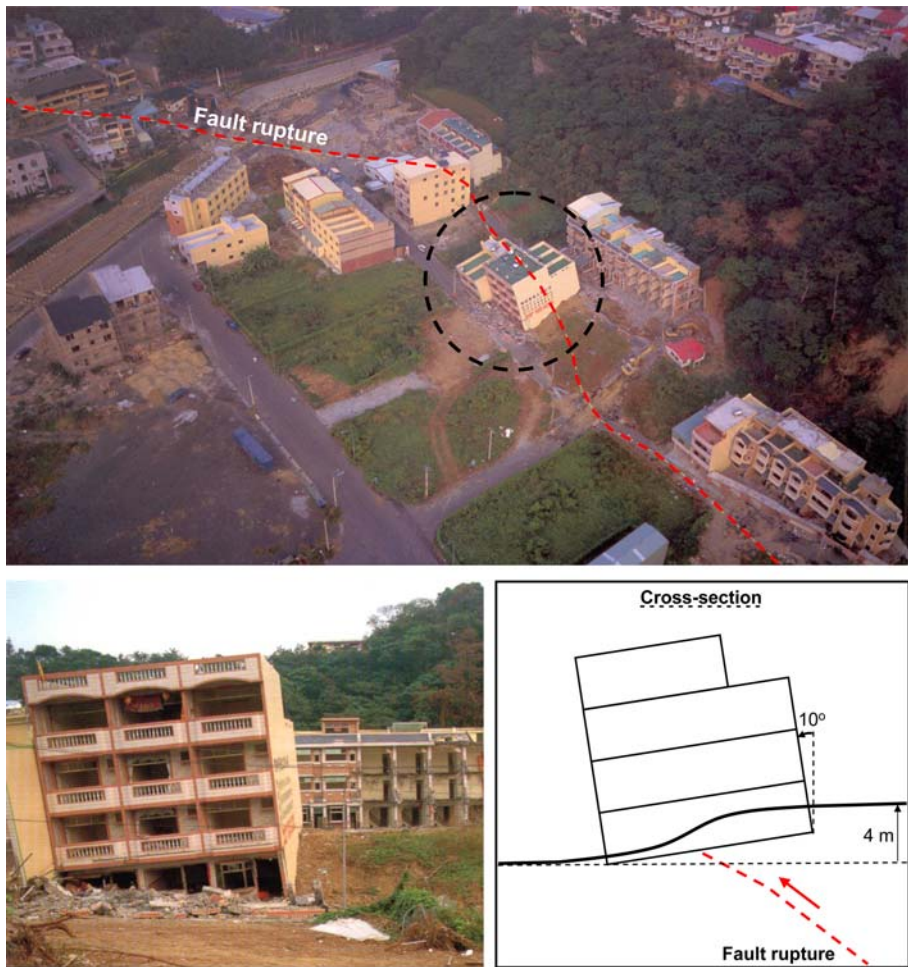
As already said, during the 1999 Chi-Chi earthquake in Taiwan a great variety of structures were crossed by the Chelungpu thrust fault. Among several other rural areas, the fault passed through Fung-Yan City in Chung-Cheng Park (see Fig. 2). Although several buildings were severely damaged or even collapsed, there were some cases of exceptional performance (see also [Dong et al. 2003](#)). One such case is the 4-storey reinforced concrete building of Fig. 7 (photos adapted from [Hwang 2000](#)). This structure survived almost 4 m of upthrust, without substantial structural damage (given the circumstances). As in the case of the 1-story building of Roccampana, due to the rigidity and continuity of its foundation system, the building underwent a rigid-body rotation (with respect to its horizontal axis, this time) of approximately 10° , without suffering much distortion.

Fig. 7 Chelungpu thrust fault, Chi-Chi, Taiwan 1999 earthquake—Chung-Cheng Park, Fung-Yan City: 4-story building resting on a continuous and rigid foundation (photos adapted from [Hwang 2000](#)). The building survived 4 m of upthrust without substantial structural damage, but subjected to approximately 10° of rigid-body rotation

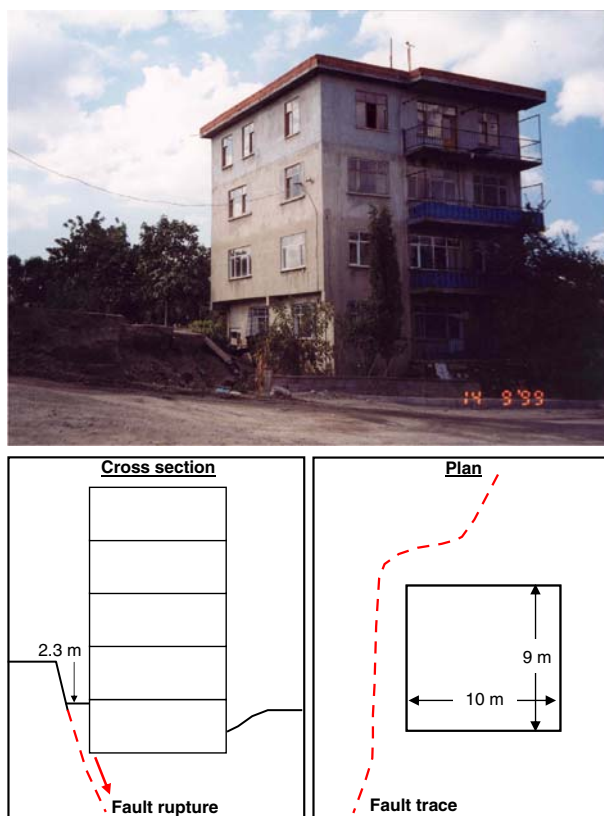
illustrates the main features of one such example, i. e. a 4-storey building with basement, resting on a continuous rigid box-type foundation. This building survived 2.3 m of downward displacement without any visible damage and, moreover, it effectively diverted the surface rupture.

Fig. 9 Normal fault east of Gölcük, Kocaeli, Turkey 1999 earthquake—Denizevler: 4-story building with basement resting on continuous and rigid box-type foundation. The building survived 2.3 m of downward displacement without any visible damage. Moreover, the surface rupture was diverted away from the building

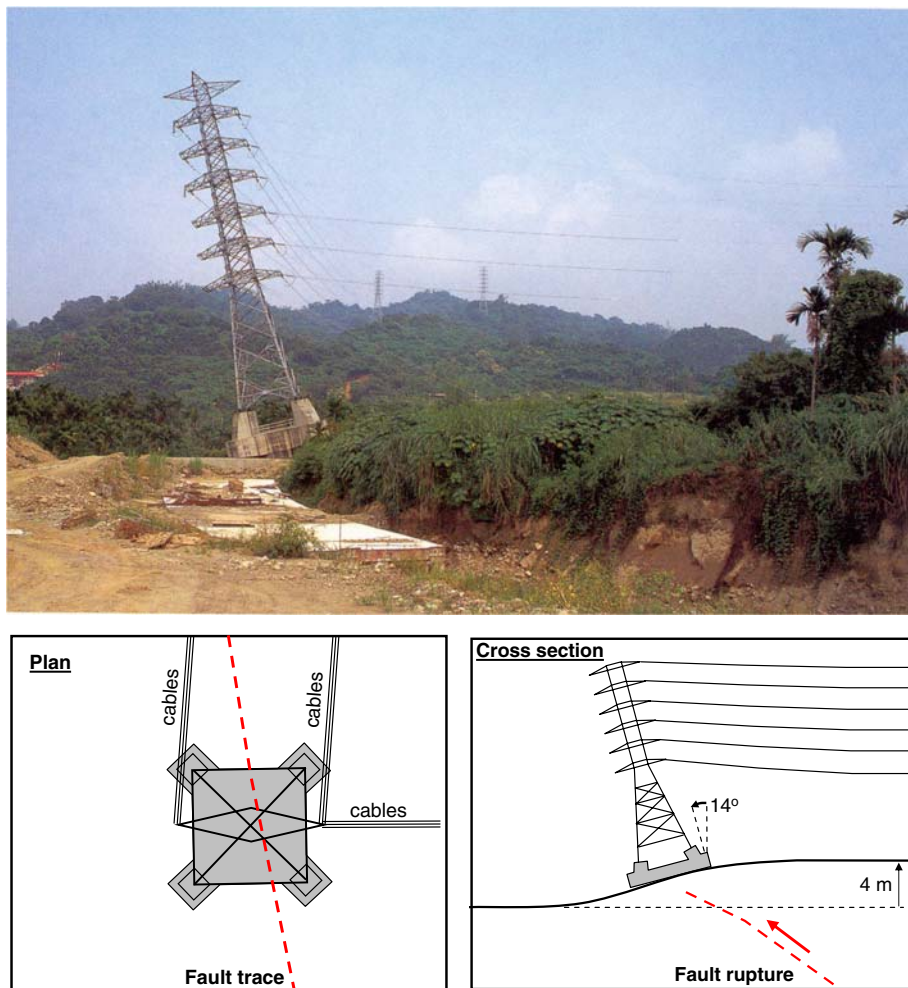
Figure 11 (photo adapted from Hwang 2000) depicts one final example from the Chi-Chi 1999 earthquake in Taiwan. It refers to a high-voltage electric line pylon in Min-Chien City (see Fig. 2b). The Chelungpu thrust fault crossed this pylon almost perpendicularly, imposing an upthrust of about 4 m. Quite interestingly, due to its rigid caisson foundation, the pylon survived the dislocation without any visible structural damage, although it underwent substantial rigid-body rotation of approximately 18° . This case-history is believed to be of particular significance, proving beyond doubt the beneficial role of such foundation systems. In the previous cases, one might conceivably have argued that the rigidity of the superstructure may have played an equally important role. However, in this case the superstructure is definitely quite flexible, and the survival of the structure can be attributed solely to its foundation.

Fig. 11 Chelungpu thrust fault, Chi-Chi, Taiwan 1999 earthquake—Min-Chien City: High-voltage electricity pylon resting on a continuous and rigid foundation (photo adapted from Hwang 2000). The pylon survived 4 m of upthrust without any visible structural damage, but subjected to approximately 14° of rigid-body rotation

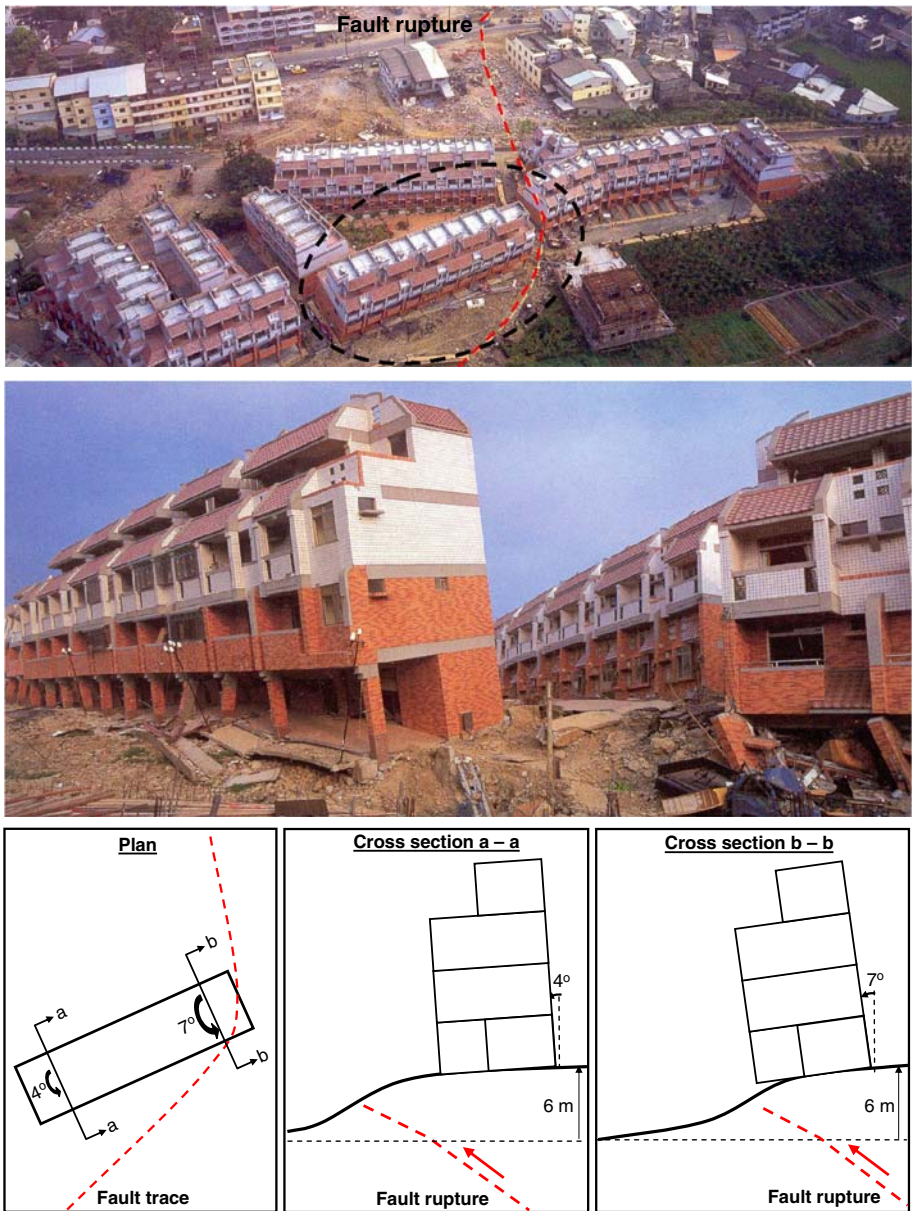
Figure 12 (photos adapted from Hwang 2000) illustrates a first such example from the Chi–Chi 1999 earthquake. It refers to a 4-storey reinforced concrete building in Fung-Yan City (see Fig. 2), the corner of which was crossed by the Chelungpu thrust fault. Subjected to 6 m of upthrust, this building barely survived the imposed deformation, having experienced substantial structural damage. Apparently, its relatively flexible foundation system did not manage to convert all of the differential displacement to rigid-body rotation. The latter ranged from approximately 7° close to the corner that was crossed by the rupture (section b-b in Fig. 12), to about 4° at the other end (section a-a). This indicates that the building did not only rotate with respect to horizontal axis, but was also subject to some torsion. Had the foundation been stiffer, the rotations at the two edges should have been almost the same.

Fig. 12 Chelungpu thrust fault, Chi-Chi, Taiwan 1999 earthquake—Fung-Yan City: 4-story building resting on a relatively flexible foundation (photos adapted from Hwang 2000). The building survived 6 m of upthrust but with substantial structural damage. The rigid-body rotation ranged from 4° to 7°

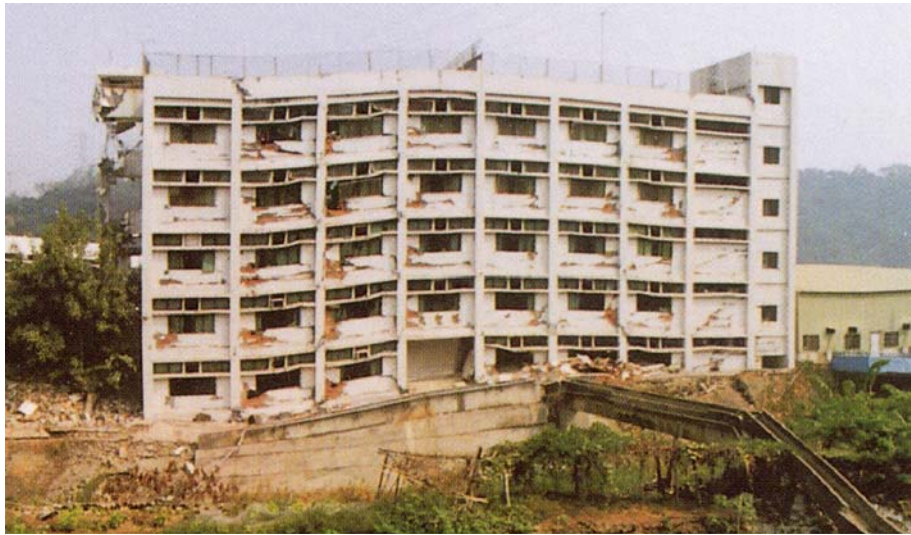
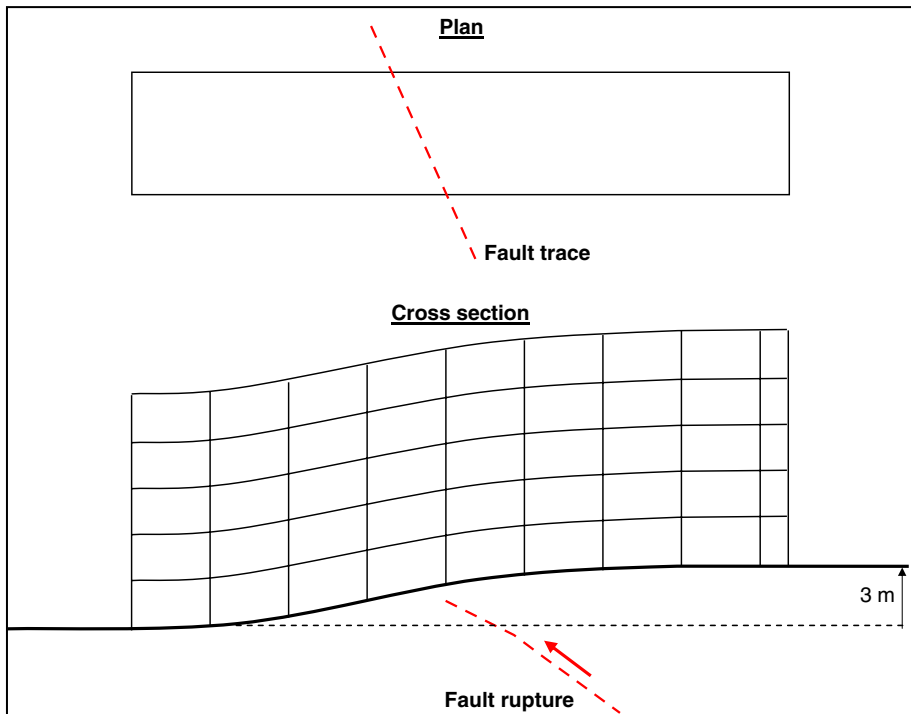
Another example from the same earthquake is given in Fig. 13 (photos adapted from Hwang 2000): a 5-storey building of the Tze-Min Commerce and Technical College in Wu-Fung Hsiang (see Fig. 2). This reinforced concrete building was crossed by the Chelungpu fault, was subjected to 3 m of upthrust. Resting on a relatively flexible foundation, this structure survived the earthquake but with heavy structural damage. Observe that there was practically no rigid-body rotation: the structure essentially followed the imposed ground

deformation profile. Compared to the previous case (Fig. 12), a noticeable difference is that this building was crossed perpendicularly to its large plan dimension. This difference in the geometry of crossing is quite crucial: the same foundation behaves much more flexibly when subjected to bending along its larger plan dimension.

Fig. 13 Chelungpu thrust fault, Chi-Chi, Taiwan 1999 earthquake—Wu-Fung Hsiang, Tze-Min Commerce and Technical College: 5-story building resting on a relatively flexible foundation. The building survived about 3 m of upthrust, but with substantial structural damage

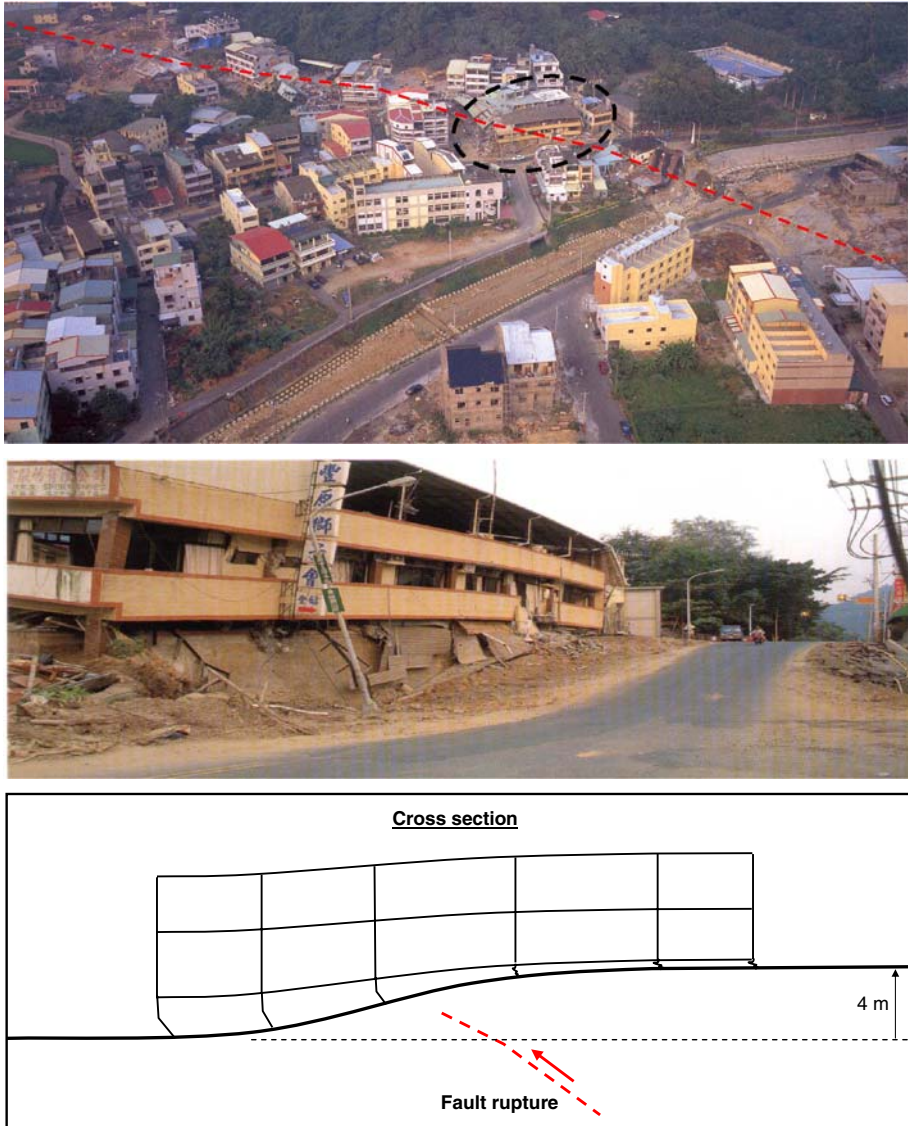
Figure 14 (photos adapted from Hwang 2000) depicts a 3-storey building in Fung-Yan City, Chung-Cheng Park (see Fig. 2). This building was also intersected by the Chelungpu fault perpendicularly to its larger dimension. Subjected to about 4 m of upthrust, the first floor of the building “pancake” collapsed. Evidently, the flexible foundation did not offer any significant bending resistance: the imposed ground deformation was practically transmitted unaltered to the superstructure, leading unavoidably to the observed collapse.

Fig. 14 Chelungpu thrust fault, Chi-Chi, Taiwan 1999 earthquake—Chung-Cheng Park, Fung-Yan City: 3-story building resting on flexible foundation (photos adapted from [Hwang 2000](#)). Subjected to 4 m of upthrust, the first floor of the building partially collapsed

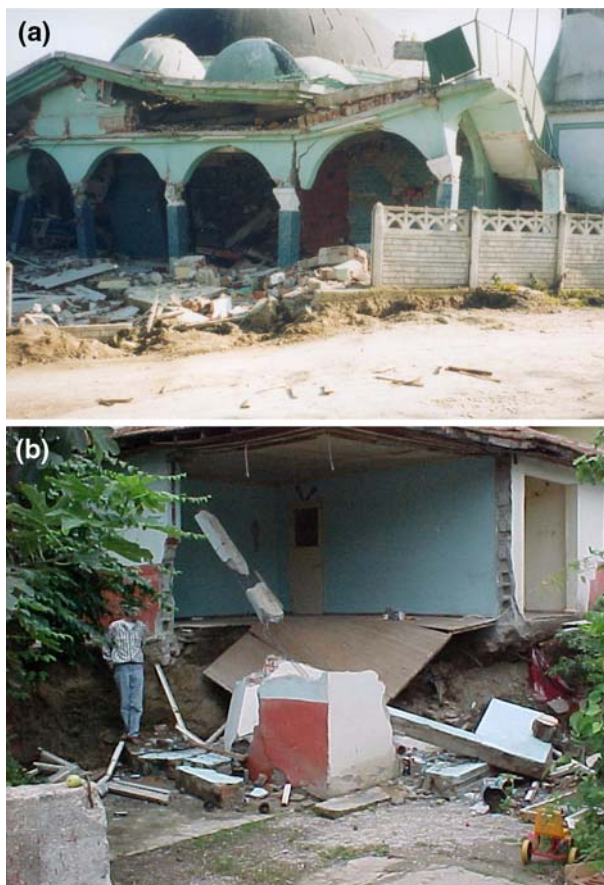
Two examples from Denizevler (Kocaeli 1999 earthquake) are illustrated in Fig. 15: (a) a Mosque resting on isolated footings (definitely a flexible foundation), and (b) a modest 1-storey cinder-block building (photo adapted from Youd et al. 2000) directly founded on the ground (an extremely flexible foundation). Both buildings were crossed by the normal fault rupture close to their corners. Subjected to about 1.5 m of differential displacement, the two structures partially collapsed, and were later demolished. As in the previous case (Chi–Chi), the differential displacements were transferred to the superstructures practically unaltered. In stark contrast to the previous case, the intensity of ground shaking is not believed to have played a major role here: the minaret of the mosque did not collapse.

Fig. 15 Normal fault east of Gölcük, Kocaeli, Turkey 1999 earthquake—Denizevler: **a** Mosque resting on flexible foundation (isolated footings), and **b** 1-story cinder-block building (photo from Youd et al. 2000), directly founded on the ground (very flexible foundation). Both buildings were subjected to about 1.5 m differential displacement and partially collapsed

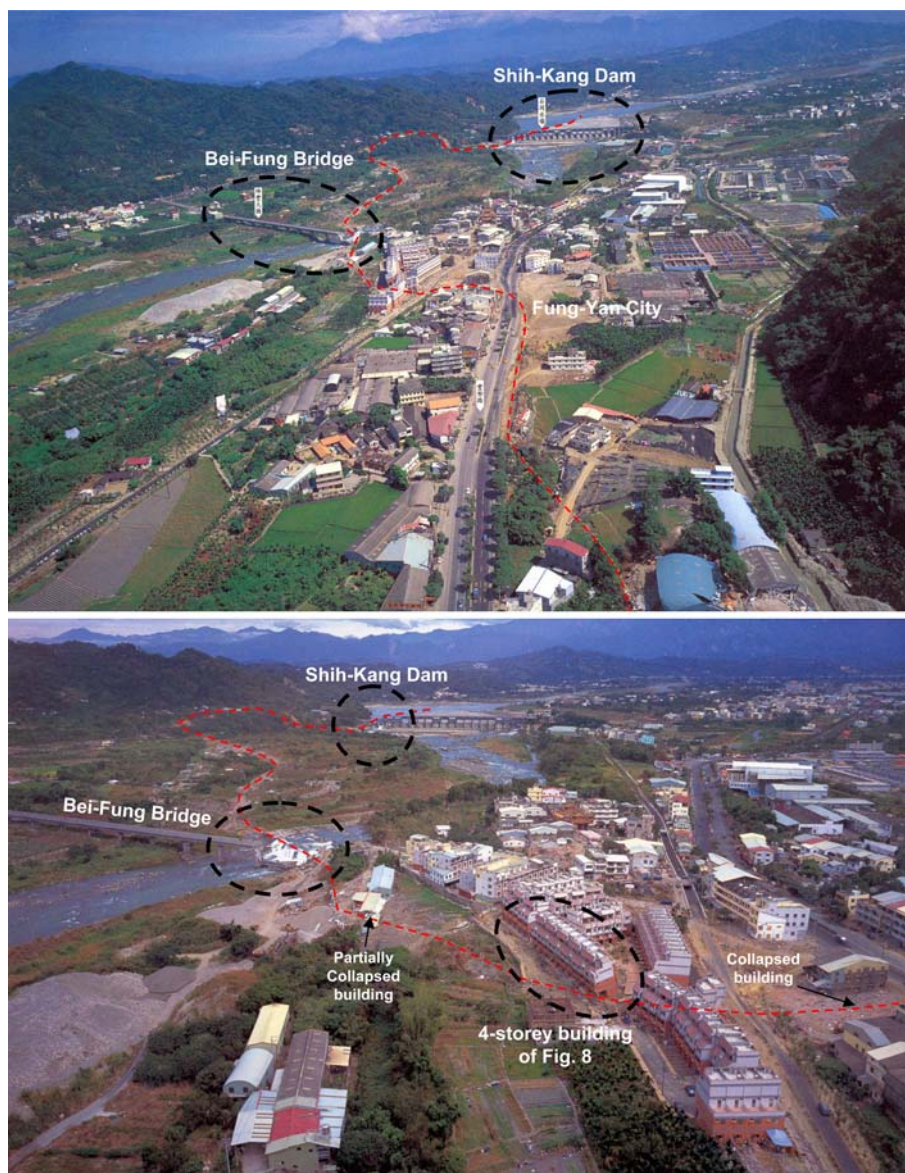
A final example from the Chi-Chi 1999 earthquake is the failure of the Shih-Kang Dam. As illustrated in Fig. 17 (photos adapted from Hwang 2000), the Chelungpu fault passed through Fung-Yan City (see also Fig. 2b). With about 7 m of upthrust, the fault rupture caused complete collapse of one building (the details of which are unknown to us), substantial damage to three other buildings (shown in detail in Fig. 9), partial collapse of a light 1-storey structure, collapse of two spans of the Bei-Fung Bridge, and the failure of the Shih-Kang concrete gravity dam. As shown in Fig. 18, the fault rupture crossed the northern part of the dam with an upthrust of about 9 m, destroying its spillways and gates. Due to its length of about 700 m

Fig. 17 Chelungpu thrust fault, Chi-Chi, Taiwan 1999 earthquake—Fung-Yan City. From bottomright to top-left: The fault rupture, of about 7 m of upthrust, passed through Fung-Yan City causing complete collapse of one building (the details of which are not known), substantial damage to three other buildings (shown in detail in Fig. 8), partial collapse of a light 1-story structure, collapse of two spans of the Bei-Fung Bridge, and failure of the Shih-Kang Dam (photos adapted from [Hwang 2000](#))

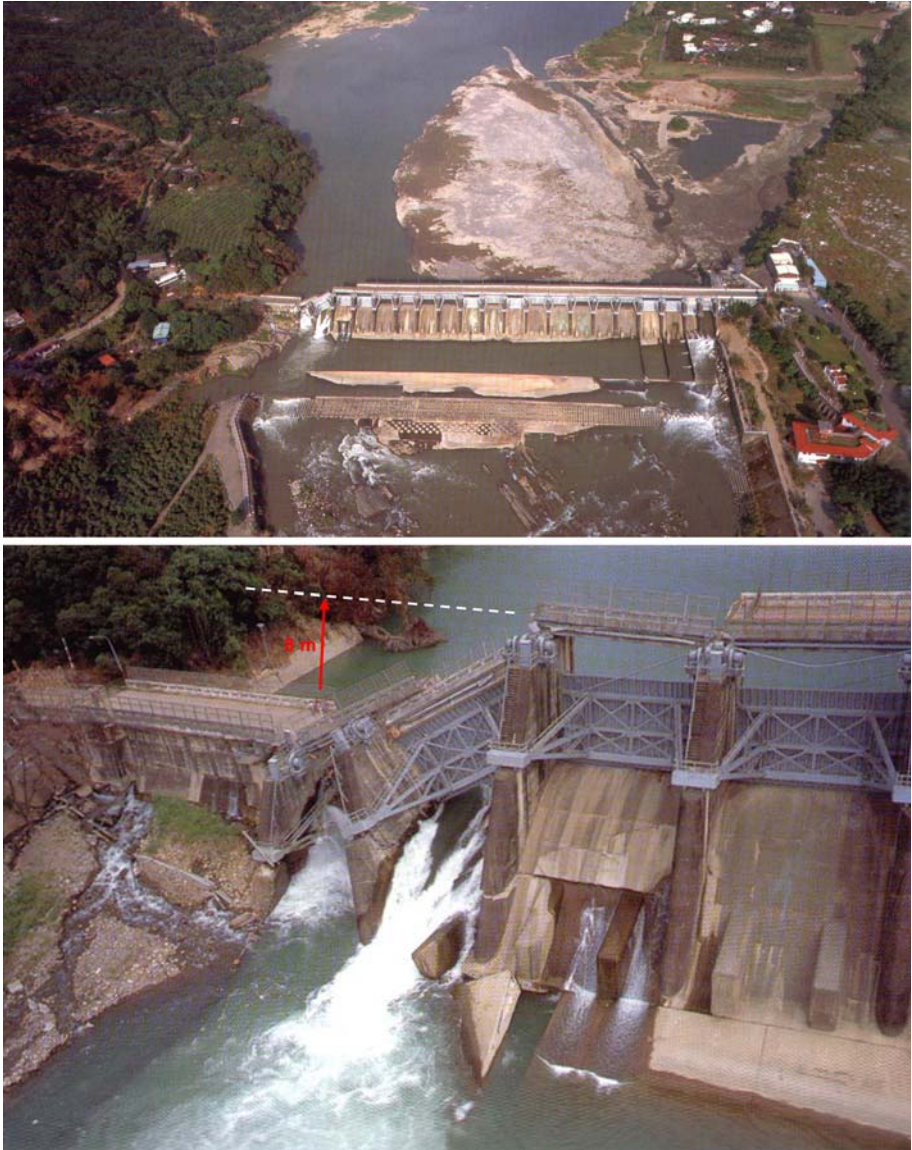
(Chen-Shan et al. 2001; Sugimura et al. 2001), the dam seems to have behaved as a structure on flexible foundation and, as in the previous examples, practically followed the imposed deformation, sustaining substantial structural damage. Despite the obvious differences with the previous case-histories (the superstructure of this dam is certainly different from that of a building), from a behavioral point-of-view the response is rather similar.

Fig. 18 Chelungpu thrust fault, Chi-Chi, Taiwan 1999 earthquake—Shih-Kang Dam. The fault rupture passed through the northern part of the dam with an upthrust of about 8 m, destroying spillways and gates. Due to its length of 700 m, the dam behaved as a flexible structure, practically following the imposed deformation (photos adapted from [Hwang 2000](#))

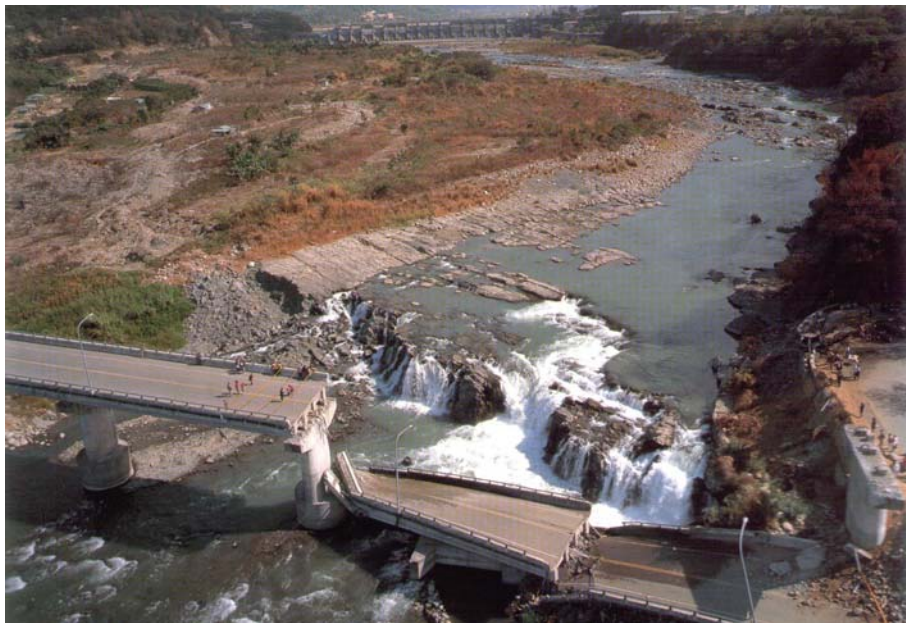
development of a small but impressive waterfall, the result of the faulting-induced deformation was the collapse of two spans of the bridge. It is evident that the differential displacement between the discrete supports (piers) of the structure (deck), was larger than the available seating. In fact, the same performance was also observed in similar bridges, such as the Shi-Wei bridge (Pamuk et al. 2005). Had the deck been continuous, it would still have collapsed, but not due to un-seating: the differential displacement would have generated dramatically large bending moments in the bridge deck.

Fig. 19 Chelungpu thrust fault, Chi-Chi, Taiwan 1999 earthquake—Fung-Yan City. The fault rupture passed through the south abutment of the Bei-Fung bridge with an upthrust of about 7 m, causing the collapse of two spans and the development of a small, but impressive, waterfall (photos adapted from [Hwang 2000](#))

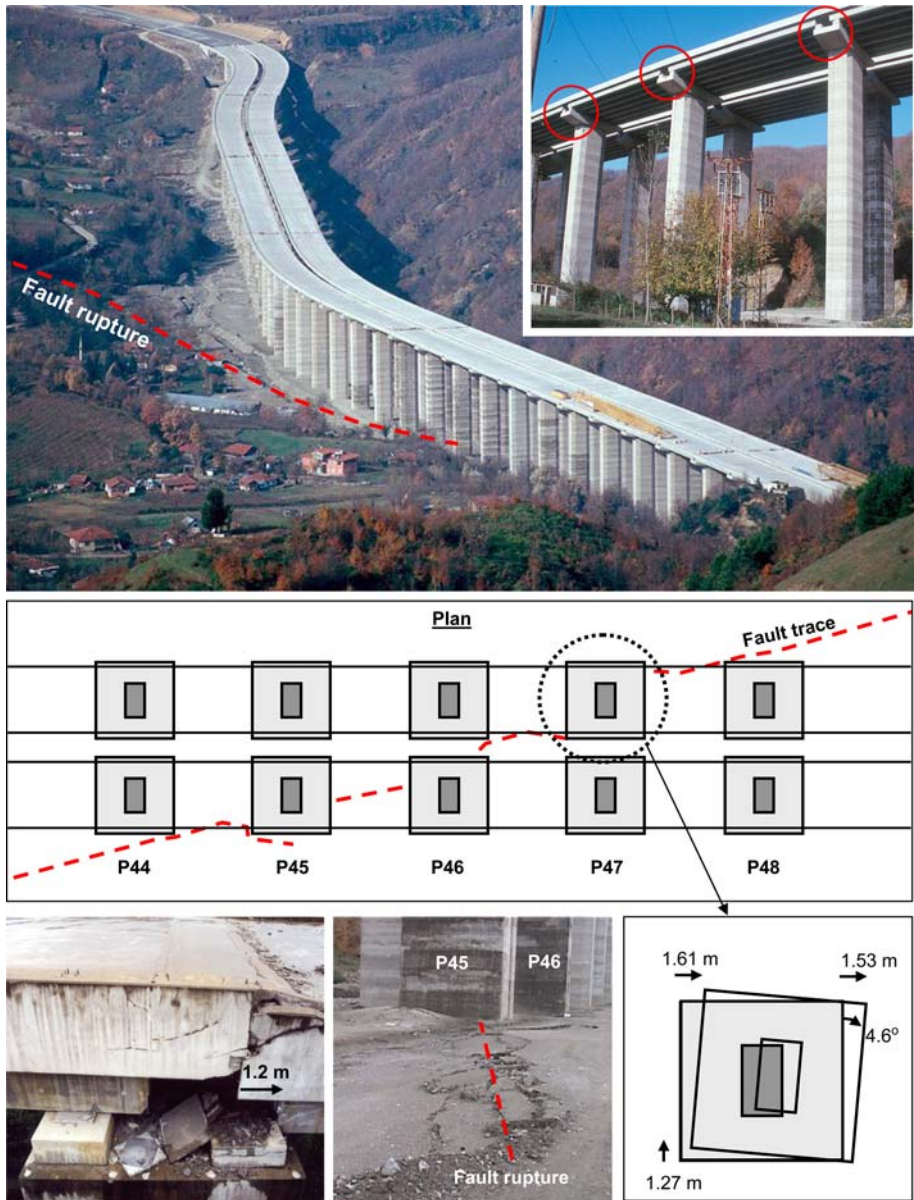
Figure 20 shows the Kaynasli Viaduct of the Trans-European Motorway in Turkey. During the Düzce-Bolu 1999 earthquake, the seismically-isolated Viaduct was crossed by the North Anatolian fault and was subjected to a strike-slip offset of the order of 1.5 m. The Viaduct consisted of two separate decks, of 58 and 59 spans. With an average span of 40 m, the bridge was about 2.3 km in total length, and was supported on 10 m to 49 m high piers, founded on pile-groups consisting of 12 piles 1.8 m in diameter. Each deck consisted of seven pre-stressed concrete beams, connected together with a reinforced concrete slab on top. The decks were supported through pot bearings, with a capacity for multi-directional sliding. Joints were installed every 10 spans, to provide temperature deformation relief. At each joint, special energy dissipating units, viscous dampers, and stoppers were installed

(Kawashima 2001). As illustrated in Fig. 20, the faulting-induced deformation was responsible for the development of substantial horizontal displacements and rotations of the piers (i.e., the discrete supports). The seismically-isolated deck experienced 1.2 m of differential displacement, barely avoiding collapse thanks to the restraint provided by the stoppers.

Fig. 20 The North-Anatolia strike-slip fault, Düzce, Turkey 1999 earthquake—Düzce-Bolu Viaduct: The fault rupture passed through the bridge generating substantial horizontal displacements and rotations of bridge piers. The seismic-isolated bridge deck was subjected to about 1.2 m of differential displacement, avoiding collapse at the last moment due to restraint provided by stoppers
