STRUCTURAL DAMAGE OF A 5-STOREY BUILDING: DIFFERENTIAL SETTLEMENT DUE TO CONSTRUCTION OF AN ADJACENT BUILDING OR BECAUSE OF CONSTRUCTION DEFECTS ?

Ioannis Anastasopoulos

National Technical University of Athens
Zografou, 15780, Athens, Greece

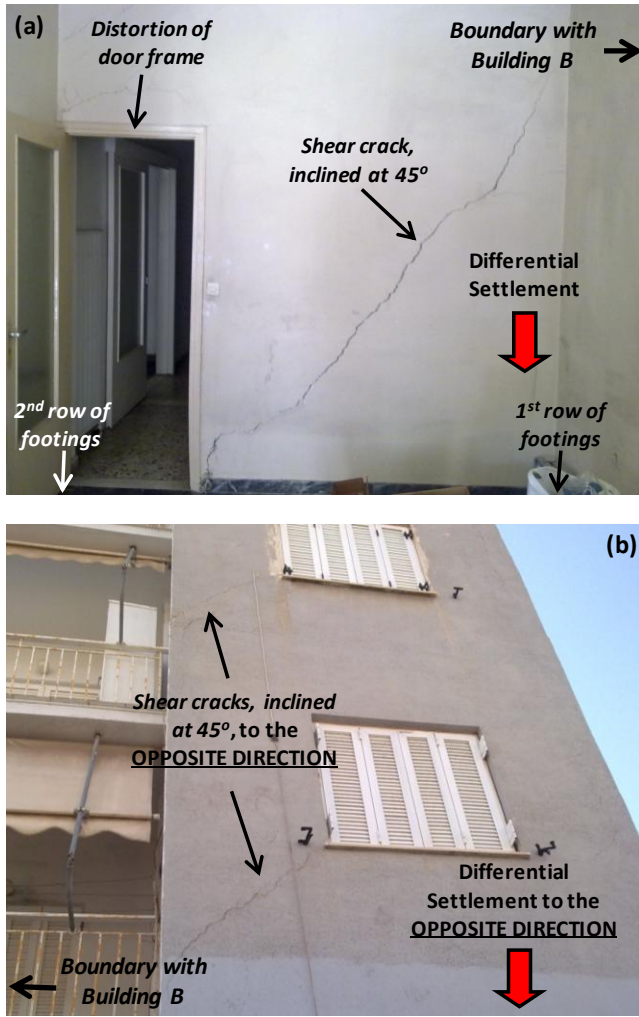
The damage to Building A first appeared in July 1999, just before completion of the erection of the RC frame of Building B, and consequently about 3 months after completion of the basement excavation. Therefore, it would not be reasonable to associate the damage with inadequate retaining during excavation, since in such a case the damage should have appeared much earlier. The damage is mainly in the form of shear cracks on infill walls in the transverse direction and distortions of internal door frames. An example of the observed cracks is shown in **Fig. 4a** (see **Fig. 2** for the exact location). Inclined at approximately 45° , the observed shear cracks are indicative of differential settlement of the first column row (closest to Building B) with respect to the second one (see also **Figs. 1** and **2**).

In addition to the cracks of the internal infill walls, which are documented in all technical reports, during the present forensic investigation similar shear cracks were detected on exterior transverse infill walls, as shown in **Fig. 4b** (see **Fig. 2** for the exact location). Inclined at approximately 45° , these cracks are also indicative of differential settlement, but to the *opposite direction*. Therefore, they cannot possibly be related to settlement caused by the additional loading due to construction of the RC frame of Building B. It was therefore deemed necessary to measure the deformation of Building A.

Fig. 4. Observed damage: (a) photo of internal transverse wall, showing shear cracks and door frame distortions; and (b) photo of external transverse wall showing shear cracks to the opposite direction.

Based on the observed cracks, in conjunction with the aforementioned precision leveling measurements, it may be concluded that Building A suffers from: (a) differential settlement of the order of 2.5 cm due to its own weight, as evidenced by the cracks of Fig. 4b and the measured height differences of the floors; and (b) differential settlement of the order of 2.5 cm due to the additional settlement of Building B, as evidenced by the cracks in Fig. 4a and the measured height differences of the floors. It is therefore reasonable to assume that the total measured differential settlement of approximately 5 cm is due to the superposition of the two above differential settlements.

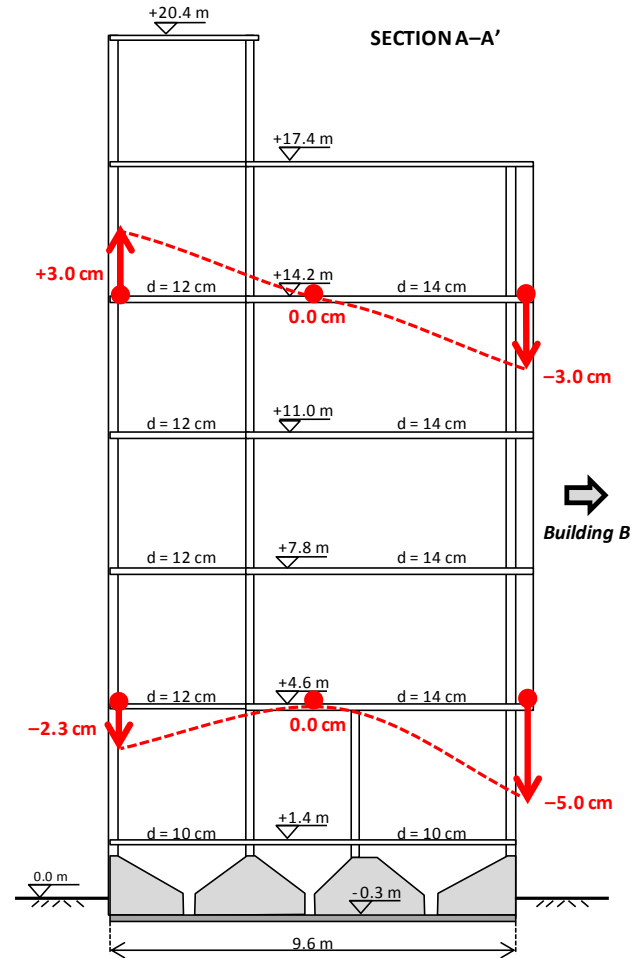
On July 2011, precision leveling measurements were conducted inside Building A, on the slabs of the 1st, 2nd, and 4th floor. Based on these measurements, the maximum height difference on the first floor is about 5 cm. As sketched in Fig. 5, having the stairway as a reference, the maximum relative settlement of 5 cm is observed at the boundary with Building B at the front wall of the building. A smaller relative settlement of 2.4 cm is observed at the opposite side of the building. Note that this differential settlement is to the opposite direction, and cannot possibly be attributed to the settlement of Building B. Evidently, the observed cracks of Figs. 4a and 4b are totally compatible with the precision leveling measurements. It should, however, be noted that the height differences measured through internal precision leveling are not necessarily exactly equal to the differential settlements, as they may be partly due to construction “flaws” of the floors.

Fig. 5. Section A-A' of Building A, showing the key results of internal precision leveling measurements (July 2011).

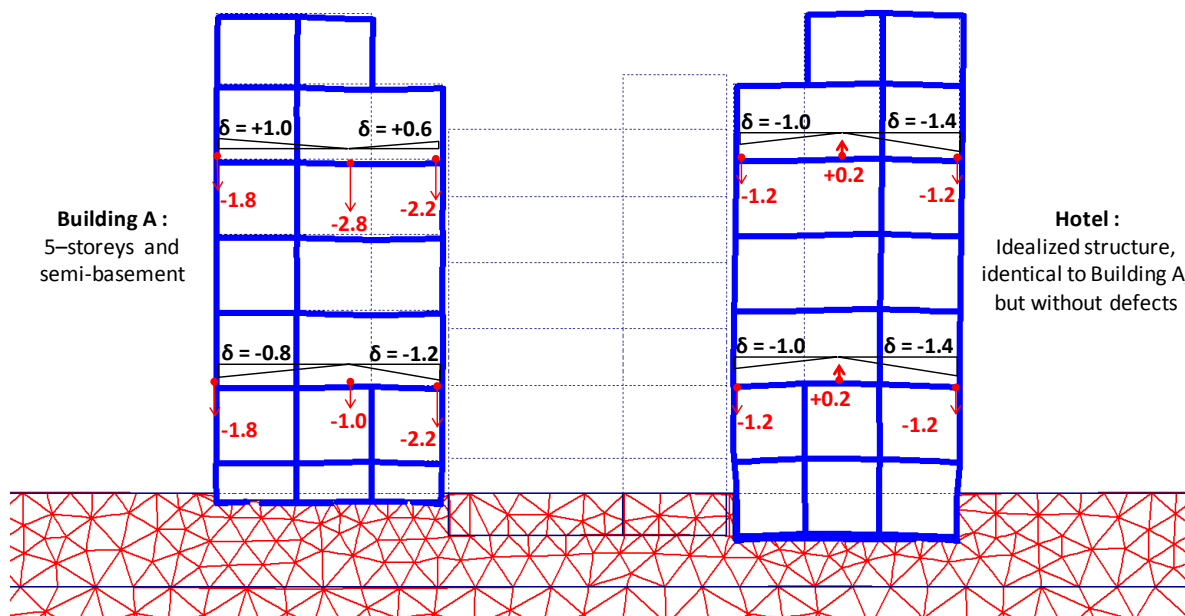
The results are presented in **Fig. 7** in terms of absolute (marked in red) and differential (marked in black) settlements at characteristic locations of the two buildings (corresponding to the locations of the measurements). Evidently, only with the dead loads of its RC frame, Building A experiences maximum absolute settlement of -2.2 cm (right footing). At the same time, the maximum absolute settlement of the idealized building at the location of the hotel is almost 50% lower: -1.2 cm . Since the two buildings are identical, this difference can only be attributed to the construction defects of Building A, due to which its foundation and superstructure are indeed extremely flexible in the transverse direction.

However, at this stage the differences between the two structures are not that important in terms of differential settlements. Taking as a reference the middle of the building (as for the precision leveling measurements), the left span of the 1st floor experiences differential settlement $d = -0.8 \text{ cm}$ and the right one -1.2 cm . In the fourth floor, the left span has a relative elevation $d = +1.0 \text{ cm}$ while the right one $+0.6 \text{ cm}$. This strange distribution is due to the elimination of the middle-right column from the first floor and above. Since the infill walls (and the door frames, etc.) have not yet been constructed at this stage, these differential settlements (or elevations) could not have caused any damage.

Fig. 7. Numerical analysis results for Step 1 – Construction of the RC frame of Building A and the corresponding idealized building in place of the adjacent Hotel: absolute (in red) and differential (in black) settlements at characteristic locations of the two buildings.

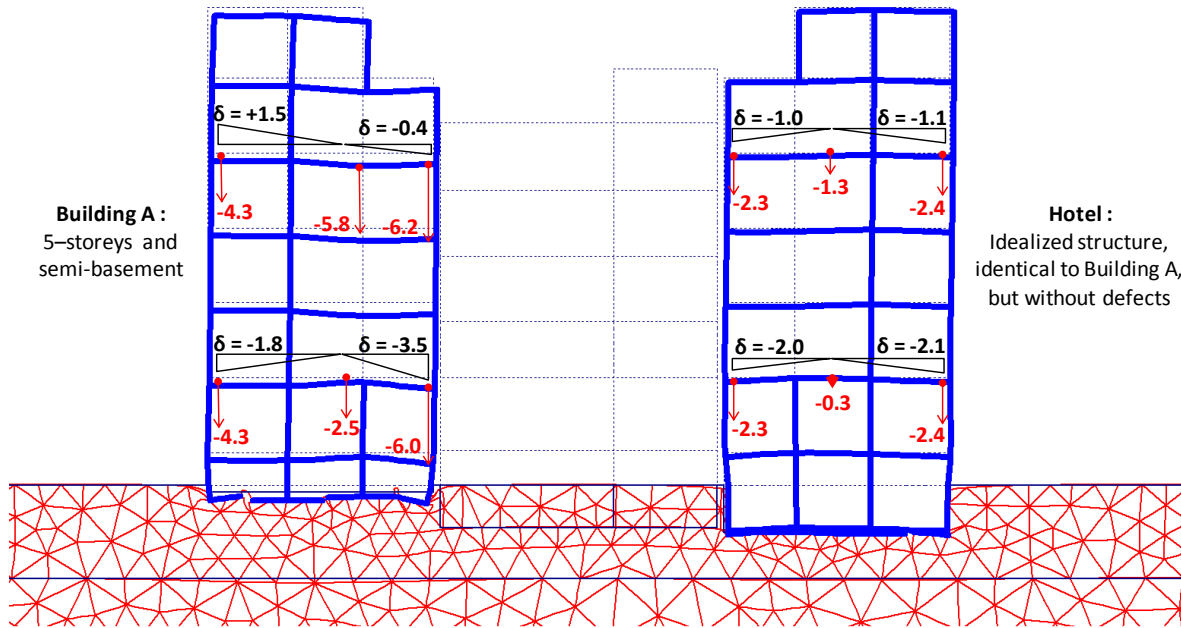
The results are presented in **Fig. 8** in terms of absolute (in red) and differential (in black) settlements at characteristic locations of the two buildings. Even considering a lower bound estimate for the additional permanent loads (infill walls, floors, etc.), and assuming that only 50% of the design live loads is imposed, Building A is subjected to a maximum absolute settlement of -6.0 cm (left footing) – purely due to its own weight. Correspondingly, the maximum absolute settlement of the idealized building in place of the neighboring Hotel does not exceed -2.4 cm . Evidently, since the two buildings are identical, this major difference is solely

due to the previously discussed construction defects of Building A (completely superficial foundation, lack of tie beams), and the absence of RC beams (and therefore frames) in the transverse direction of its superstructure. As a result, the entire foundation–structure system is excessively flexible, being susceptible to differential settlements.

Fig. 8. Numerical analysis results for Step 2 – Completion of Building A and the corresponding idealized building in place of the adjacent Hotel: absolute (in red) and differential (in black) settlements at characteristic locations of the two buildings.

- Before the erection of the RC frame of Building B (**Fig. 8**), the maximum settlement of Building A (due to its own weight) reached -6.0 cm, leading to maximum differential settlement of -3.5 cm. Since the latter took place gradually during construction, the infill walls were subjected to the differential settlements that took place after their construction, namely -2.3 cm. Therefore, it is reasonable that no damage had been observed for 30 years.

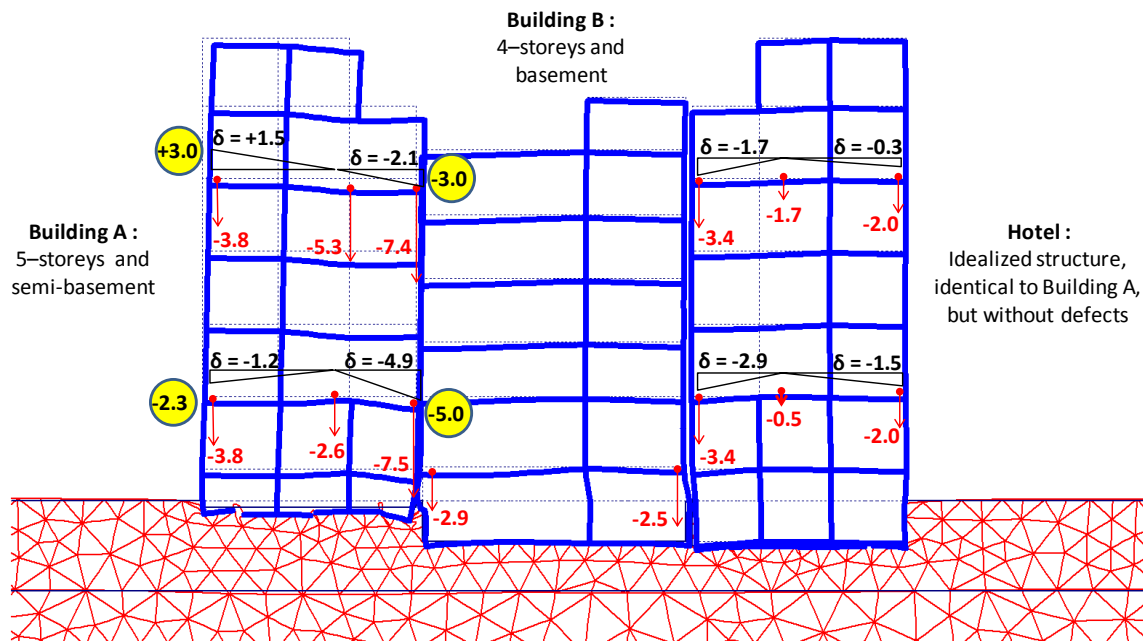
Taking as a reference the middle of the building, the computed differential settlements (or elevations) are directly comparable to the precision leveling measurements. In Fig. 9, the measured values are shown in yellow circles to facilitate direct comparison with the numerical analysis results. On the left span of the 1st floor of Building A, a differential settlement $d = -1.2$ cm is computed (compared to -2.3 cm of the measurements); the right span of the same floor experiences much larger differential settlement $d = -4.9$ cm (as opposed to -5 cm of the measurements). Note that this is exactly at the location where the most severe shear cracking is observed (see the photo of Fig. 4a). Moreover, notice that the differential settlement of the left span is to the opposite direction, being totally consistent with the observed damage of the outer infill walls (see the photo of Fig. 4b). In the 4th floor, the left span experiences differential elevation $d = +1.5$ cm (compared to +3.0 cm of the measurements), and the right one differential settlement $d = -2.1$ cm (as opposed to -3.0 cm of the measurements). The numerical prediction can be seen to compare adequately well with the measurements qualitatively and quantitatively, confirming the validity of the analysis method and the adopted soil parameters.

As previously discussed, the deformation of the infill walls of Building A can only be associated with the differential settlements that occurred after their construction (i.e., the difference between Step 3 and Step 1). Hence, the differential settlement actually suffered by the infill walls of Building A currently stands at -3.7 cm (close to the border with Building B), and is quite reasonable to have led to the observed damage (shear cracking of infill walls and distortion of inner door panels). Note that from the -3.7 cm of differential settlement, -2.3 cm are due to the dead loads of Building A, and only the remaining -1.4 cm took place during construction of the RC frame of Building B.

Fig. 9. Numerical analysis results for Step 3 – Construction of the RC frame of Building B: absolute (in red) and differential (in black) settlements at characteristic locations of the two buildings. The values in yellow circles correspond to the measurements.

- The additional loads due to construction of the RC frame of Building B (**Fig. 9**) led to maximum absolute settlement of -2.9 cm – reasonable for such soft soil. This led to an increase of the maximum absolute settlement of Building A from -6.0 cm to -7.5 cm, and to an increase of the maximum differential settlement from -3.5 cm to -4.9 cm. The differential settlement actually suffered by the infill walls of Building A rose from -2.3 cm to -3.7 cm, leading to the observed shear cracking of infill walls.
