STRUCTURAL AND GEOTECHNICAL ASPECTS OF THE CHRISTCHURCH (2011) AND DARFIELD (2010) EARTHQUAKES IN N.ZEALAND

Eleni Smyrou¹, Panagiota Tasiopoulou², İhsan E. Bal³,
George Gazetas⁴ and Elizabeth Vintzileou⁵

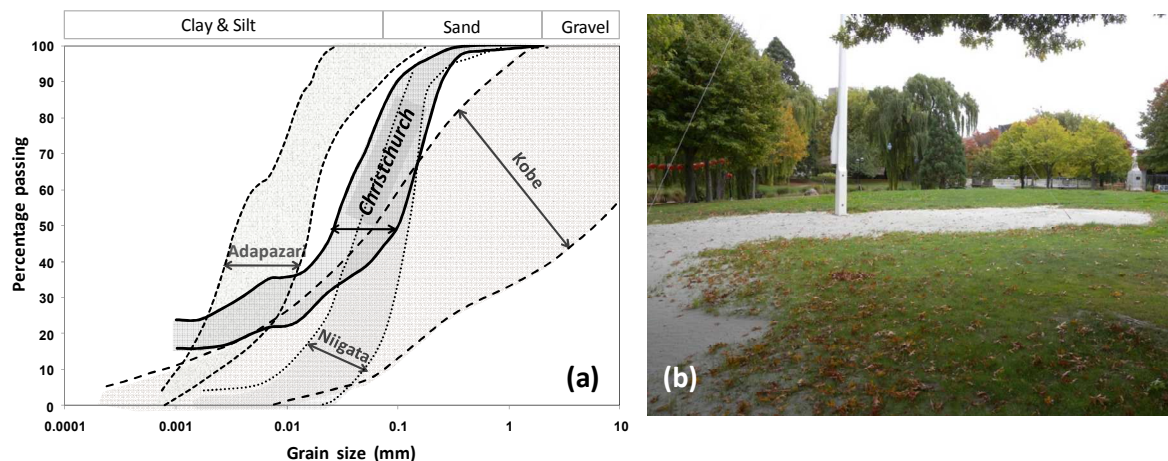
The predominant geotechnical characteristic of both earthquakes events was liquefaction and lateral spreading. The Darfield earthquake caused significant liquefaction with evident signs of surface manifestation mostly in the eastern suburbs of Christchurch along the Avon river such as Avonside, Dallington, New Brighton and Bexley (Cubrinovsky et al., 2010). The CBD was much less affected by liquefaction. The subsequent Christchurch earthquake did not only re-liquefy the previously mentioned areas, but caused a more widespread liquefaction which also affected the southern suburbs and the CBD (Figure 3b). In particular, liquefaction in CBD was demonstrated by numerous sandboils formed in the perimeter of buildings and the large amount of sand emerging on to the surface.

Figure 3. (a) Range of grain size distribution curves of soil samples from Dallington and Bexley areas after Darfield earthquake (Cubrinovski et al., 2010), compared with curves from Adapazari, Niigata and Kobe areas which have sustained liquefaction in past earthquakes. (b) Indicative photo of liquefaction along Avon River in CBD showing sandboils on the ground surface.

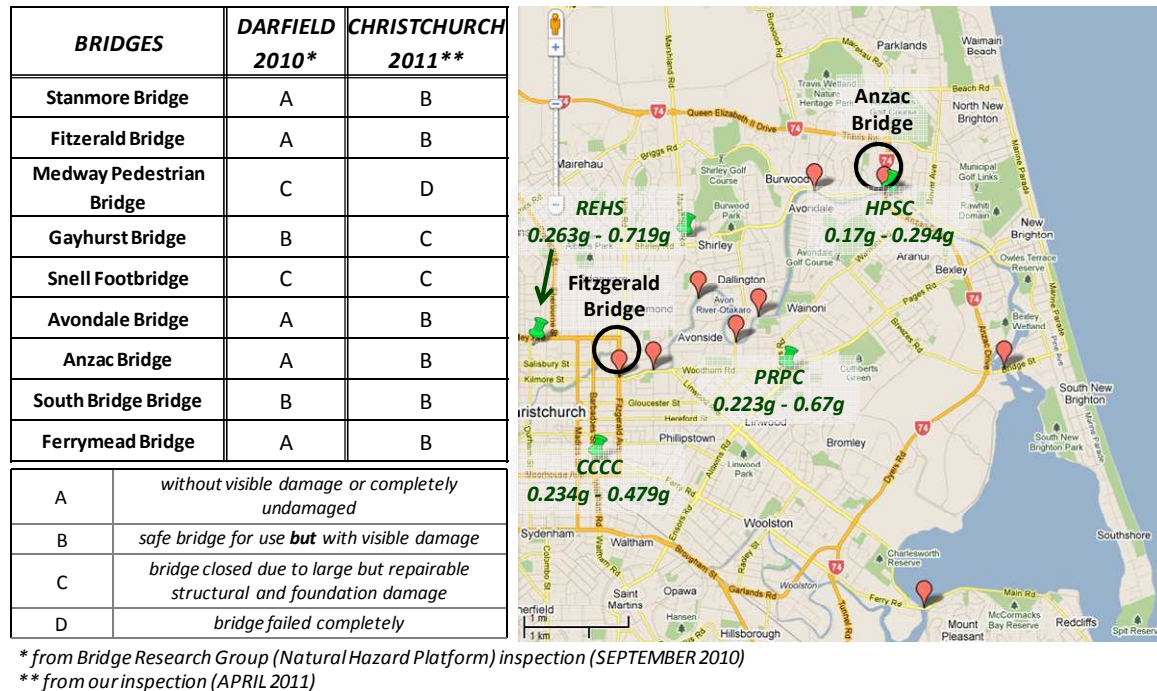
Figure 4. Damage assessment of bridges along Avon and Heathcote river due to lateral spreading during Darfield and Christchurch earthquakes. The map illustrates the location of the bridges (red signs) and the seismic stations (green signs) with the corresponding recorded PGAs (1st and 2nd value correspond to Darfield and Christchurch earthquakes respectively) in the broader area occupied by the bridges.

Liquefaction along Avon River caused lateral spreading of the ground. Evidently, bridges were the structures mostly affected by lateral spreading. As Avon river forms several meanders within the city, there is a large number of bridges crossing the river. During our visit in April 2011, we inspected 9 bridges (8 crossing Avon river and 1 crossing Heathcote river). Typically, most of them are small-span concrete bridges with none to two piers, seat type abutments on piles, with the exception of the two pedestrian bridges, i.e. the steel truss Medway bridge and the arch Snell Footbridge. The table in Figure 4 includes all nine bridges and illustrates their response during Darfield and Christchurch earthquakes according to certain performance states described in the legend below the table. It can be clearly concluded that: i) most of the bridges performed very well during Darfield earthquake, apart from Gayhurst and South Bridge Bridges with moderate visible damage and the two pedestrian bridges with significant damage and ii) the performance of the bridges was worse, but still satisfactory in general, during Christchurch earthquake. This is partially attributed to the smaller ground accelerations of Darfield earthquake and thus, to the smaller inertial forces developed to the bridge decks. However, the deflection of the bridges points out lateral spreading as the prevailing source of load.

The deformation pattern of the concrete road bridges consists of lateral displacement of the abutments towards the river and their rotation around their contact point with the deck, accompanied by subsequent settlement of the fill behind the abutment and distress of the piles. This typical pattern of deformation is attributed to lateral spreading of the ground. Aiming to investigate the reason why the bridges that were damaged during the Christchurch earthquake performed really well in Darfield earthquake, despite the fact that liquefaction occurred in both earthquakes, especially in the eastern suburbs, an evaluation of the liquefaction potential with depth was conducted for Anzac Bridge and Fitzgerald Bridge, for both earthquakes (see map of Figure 4).

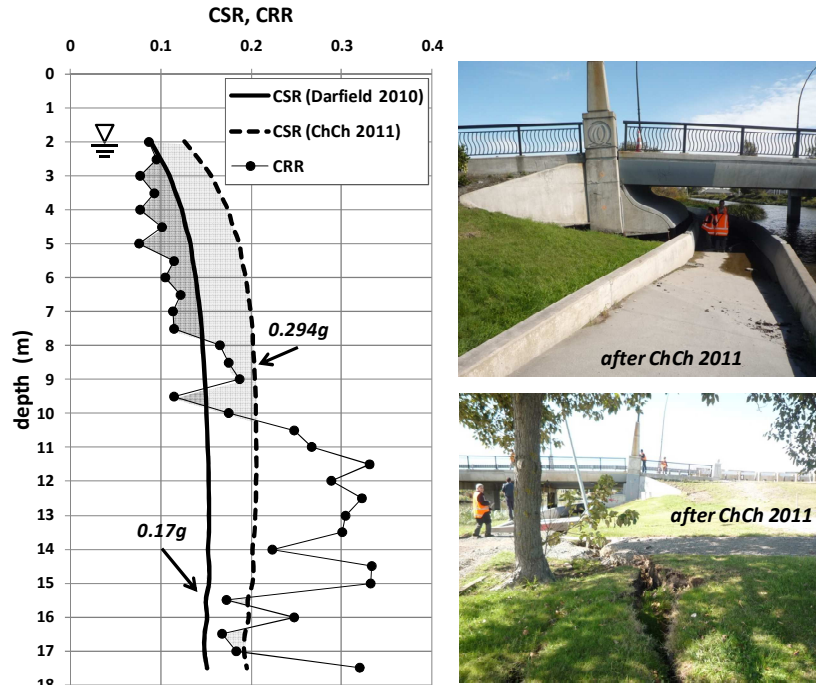
Figure 5. The graph (left) depicts the distribution of CRR with depth of a site between the HPSC station and Anzac Bridge (see map of Figure 4) compared with the CSR one during Darfield and Christchurch earthquakes. The shadowed areas indicate liquefaction susceptibility. The photos (right) illustrate the rotation of the abutments of Anzac Bridge and the cracks due to lateral spreading along the Avon river coast.

The liquefaction potential analysis of the soil profile, obtained from a borehole between the southern abutment of the Anzac Bridge and the HPSC seismic station (located at a distance of 100m approximately) using the PGA records of the aforementioned station (Figure 5), indicates that during the Darfield earthquake (0.17g) the liquefaction took place practically from the ground water level to a depth of 8m (shadowed area). The applied CSR values are larger but close enough to the CRR values, so that liquefaction may not be severe. In the case of Christchurch earthquake (0.29g), the applied CSR is significantly larger than the CRR to a larger depth (10m). These facts imply that liquefaction is certain during Christchurch earthquake and definitely more extensive than the one during Darfield earthquake, causing larger soil lateral movement and at a greater depth – perhaps even below the pile foundation. This justifies partly why the Anzac bridge sustained no damage during Darfield, but 50cm horizontal displacement, plus rotation of abutments during Christchurch earthquake.

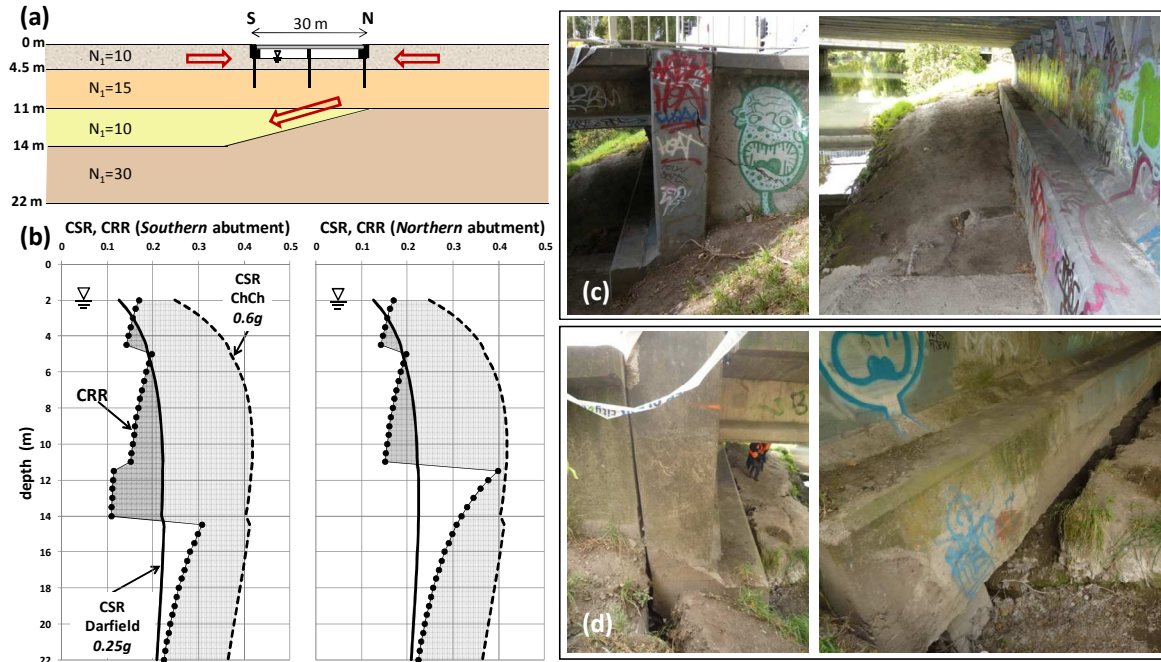
In the case of Fitzgerald Bridge the complete soil profile geometry profile (Figure 6a) is available (Bradley et al., 2009). There is an inclination of the third soil layer towards the southern abutment, which tends to cause an additional lateral soil movement at the side of the northern abutment towards East, even below the pile foundation (8m deep), as indicated by the red arrows. This is also supported by the liquefaction potential analysis of the soil profile below the northern and southern abutment (Figure 6b) which indicates that in the soil between 11 and 14m depth the liquefaction susceptibility is greater in the case of the northern abutment. It should be noted that CSR was estimated using an average PGA value of the REHS and CCCC records which are the closest to the bridge site. The southern abutment, shown in Figure 6c, after the Christchurch earthquake, suffered only some moderate cracks, with no significant horizontal displacement or rotation. Moreover, there were no signs of lateral spreading (cracks, gap between abutment and soil) in front of the toe of the abutment. On the other hand, the northern abutment (Figure 6d)

sustained substantial rotation, the backfill has settled and the ground in front of the toe has spread towards the river, exposing the top of the piles.

The fact that there was no visible damage of the bridge during Darfield earthquake can be explained by the lower liquefaction potential of the soil profiles (shadowed areas) and its smallest range in depth compared to that obtained for Christchurch earthquake. In addition, there was no ground manifestation of liquefaction close to the bridge site in the case of Darfield earthquake, in contrast to the case of Christchurch earthquake. This observation is also supported by the analysis showing deeper liquefaction (practically below the depth of 8m) during the first earthquake. Thus, it is more difficult for the sand to be ejected on the ground surface.

Figure 6. (a) Soil profile geometry along Fitzgerald Bridge. The red arrows indicate the soil displacement due to lateral spreading. (b) Distribution of CRR with depth based on SPT values compared with the CSR for the northern and southern abutments. (c) Performance of southern abutment after ChCh earthquake. (d) Performance of northern abutment after ChCh earthquake.
