Bridge pile–abutment–deck interaction in laterally spreading ground: Lessons from Christchurch

SUMMARY:

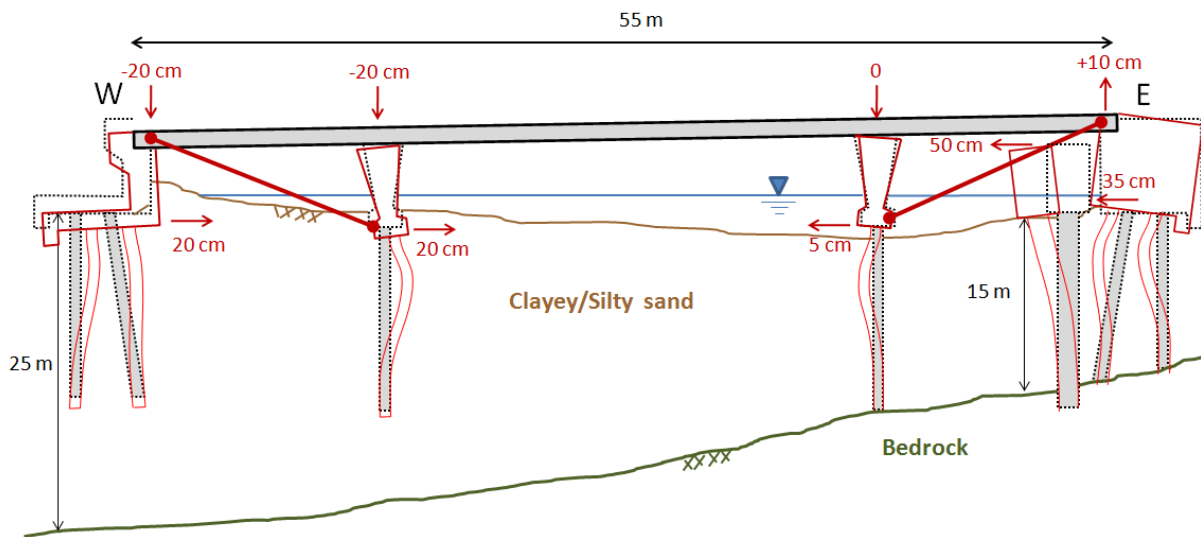
Figure 2.1. Sketch of deflection pattern of Ferrymead Bridge. The base of the piers has been tied to the deck edges after Christchurch earthquake in order to keep them in place and restrain any further inward movement until the strengthening project of the bridge is completed.

The abutment tended to move laterally following the soil deformation but the deck restrained the horizontal displacement at top due to its high axial stiffness in compression. Thus, the abutments, being pinned to the deck, back rotated. The piers, on which the deck is seated on bearing pads back rotated in a similar way. The sketch of Fig.2.1. illustrates the deformation of all structural members of the bridge. The difference of the deflection pattern between the old east abutment and the new abutment, located in front of the old one being unattached to the deck, should be noticed and attributed to the presence of the deck constraint. In particular, considering that the old east abutment is 4 m high, it back rotated by 5°, resulting in a riverward displacement of 35 cm at its base (and top of the piles). The horizontal shear crack on the abutment wall at the height of the lower part of the deck, shown in Fig.2.2.a, is indicative of the degree of constraint applied by the deck to the abutment wall through a high axial reaction force. In contrast, the new abutment forward rotated and moved horizontally by 50 cm approximately (Figs.2.2.b and 2.2.c), a movement greater than that of the old one.

Moreover, the piers also moved riverwards, back rotating and forming a gap between their top and the deck. The west pier sustained larger horizontal displacement than the east one most probably due its embedded pile-cap, which transmitted additional load from the laterally spreading ground to the pier-pile system. After damage assessment was performed, the base of the piers was tied to the nearest edges of the firm deck, so as to restrain any further movement of the piers due to aftershocks and/or creep phenomena.

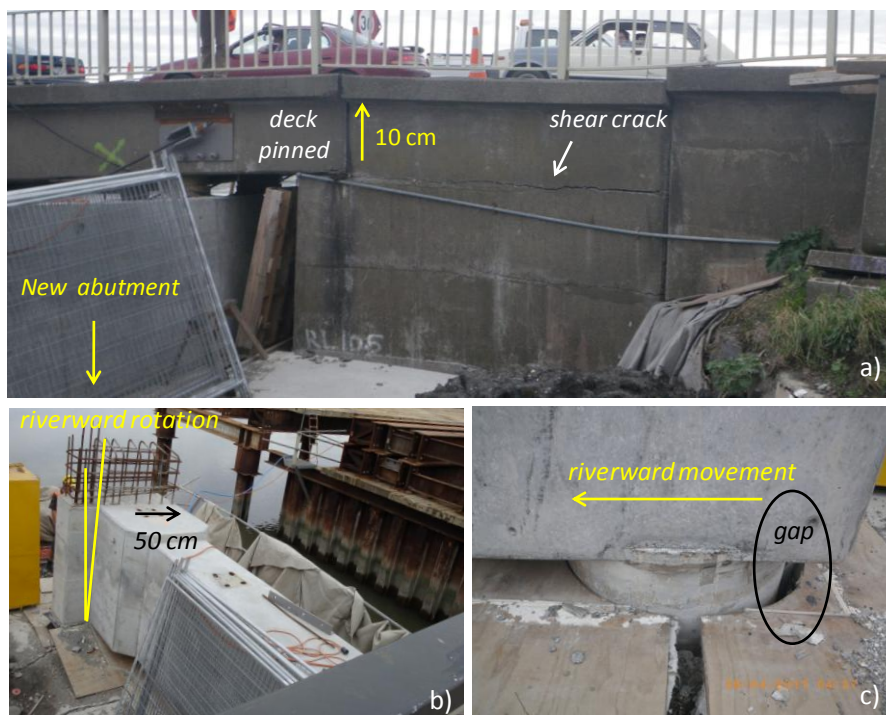
Figure 2.2. a) The front section of the east abutment has back rotated and moved upwards by 10 cm. A major horizontal crack was formed at the height of the lower part of the deck, b) The new east abutment has inclined towards the center of the bridge, c) A gap opening at the back side of the shaft due to riverward movement of the new abutment.

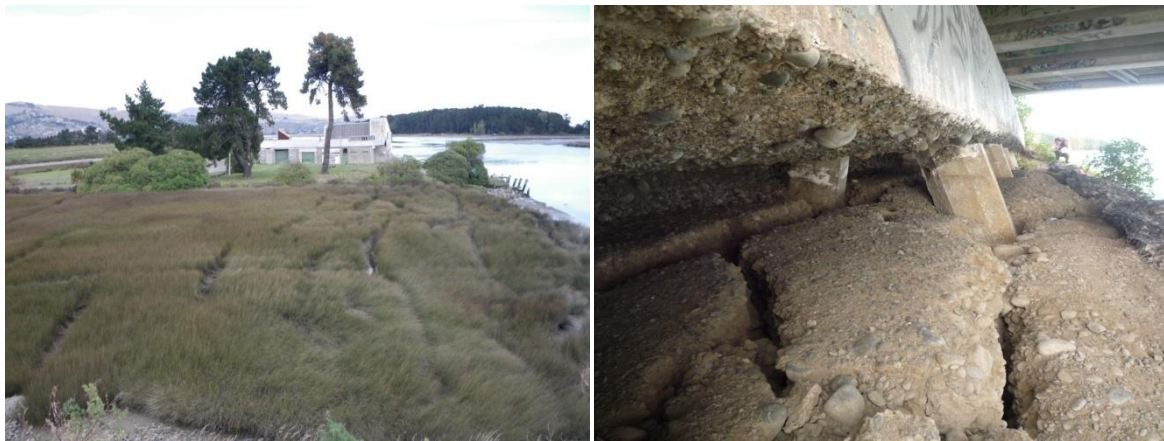
Figure 2.3. Large lateral spreading cracks in the ground parallel to the coast and adjacent to the abutments of South Bridge Road Bridge extending at a great distance inland (left). Back rotation of the west abutment around the deck and slump of the approach fill. The soil underneath the abutments has moved riverwards opening large cracks in the superficial crust and crating gaps in the front side of the piles (right).

The bridge suffered significant damage during Darfield earthquake due to lateral spreading. The soil in the wetland is very prone to liquefaction (Fig.2.3.). Thus, the ground deformation induced by liquefaction caused back rotation of the abutments, slumping of the approach fills, settlement underneath the abutments and exposure of the pile heads. During Christchurch earthquake, lateral spreading was even more severe, forming cracks in the ground which expanded several meters inland. The initiated damage by Darfield earthquake was extended with evidence of plastic hinging at the top of piles, cracks and concrete spalling in the abutments, as well as even greater subsidence of the backfill(Fig.2.4.). However, in overall, the rotation and horizontal displacement of the abutments only slightly increased compared to how much larger was the soil movement in Christchurch earthquake (Fig.2.5.). This is due to the deck restraining and increase of the pile bending resistance. Thus, the main damage of the bridge is attributed to the first earthquake.

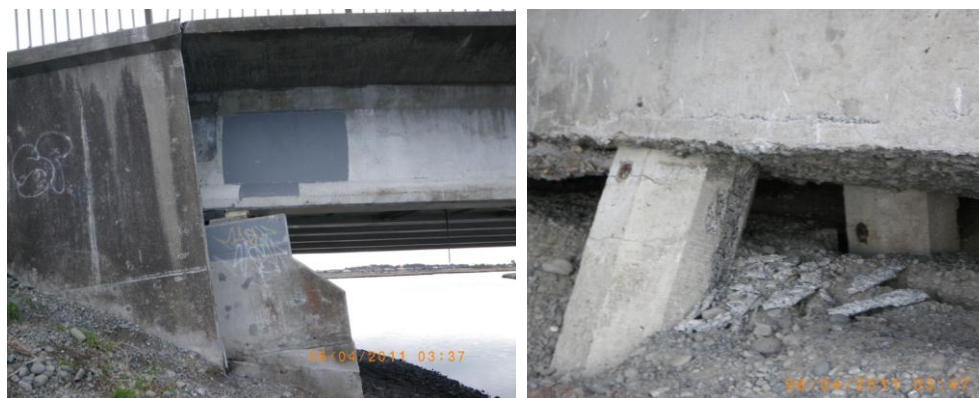
Figure 2.4. Back rotation of the west abutment of South Bridge Road Bridge around the deck and slump of the approach fill (left). Concrete spalling exposing the pile reinforcement and flexural cracks developed at the top of the piles indicating initiation of plastic hinging (right).

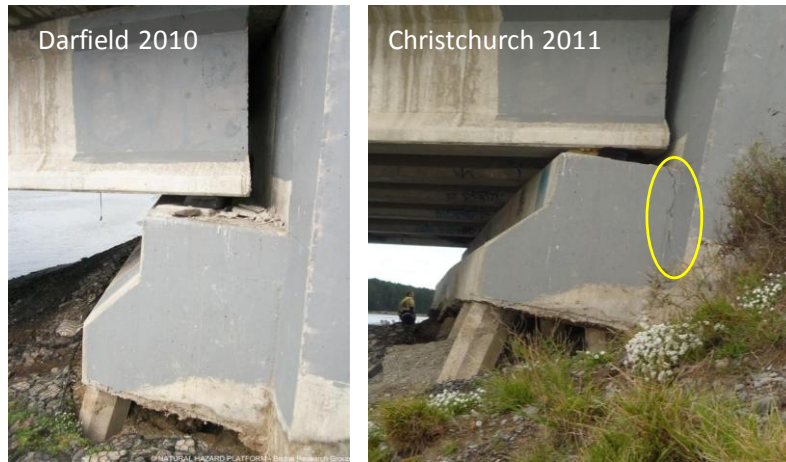
Figure 2.5. West abutment of South Bridge Road Bridge after Darfield (left) and Christchurch (right) shaking events. During Christchurch earthquake, the bridge sustained additional settlement and lateral displacements indicated by the greater exposure of the top of the pile foundation and the abutment cracks (yellow circle) in comparison to its state after Darfield earthquake (Source of left photo: NHP- Bridge Research Group).

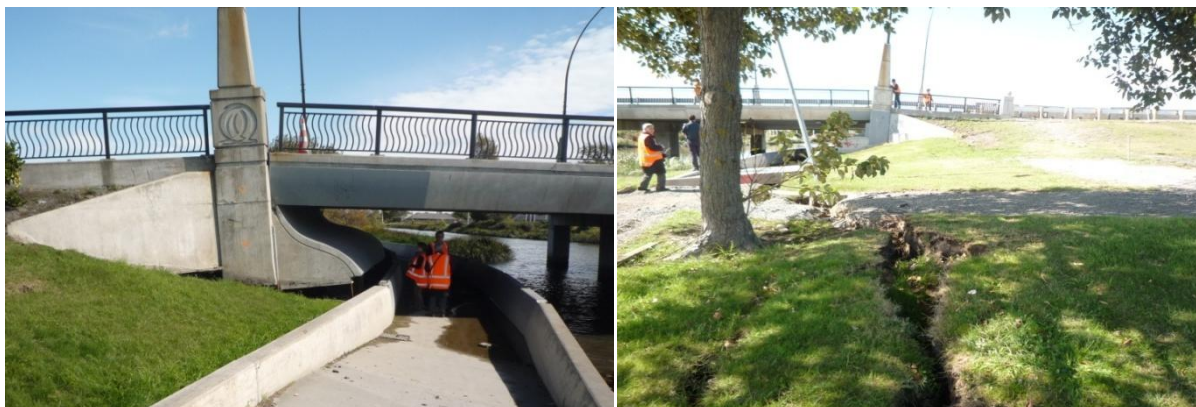
Figure 2.6. Back rotation of the abutments of Anzac Bridge and slump of the backfill. Large lateral spreading cracks in the ground parallel to Avon river coast extending in a great distance from the abutments indicating horizontal ground displacement in the free field more than 1 m.

Anzac Bridge is one of the most recent bridges in Christchurch, built in 2000. It is a totally precast structure, with a three-span deck supported on two bents of three columns and concrete abutments with wingwalls on vertical piles. The bridge was almost undamaged in Darfield earthquake. However, severe liquefaction and subsequent lateral spreading occurred during Christchurch earthquake, as illustrated by the large cracks on the ground surface in the near field (Fig. 2.6.). The significant riverward soil movement (about 2 m in the free field) combined with the rigid continuous deck led to back rotation of the abutments and horizontal displacements of the base of abutments in the order of 50 cm which may imply potential plastic hinging of the piles. The deck was undamaged and once again it proved to prevent the bridge failure.

The liquefaction potential analysis of the soil profile (Tasiopoulou et al., 2011), obtained from a borehole between the southern abutment of the Anzac Bridge and the HPSC seismic station (located at a distance of 100m approximately) using the PGA records of the aforementioned station, indicates that liquefaction is certain during Christchurch earthquake (0.29g) and definitely more extensive than the one during Darfield earthquake (0.17g), causing larger soil lateral movement and at a greater depth (10 m). This can reasonably justify why the Anzac bridge sustained no damage during Darfield, but 50cm horizontal displacement, plus rotation of abutments during Christchurch earthquake.

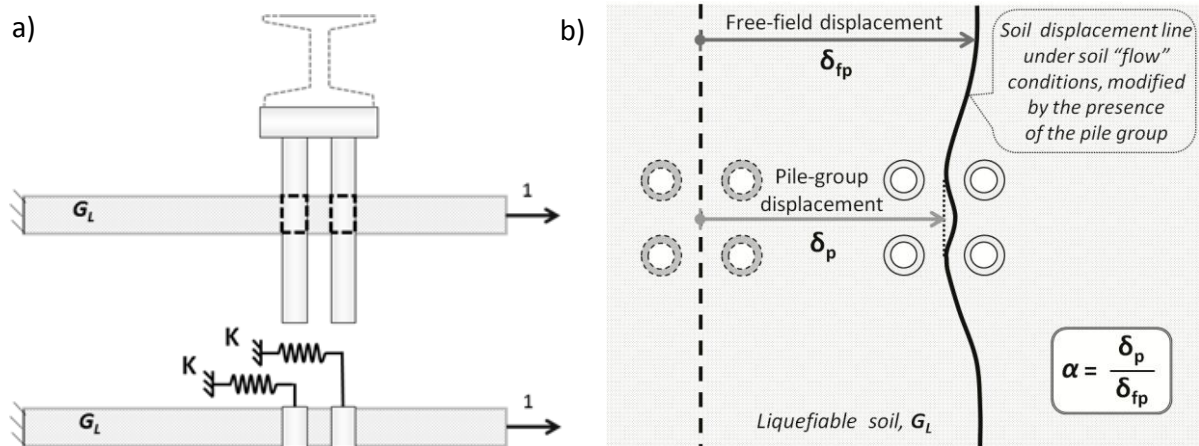
Figure 3.1. a) The pile–foundation can be replaced by an out of plane spring, representing the horizontal stiffness of the pile–superstructure system within the liquefied soil, b) Definition of ratio α as the pile group displacement over the free-field soil displacement due to liquefaction induced soil "flow" (plan view).

An attempt to quantify the contribution of the superstructure (deck–abutment) to the pile–foundation performance is based on the simplified method proposed by Tasiopoulou et al.(2012). The piles are subjected to strong kinematic load within the liquefied zone, where the surrounding soil loses its strength and develops large strains. The laterally moving soil "carries" the overlying layers and provides the driving force displacing the pile only a certain amount depending on the relative stiffnesses between piles (K) and soil (G_L). The magnitude of soil movement, the stiffness degradation of the liquefiable zone and the rigidity of pile–superstructure system are the major parameters controlling the pile response and determining the ratio of the pile displacement, δ_p , over the free field one, δ_{fp} , within the liquefied layer, called ratio α (Fig.3.1.).

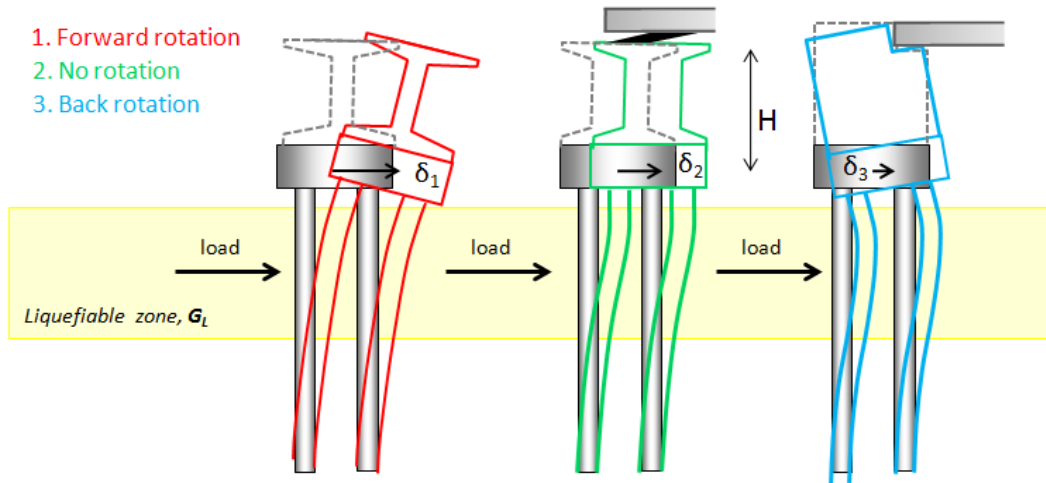
Figure 3.2. Three characteristic cases of pile deformation, depending on the rotation imposed or not by the superstructure.

In the following, the rigidity of the deck–abutment–pile system is explored. Initially, three characteristic pile deflection patterns are shown in Fig.3.2, depending on the rotation at the pile-top imposed by the superstructure system.

- Case 1 (lower stiffness): No deck constraint is applied to the pile–foundation. Thus, the pile forward rotated in a similar way as a cantilever beam. This deflection pattern is dominant in cases where the deck is not continuous and parts of the seated deck have fallen due to differential movement of consecutive bents.
- Case 2 (higher stiffness): No rotation is allowed to the pile top, only horizontal movement parallel to the deck. This deflection can apply to bridge decks seated on rubber pads.
- Case 3 (high stiffness): The abutment–pile system is pinned around the edge of a continuous deck and the pile top back rotates following the abutment wall. This deflection was observed

to all case histories from Christchurch described above.

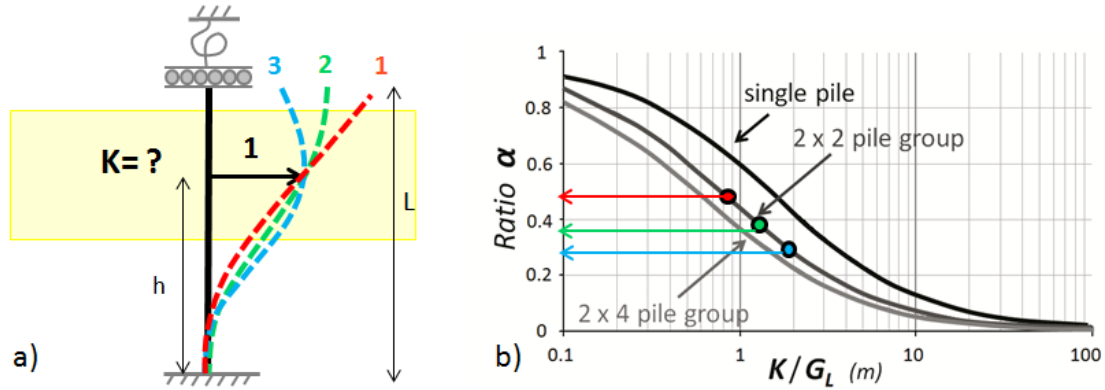
Figure 3.3. a) Determination of pile stiffness, K , as the equivalent concentrated load to cause unit displacement of piles in the middle of the liquefied zone, considering a column beam with appropriate boundaries conditions, b) The ratio α as a function of the relative stiffness between piles (K) and soil (G_L) for three different pile configurations (Tasiopoulou et al., 2012).

where E is the elastic modulus of pile material, I is the moment of inertia, L is the pile "active length" and h is the depth from the middle of liquefied zone to effective fixity (Fig.3.3.a).

Moreover, it is evident from Eqs 5.1 to 5.3, that $K_1 \leq K_2 \leq K_3$ always stands true. Therefore, for a given free-field displacement and a given degraded soil shear modulus, G_L , the ratio α obtained from graph in Fig. 3.3.b for each case follows that $\alpha_1 \geq \alpha_2 \geq \alpha_3$, which means that the pile displacement is greater

for Case 1 (cantilever) and less for Case 3 (back rotation), as expected. This is representative of the different response between the old east abutment (Case 3) and the new east abutment (close to Case 1) of Ferrymead Bridge. It should be reminded, though, that increase of pile stiffness due to superstructure constraint does not only induce the beneficial effect of limitation of displacements, but is also accompanied by additional bending moments which can lead to pile failure.
