Geotechnical and Structural Field Observations from Christchurch, February 2011 Earthquake, in New Zealand

Research Report

September 2011

National Technical University of Athens, Greece

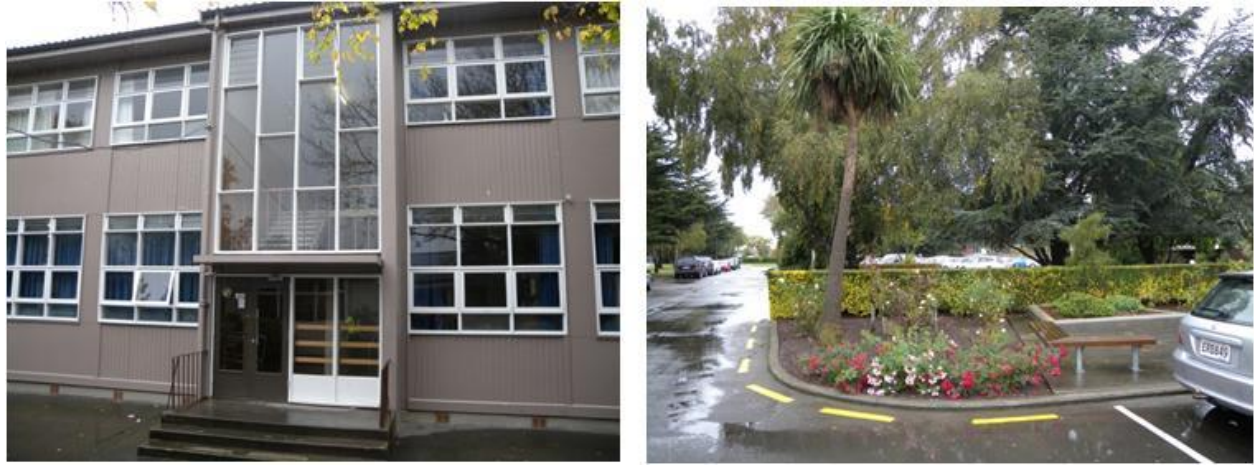
The school building, a steel made light structure, performed well during Christchurch earthquake, sustaining only minor damage, like superficial cracking in the walls. This may partially attributed to the fact that the building had been strengthened with steel braces 4 years four years ago. Close to the school there is large open space used for sport activities, while the buildings in the vicinity are also low light structures. These facts can lead to a safe conclusion that RHSC records are free-field motions, not essentially affected by the building response.

Figure 2.8. Riccarton High School (left) and its yard (right).

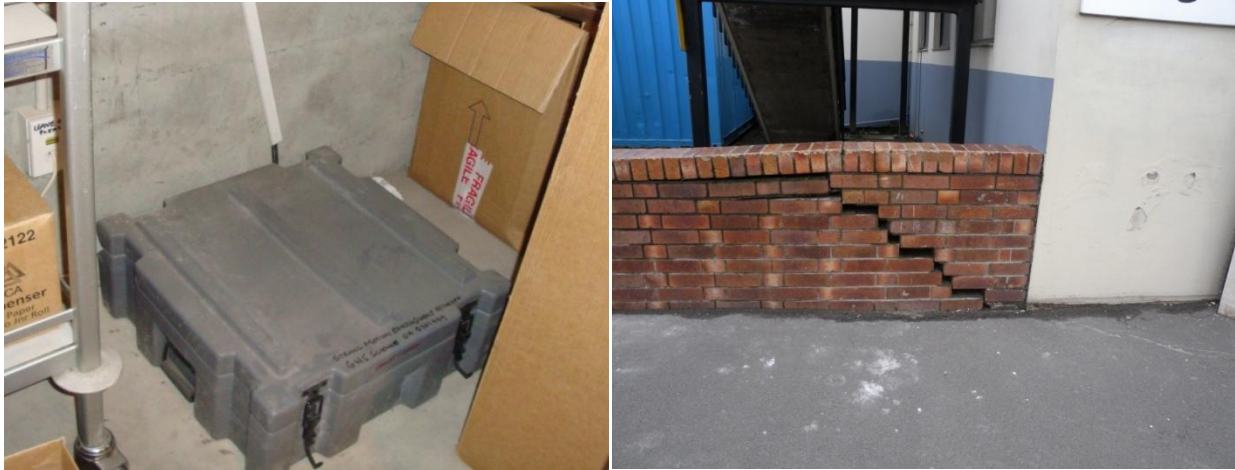
Figure 2.16. Seismograph placed on the ground floor (left). Shear crack in a wall adjacent to CHHC seismic station building due to liquefaction-induced differential settlement and possible heaving (right).

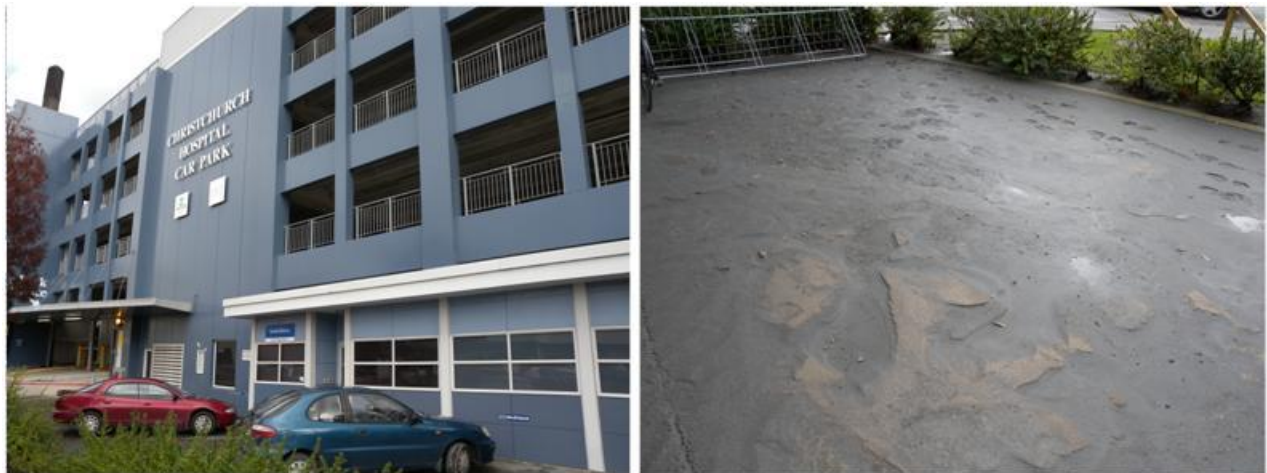
Sandboils were evident all over the neighborhood, which consists of heavy steel and concrete structures. The car park building across the seismic station was seriously damaged, as well as the Nurses' Training Building adjacent to the hospital. Overall, the CHHC recorded shaking is a strong one, despite the relative low value of accelerations, due to its rich period content. Last, it should be mentioned that the recorded ground motions must have been affected by the structure response and cannot be characterized as free-field records.

Figure 2.17. Christchurch Hospital Car Park (239 Antigua St) adjacent to CHHC seismic station building (left). Sand ejecta in front of Christchurch Hospital Car Park (right).

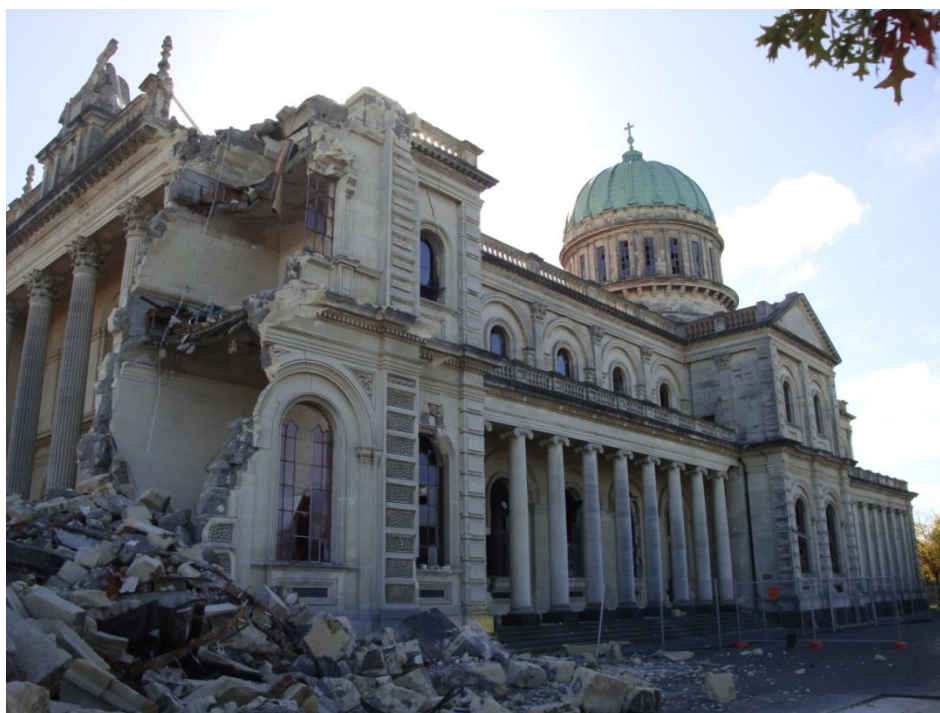
CCCC seismic station is situated at the Christchurch Cathedral College close to the southeast edge of CBD. We were not able to enter the building in order to exactly locate the seismograph. The College is a new designed building which sustained no visible damage during the earthquake. However, the Cathedral of the Blessed Sacrament was partially collapsed. Sandboils appeared all over the site especially on the open space next to the college building. The superficial soil deposits, 20 m thick, consist of sand and clay, as indicated by the borelog conducted in the site (Figure 2.21).

Figure 2.23. Partial collapse of the Cathedral of the Blessed Sacrament, close to CCCC station.

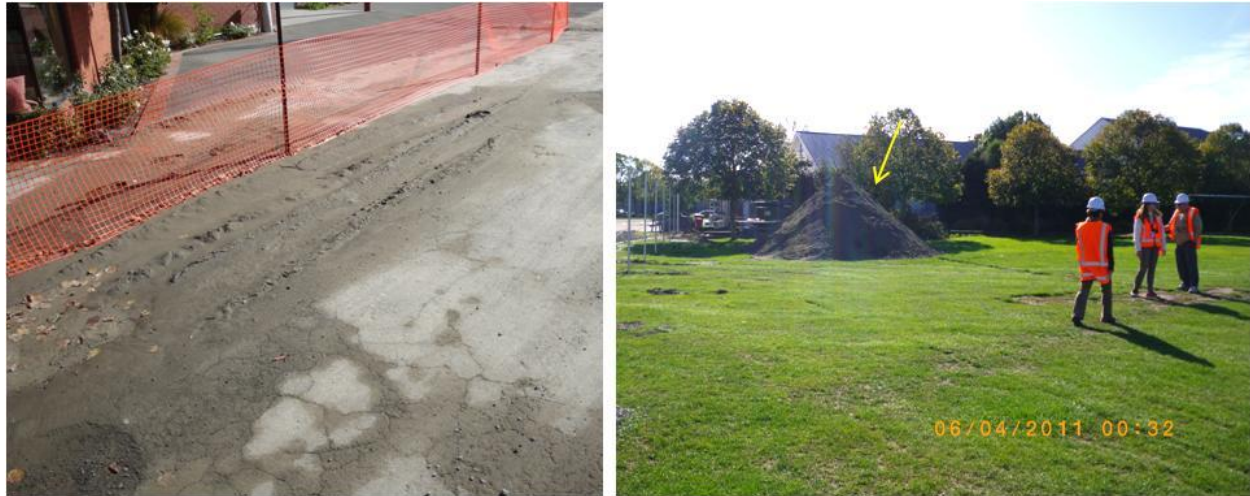
Figure 2.24. Liquefaction in front of Christchurch Cathedral College (right). Ejected sand from the open space next to CCCC station cumulated in a pile (right).

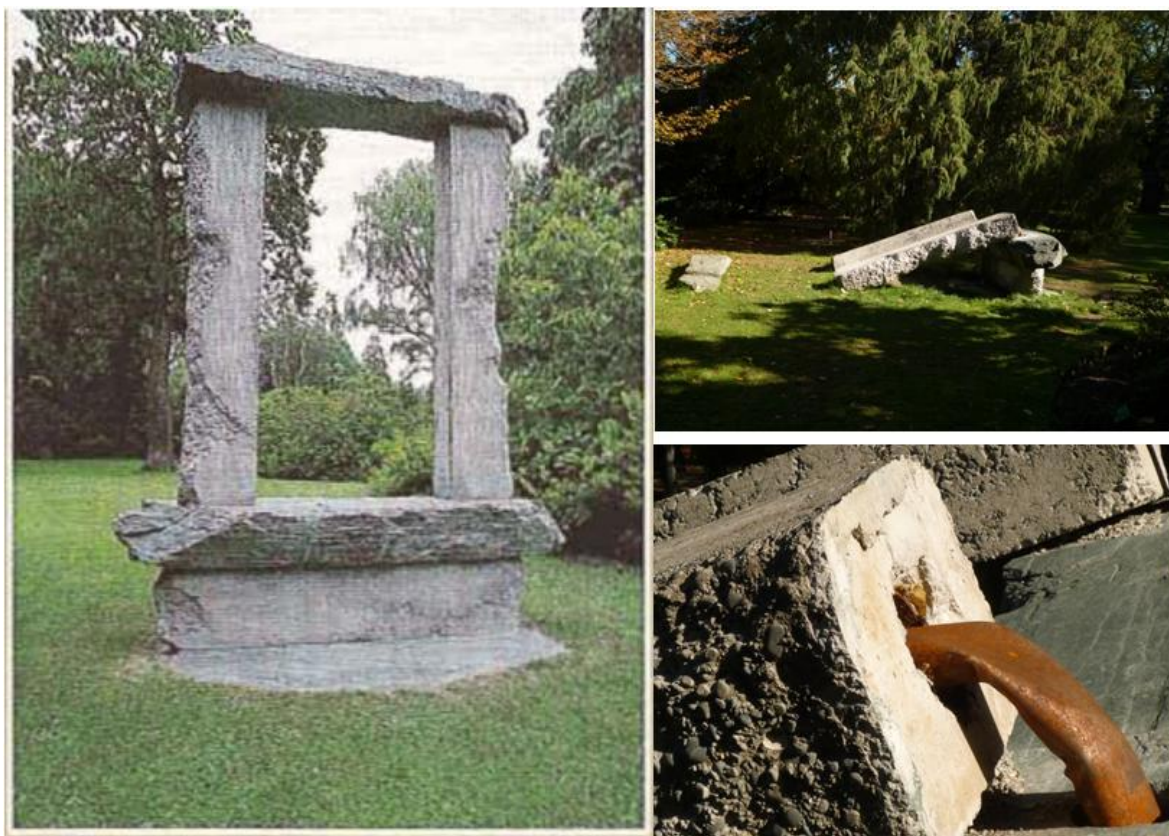
The monument in the “Azalea garden” section of the Botanic Gardens, named as “An Inside Outlook” by the sculptor Stuart Griffiths, consists of a concrete base, a green granite piece on the base, 2 concrete columns (fairly regularly shaped) and a green granite top (see Figures 2.37 to 2.39). The 2 concrete columns are connected to the base by using steel tubes with 9cm diameter and 2mm wall thickness.

The monument fell down towards the South-East direction causing failure of the steel tubes. The tubes were buckled and exceeded their bearing capacity.

Figure 2.37. "An Inside Outlook" by sculptor Stuart Griffiths in Azalea Gardens before Christchurch earthquake (left). Fallen sculpt after the earthquake (right).

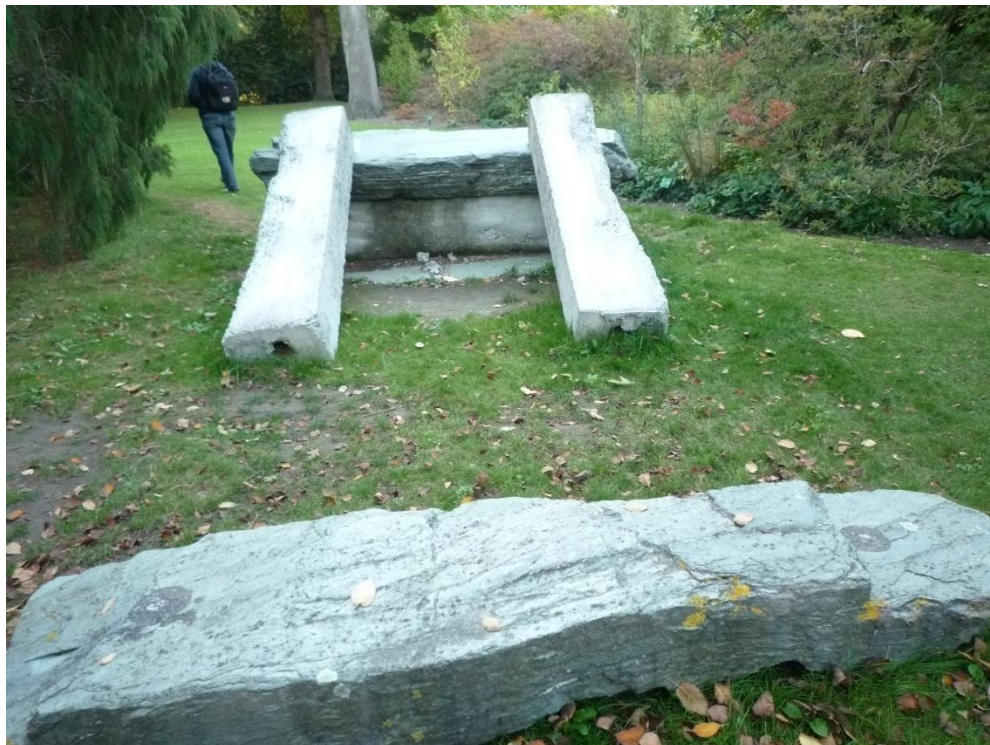
Figure 2.38. Sand ejecta on the site of the fallen sculpt in Azalea gardens.

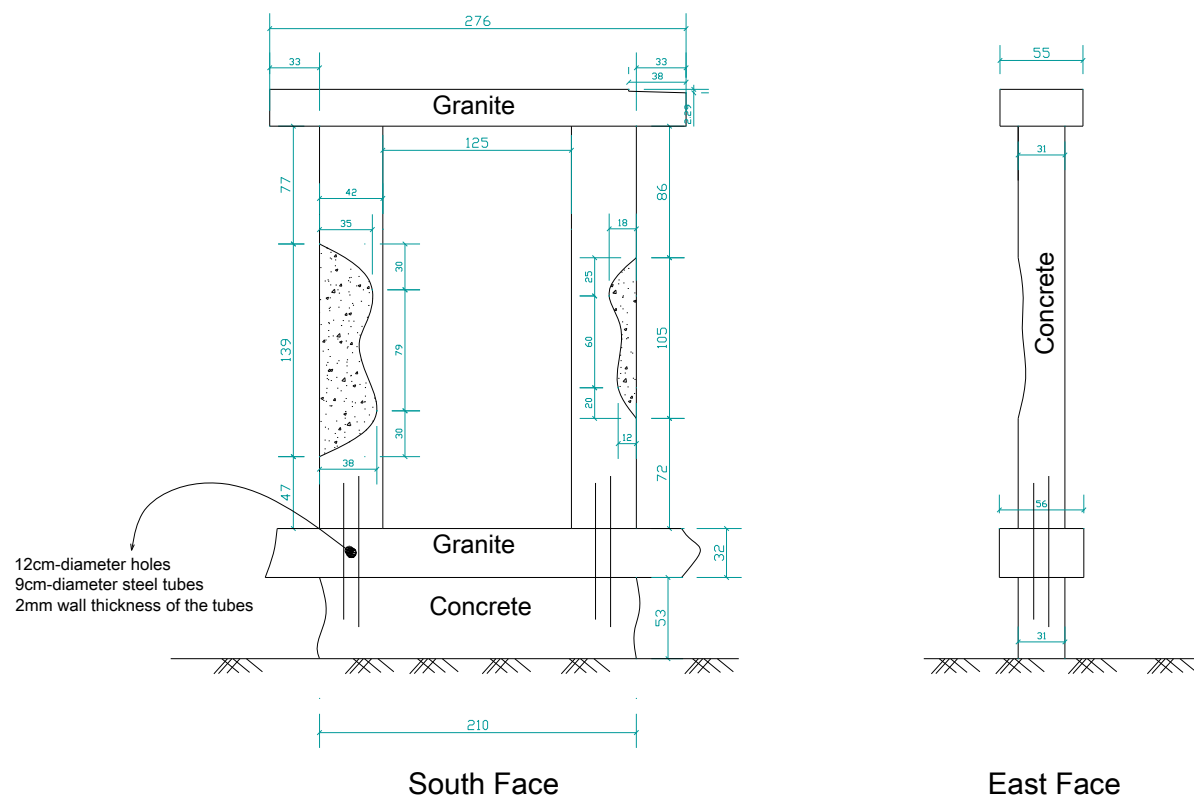
Figure 2.39. Elevation of the fallen monument "An Inside Outlook" close to the CBGS recorder

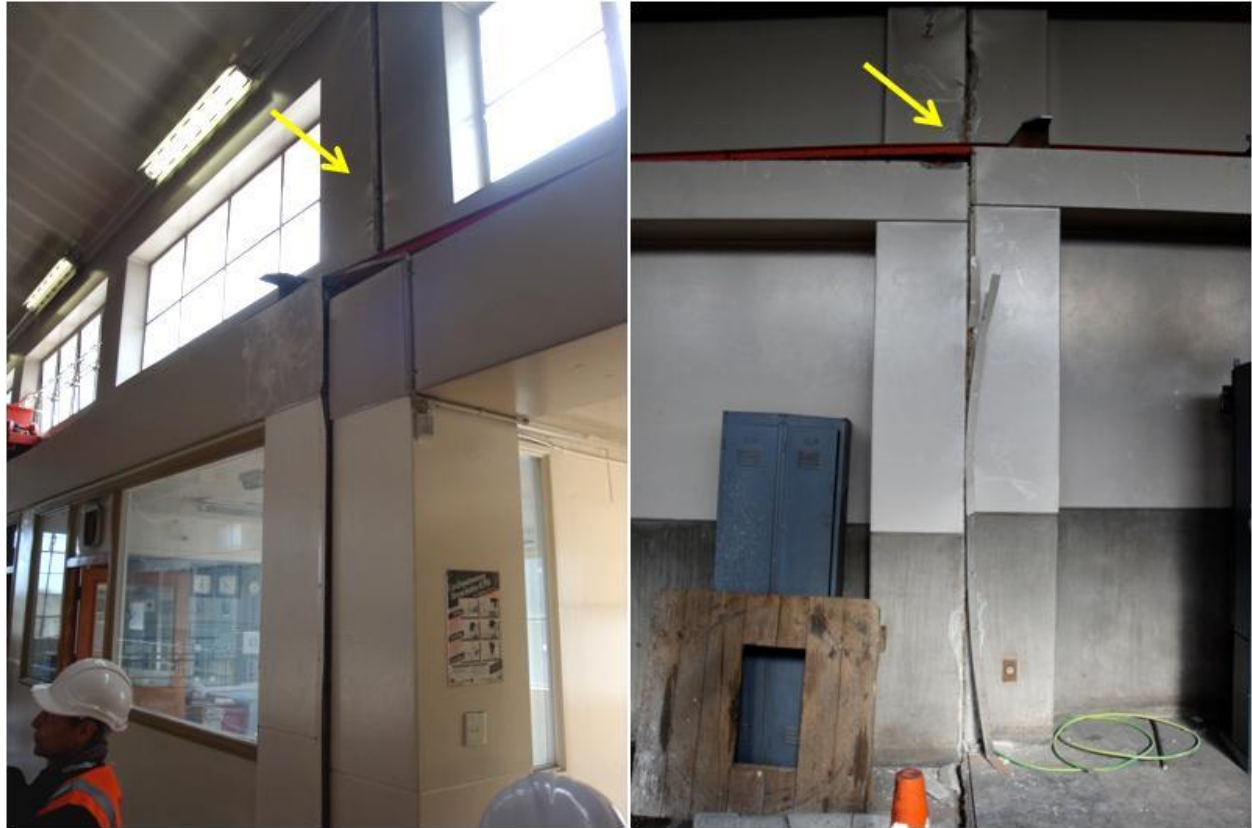
The Pumping Station suffered significant damage during the earthquake and was unoccupied by the time of our visit. Differential displacement of one section relative to the adjacent one was the primary damage. Moreover, there was no evidence of liquefaction on the site, when we arrived, not even remnants of sand. However, a borelog contacted in the site shows that the superficial layer 27 m consists only of sand (Figure 2.44). Moreover, typical characteristics for liquefied sites, such as long period cycles and acceleration cut-off can be observed in the recorded acceleration time histories and the corresponding spectra. The maximum PGA value recorded by the seismograph is 0.72g (Figure 2.45) in the EW direction. It should be mentioned, though, that the EW record seems to have been affected by the objects surrounding the instrument.

Figure 2.43. Interior of the Pumping Station next to the garage. Differential movement at the joint of one section of the building with the other.

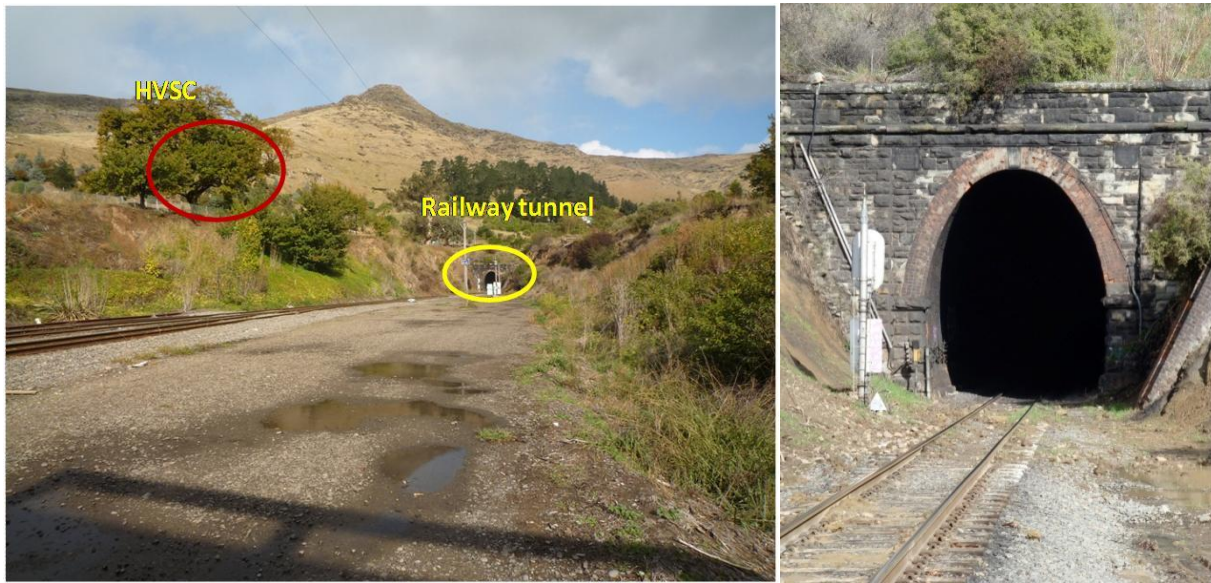
Figure 2.48. The excavation adjacent to HVSC station, leading to railway tunnel. The remnants of rain water show that it cannot be easily absorbed by the soil which is indicative of clayey soil with low permeability(left). The entrance to the railway tunnel showing, no damage (right).

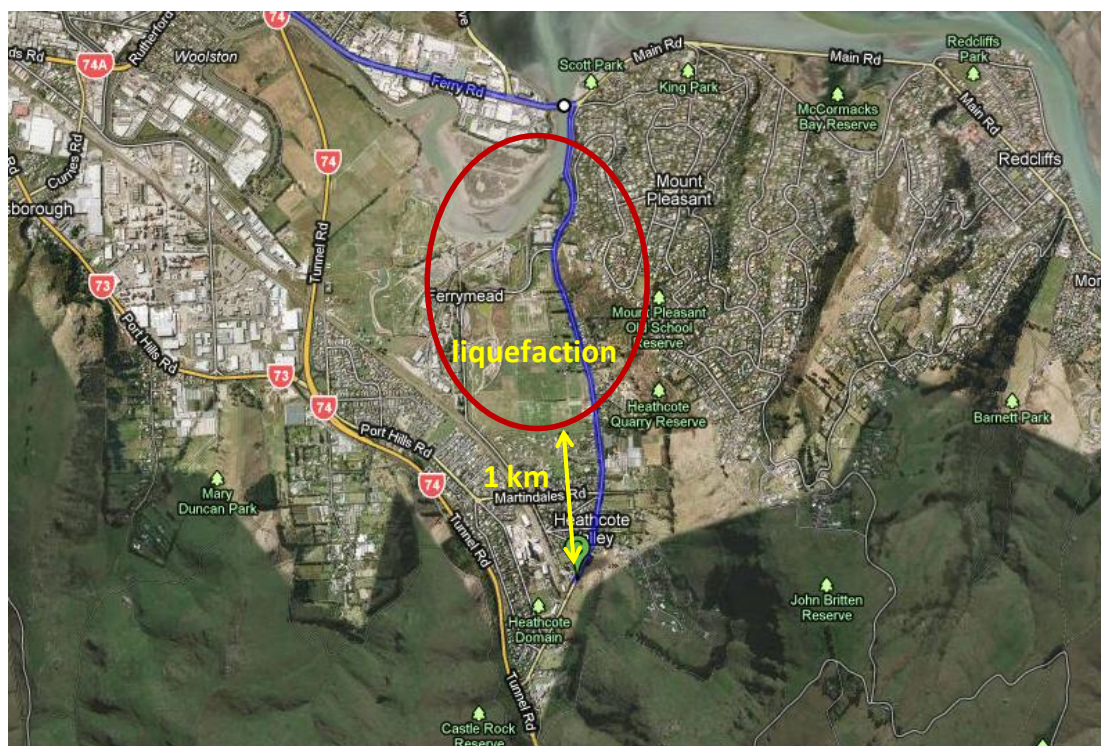
Figure 2.51. Evidence of liquefaction appears in Ferrymead, 1.5 km north of HVSC station.

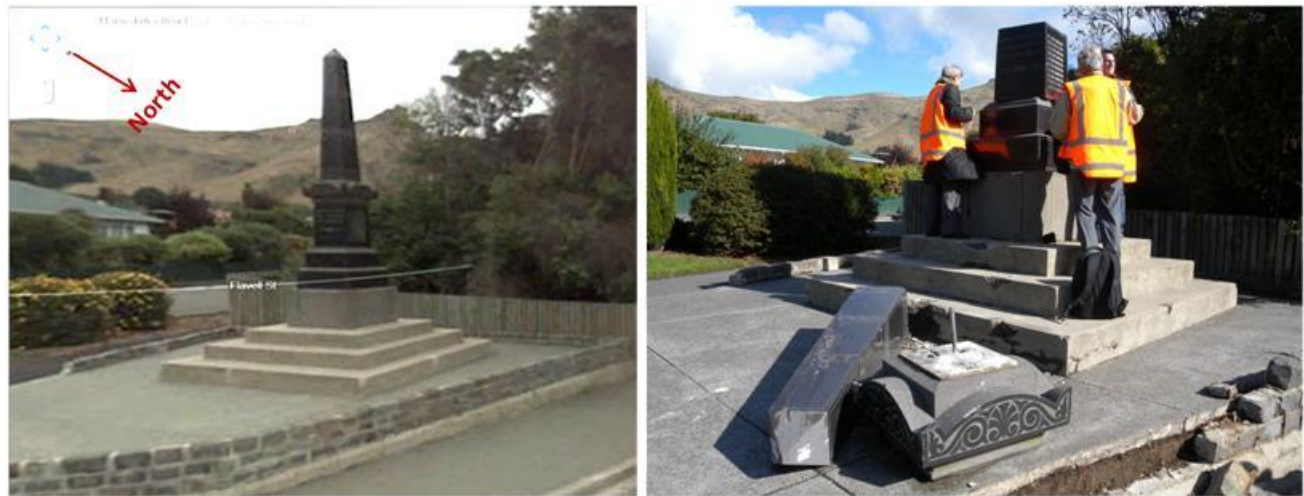
The memorial obelisk in Heathcote Valley (Figure 2.54 to 2.56) has fallen down in an angle 45 degrees towards East from North (see Figure 2.55). The base of the obelisk where the names are written has also tilted about 12 degrees towards in anti-clockwise direction. No shear connection is observed on the site between the tilted piece and the pieces above or below.

Figure 2.54. Obelisk at the corner of Bridle Path Road and Martindales Road close to HVSC station before Christchurch earthquake (left). Fallen obelisk after the earthquake (right).

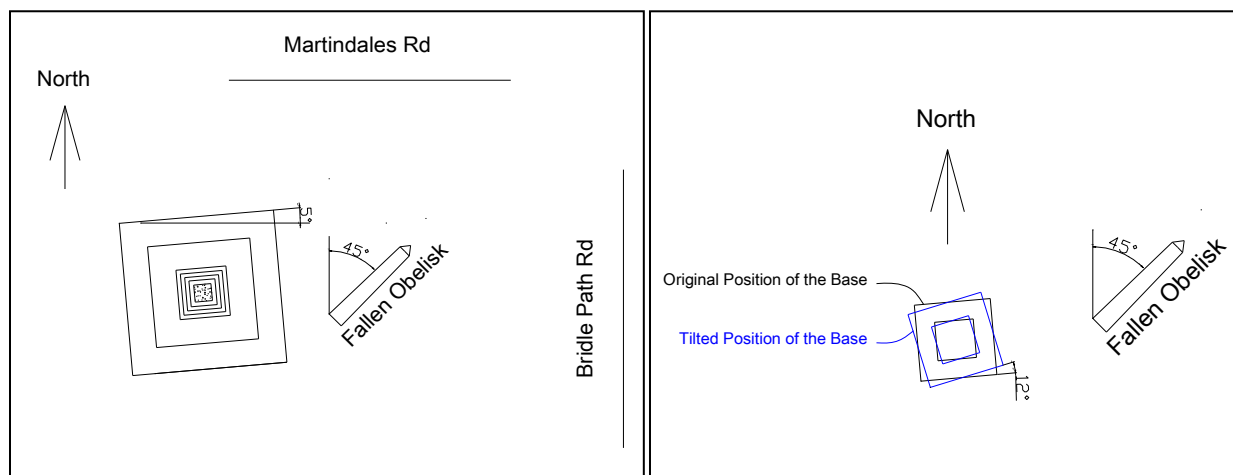
Figure 2.55. Original and tilted-fallen positions of the base of the monument and the obelisk.

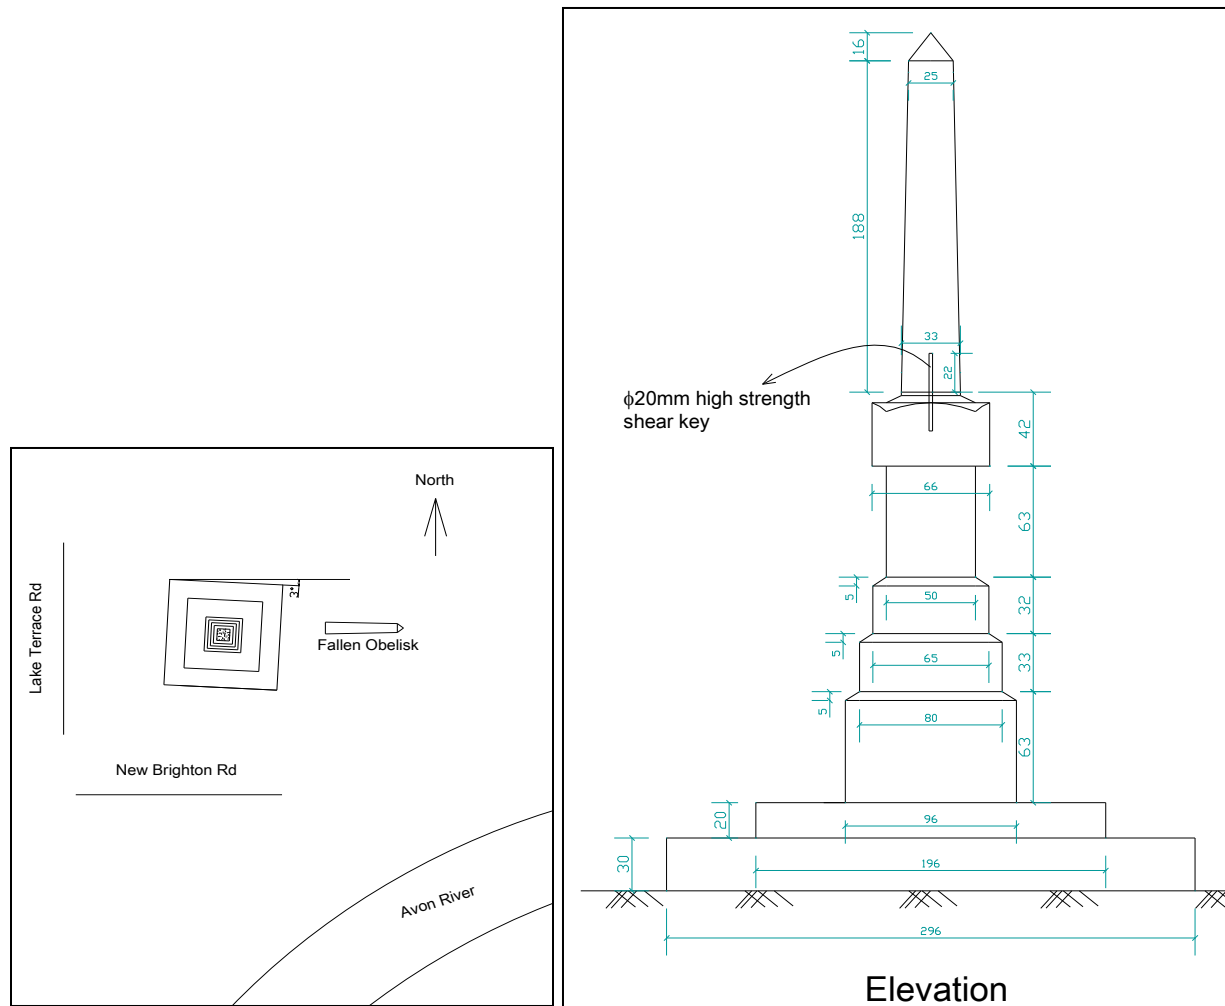
There is another fallen monument along Avon River, at the corner of New Brighton Road and Lake Terrace Road (Figure 2.57) that has almost the same dimensions with the monument in Heathcote Valley. The memorial obelisk by Avon River, at the corner of New Brighton Road and Lake Terrace Road, fell down during the Christchurch Earthquake of February 22nd. The falling direction of the obelisk is almost perfectly aligned with East. The axes of the base of the obelisk are aligned, with 3 degrees difference, with NS and EW. The base piece, just below the obelisk, is also simply placed on the rest of the bottom part of the monument but no tilting or translational displacement was observed. The monument is 2.8km far from the PRPC recording station. That monument was 1.5km away from the HPSC (Hulverstone Drive Pumping Station).

Figure 2.57. Elevation of the marble monument along Avon River, relatively close to the HPSC recorder.

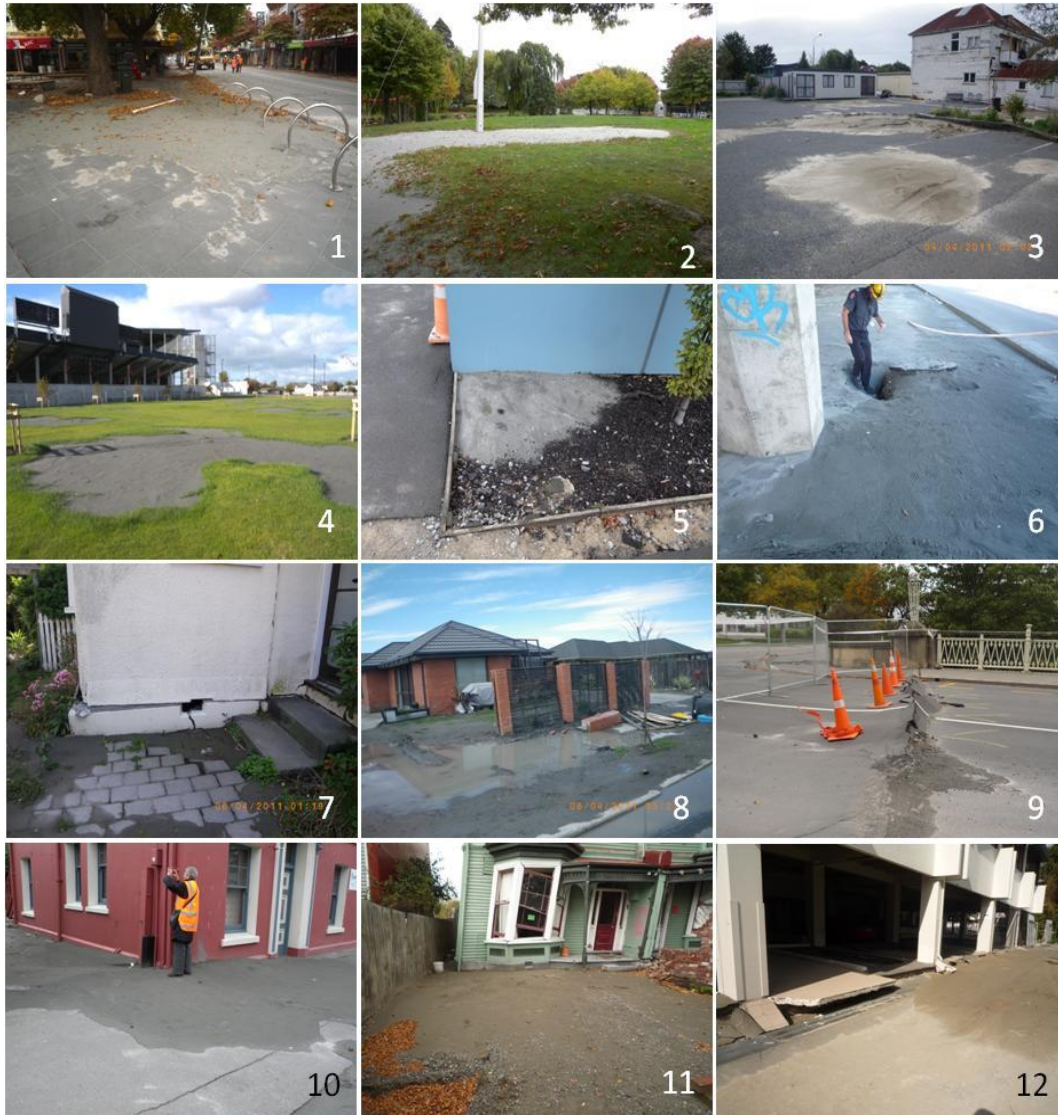
Figure 2.62. Photos of liquefied sites after Christchurch earthquake.

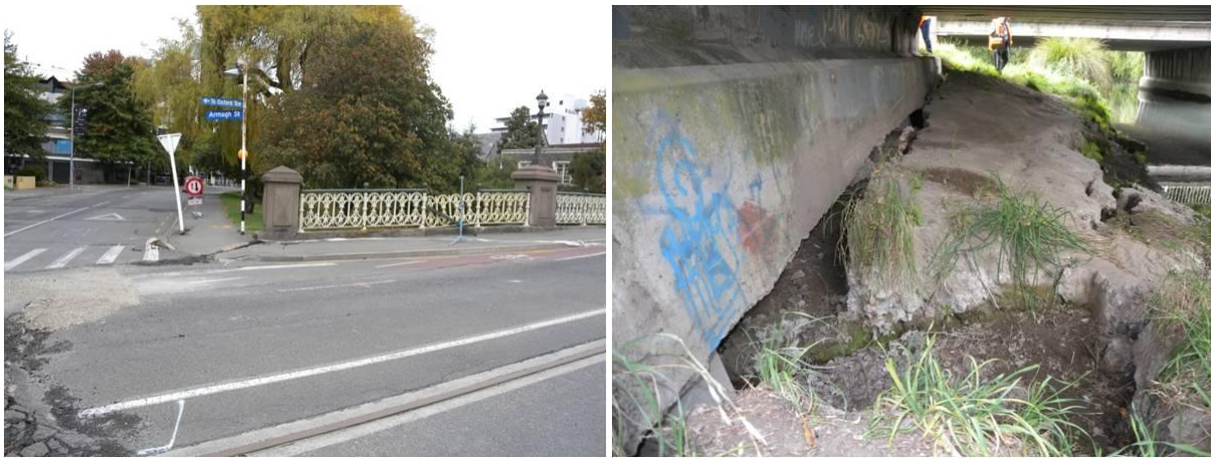
The old bridge on Manchester Street, crossing Avon River and Oxford Terrace, did not have any major damage but it suffered slight rotation of abutments due to lateral spreading, road cracks at the edges of the bridge. A nearby small park with lots of sand boils and large amount of sand made liquefaction clear.

Fitzgerald Bridge has suffered some significant abutment rotation due to major lateral spreading. Piles appeared due to subsidence of lateral movement of ground soil. The most of the damage was caused by the Darfield Earthquake, 2010.

Figure 3. 2. Bridge at Oxford Terrace (left) and rotated abutment of Fitzgerald bridge (right).

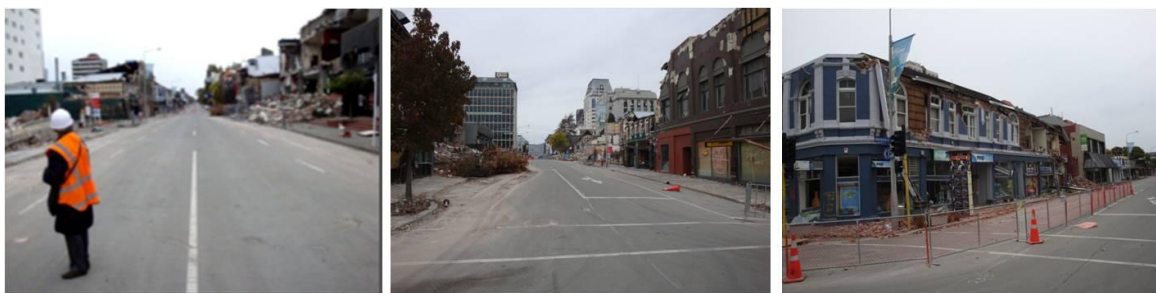
Manchester Street consists of several unreinforced masonry buildings, most of which has suffered out-of-plane failure of the perimeter walls (see Figure 3. 3 and Figure 3. 4).

Figure 3. 3. View of Manchester Street.

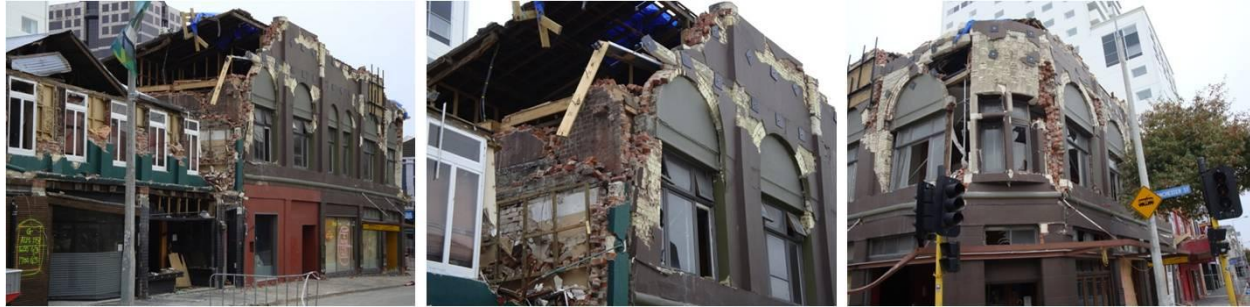
There is difficulty in identifying any connection between the bearing system and the external walls, resulting in the out-of-plane collapse of the latter, probably due to incompatibility of deformation. A type of composite slab that combines wood flooring with iron or steel beams was observed in most of the unreinforced masonry buildings (Figure 3. 5).

Figure 3. 4. Damaged buildings at Manchester Street.

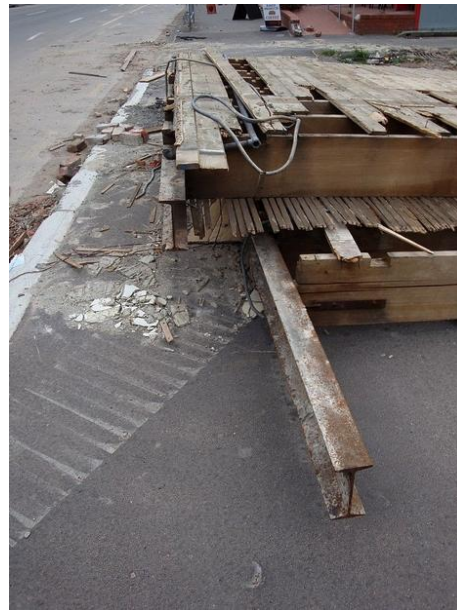
Figure 3. 5. A composite slab found at Manchester Street.

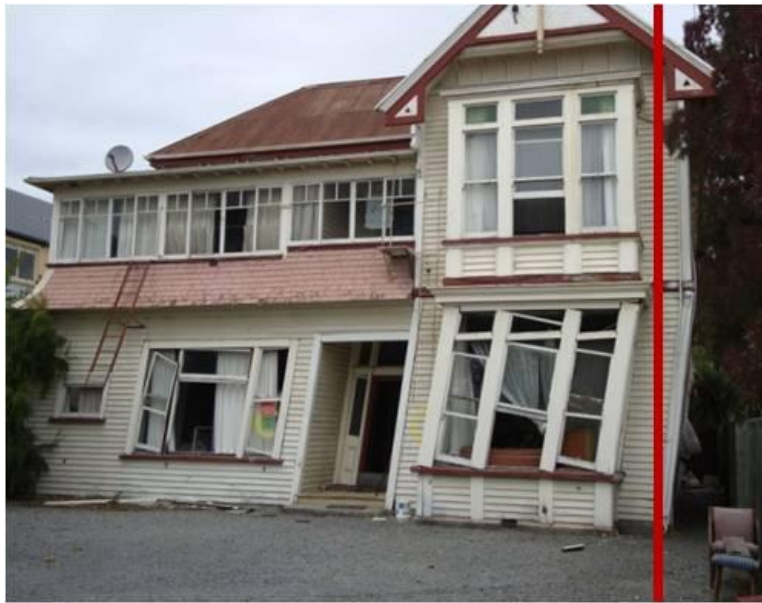
The generally satisfactory performance of most wooden structures can be attributed to their inherent flexibility. However, the lack of an appropriate lateral system of resistance led to failures such as the one shown in Figure 3. 6 in which a soft storey mechanism was formed, resulting in considerable residual displacements. Old-style timber bearing systems found in the area lack diagonal stiffening elements and moment-resisting joints at floor levels, causing formation of hinges. The modern timber structure (as shown in Figure 3. 9), some of which were found under construction; seem to be designed to resist lateral loads specifically, a fact that is confirmed with low level of damage in modern timber structures.

Figure 3. 6. Collapsed wooden residence at Gloucester St.

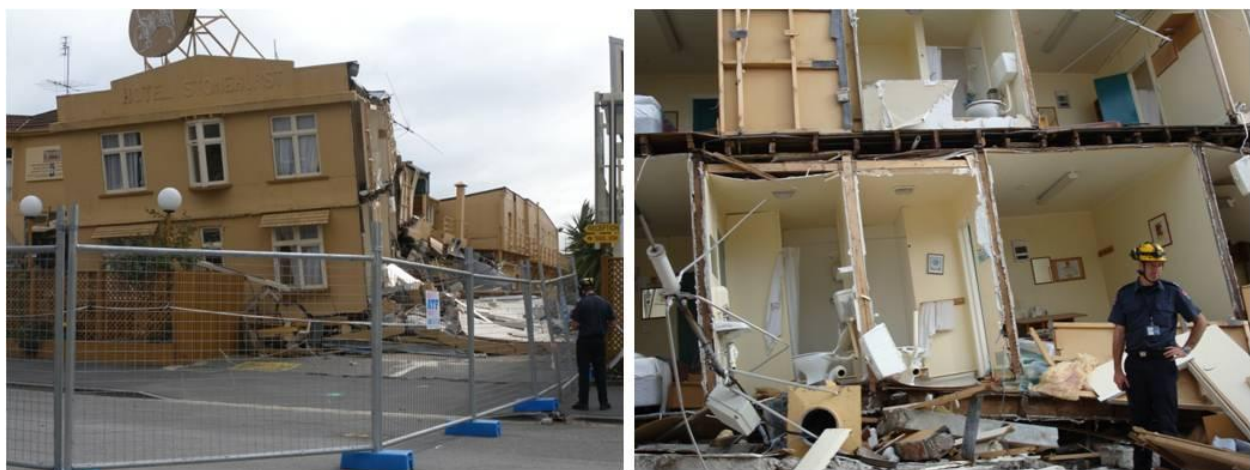
In this part of the route, liquefaction was evident almost everywhere, tons of sand coming out of the boundaries of buildings. The area is not densely built and there are lots of free fields around. The building stock consists of low-rise structures in general. There were timber frame houses along that route which extensively damaged (see Figure 3. 6). A timber hostel building with a very heavy external wall was collapsed. The hostel building also had tilting due to differential settlement of the soil (Figure 3. 7 and Figure 3. 8).

Figure 3. 7. Collapsed Stonehurst Hostel at Gloucester Street.

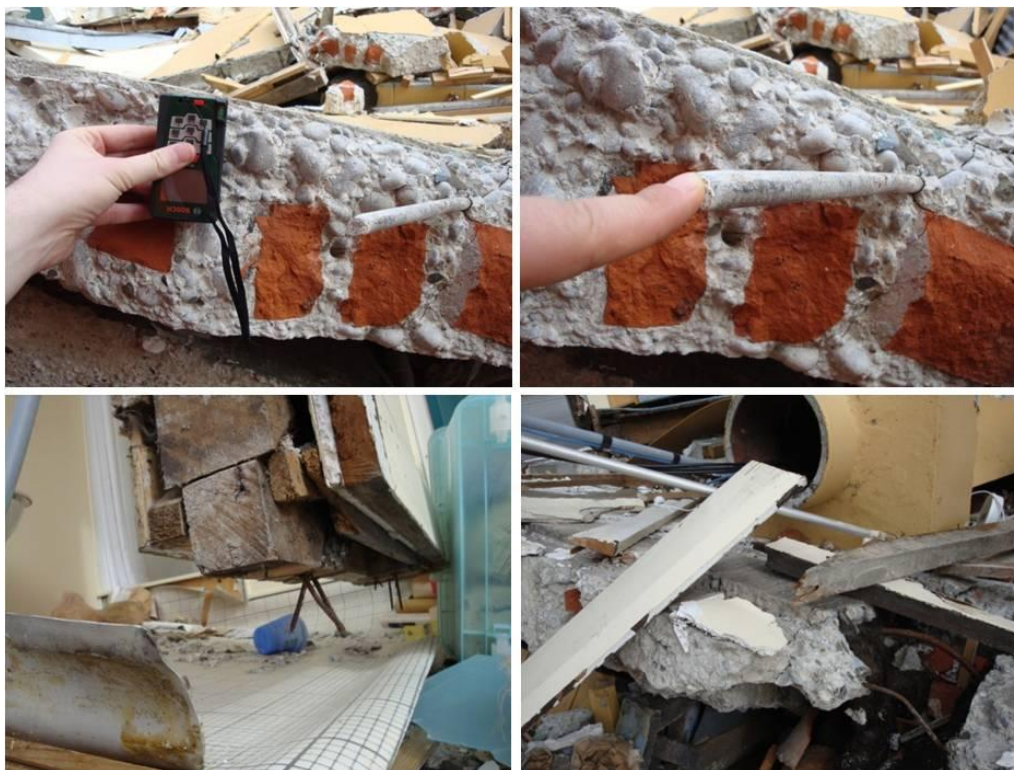
Figure 3. 8. The heavy external wall and the slab detail of the collapsed Stonehurst Hostel.

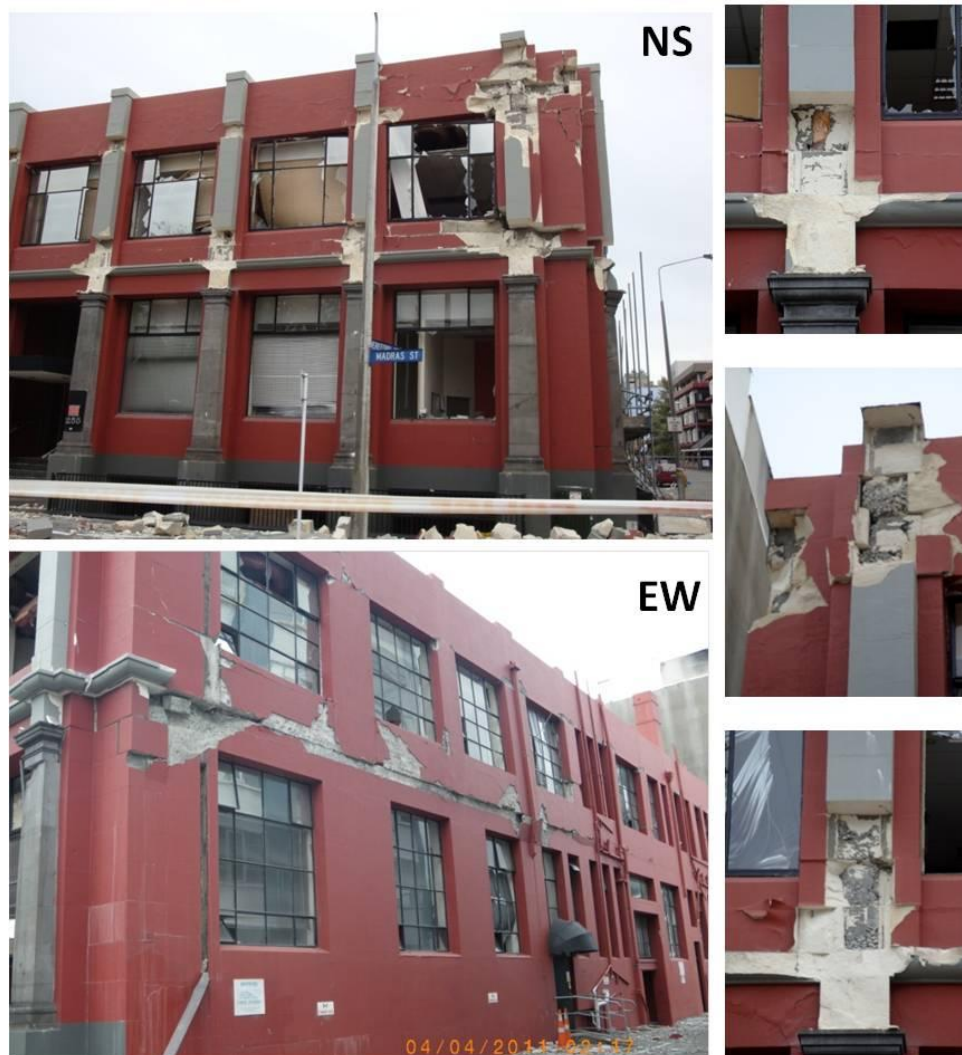
Figure 3. 10. Building at Hereford and Madras Streets.

For example, the building in the corner of Hereford and Madras Streets bore serious structural cracks in the EW direction (along Hereford St), while in NS direction there were damages of non-structural elements primarily (Figure 3. 10). In the damaged direction of that building, characteristic shear cracks in the joints, considerable movement resulting in the fall or detachment of non-structural elements, wide cracks in corner column, and rigid body movement of decorative one-piece column are the main observations regarding the damage.

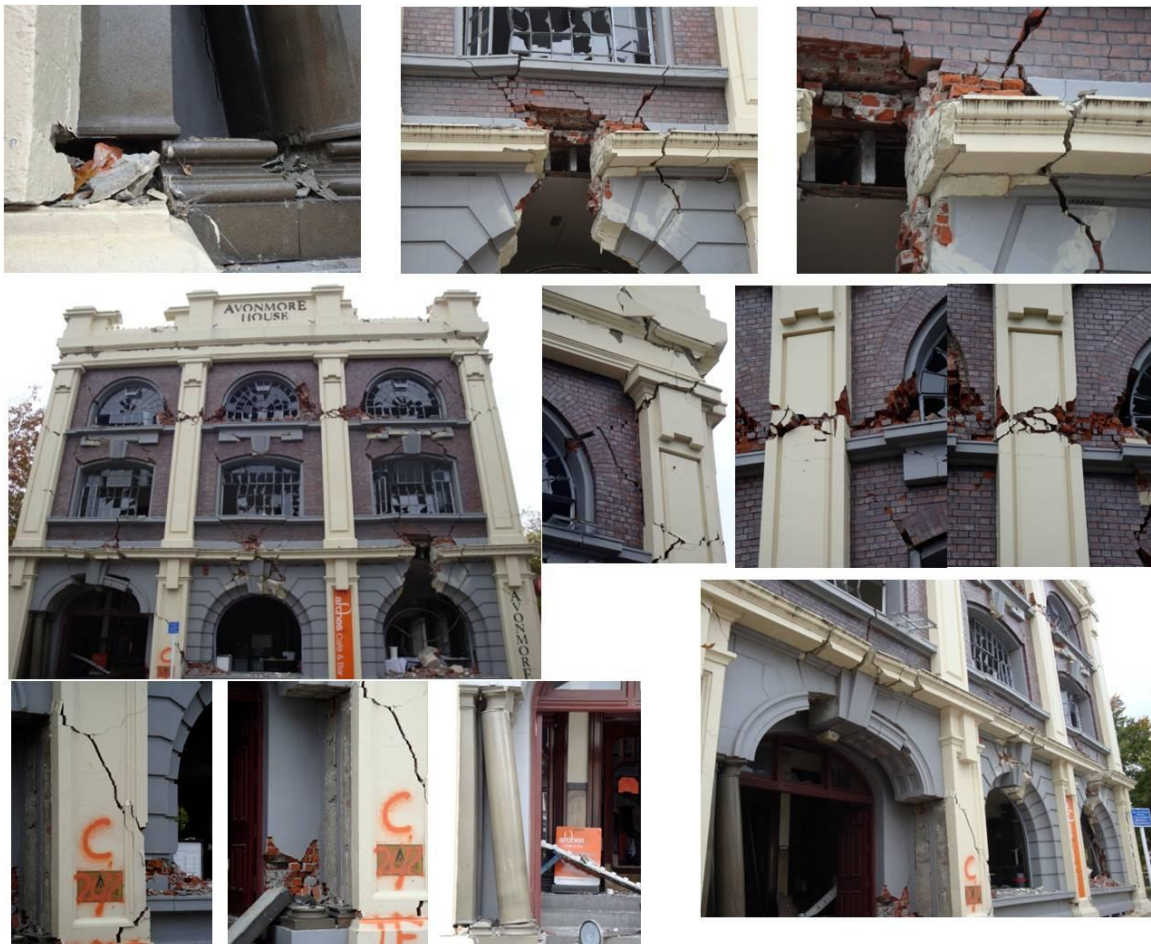
Similarly to above, the building at Hereford St and Latimer Square exhibits major shear cracks in the EW direction, while in the NS direction has suffered limited damage compared to the opposite direction (from Figure 3. 11 to Figure 3. 13). Damages in that building are due to the existence of squat piers in the corners of rectangular openings. The situation is deteriorated by the repeated pattern of semi-circular arches resting on short columns that practically cuts the entire floor.

Figure 3. 11. Building at Hereford St and Latimer Square – EW direction

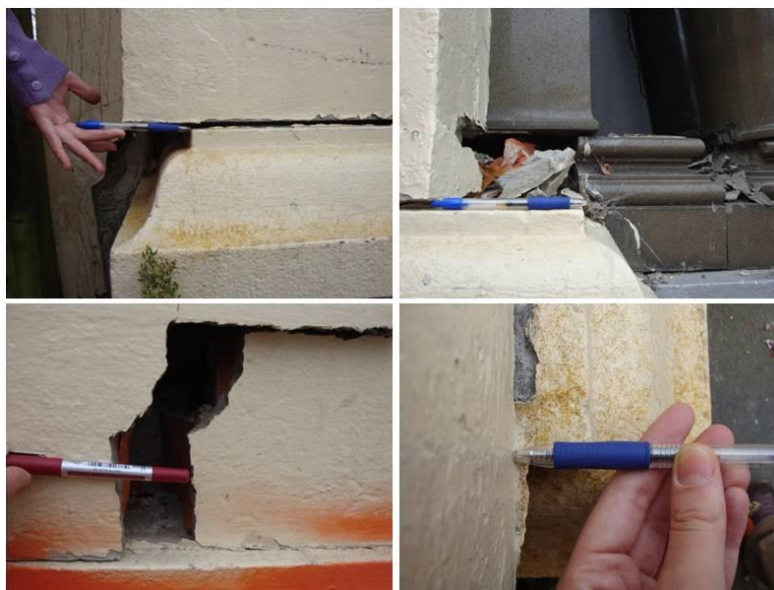
Figure 3. 12. Lateral displacement of columns in the EW direction.

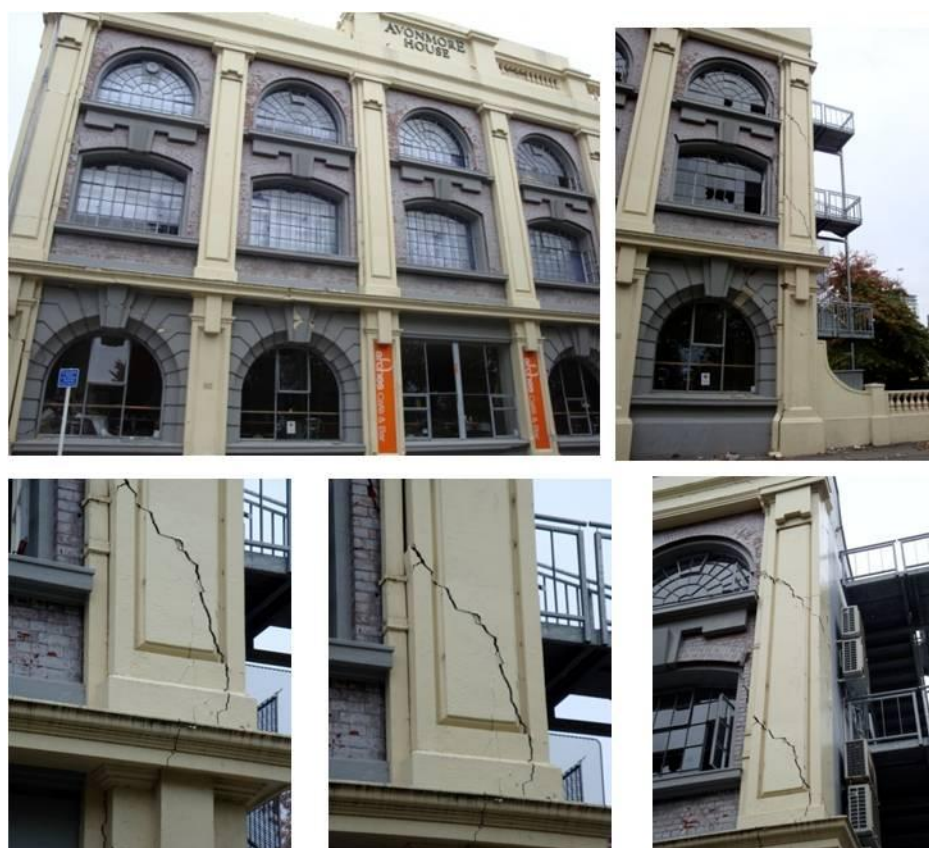
Figure 3. 13. Building at Hereford St and Latimer Square – NS direction.

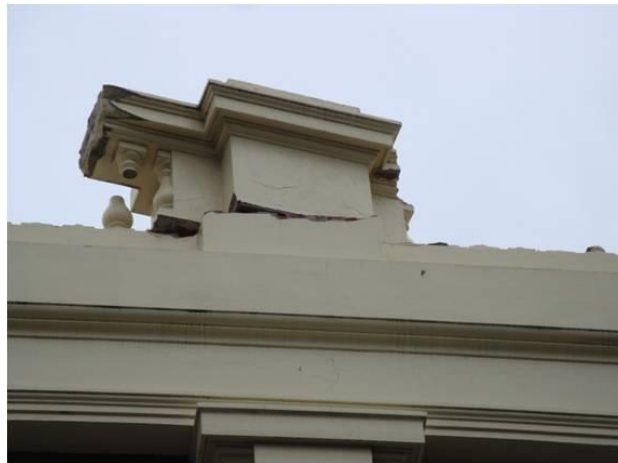
Massive decorative elements, badly connected to the buildings as shown in Figure 3. 14, caused loss of life during the earthquake. It should be noted that such elements' fall is due to high accelerations, that is why those in the NS side (normal to the strong component of the earthquake) are affected mostly, while the damage in EW side is primarily structural. A characteristic case of failure of non-structural elements is collapse of a massive perimeter beam element which was not structural, as shown in Figure 3. 15, constructed using bad quality concrete and reinforced with insufficient in number and area bars. That beam collapsed during the shaking and caused 1 casualty.

Figure 3. 14. Massive decorative element disconnected from the main body of the structure.

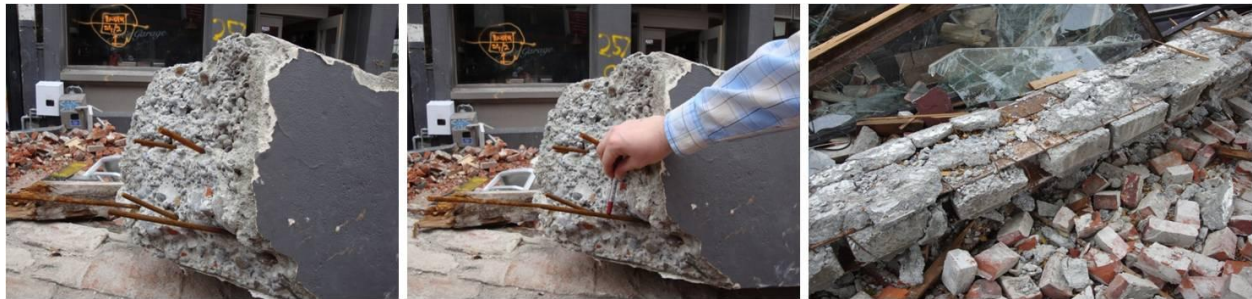
Figure 3. 15. Insufficient reinforcement, low quality concrete and bad application caused collapse of a decorative beam and 1 casualty.
