Geotechnical and Structural Field Observations from Christchurch, February 2011 Earthquake, in New Zealand

Research Report

September 2011

National Technical University of Athens, Greece

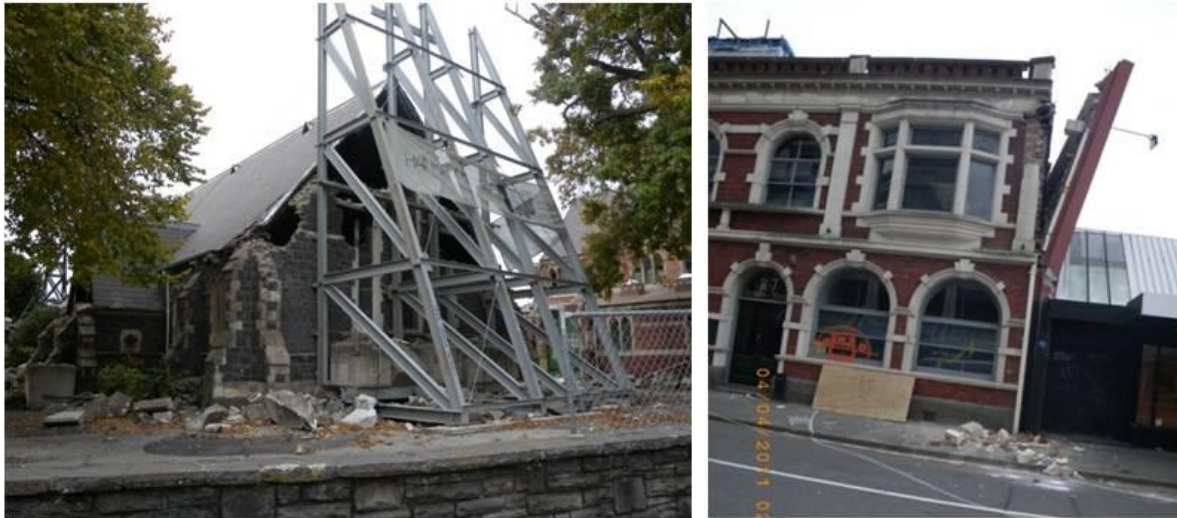
The high accelerations induced by the earthquake, as recorded by the four stations in CBD, led to out-of-plane failures of the external leaf of masonry walls that were detached from the usually wooden frame of the structures (Figure 3. 16). After the earthquake the support of whole side of some masonry structures was needed in order to avoid their collapse. However, the overturning of wall segments was deterred in several cases with the application of tie rods. Again, in most of the cases, the out-of-plane movement of the facade occurred towards East.

Figure 3. 16. Out-of-plane failures around Hereford Street.

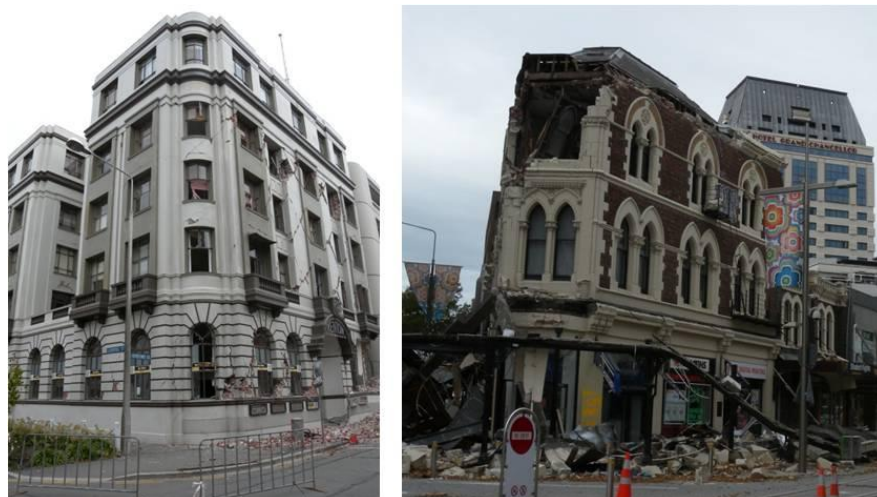
Liquefaction was evident around Stewart square with sand on the surface and cracks on the sidewalks. Old masonry buildings had significant damage and partial collapse (Figure 3. 17). A monumental structure with a tower and a dome has partially collapsed (Figure 3. 18).

Figure 3. 17. Severely damaged building at Hereford St with characteristic shear cracks and historical building at Stewart Square.

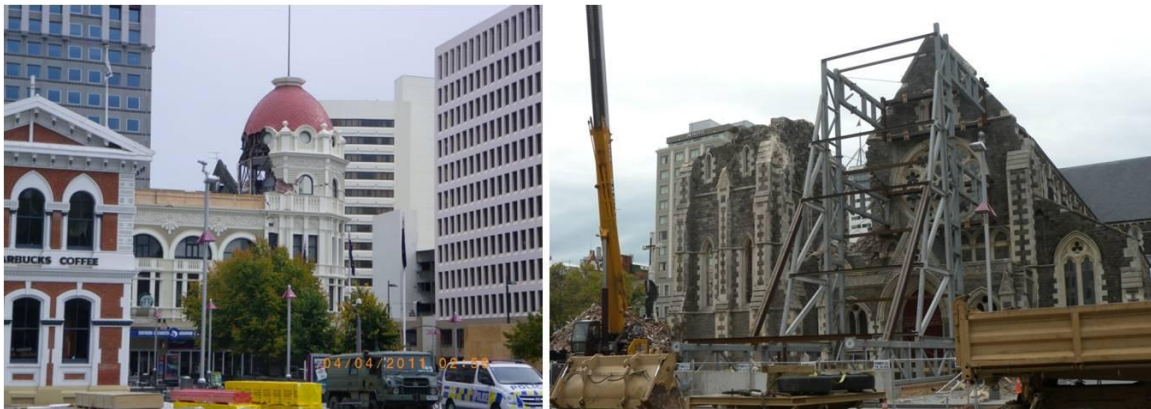
Figure 3. 18. Collapse of dome and view of the heavily damaged and partially collapsed Cathedral.

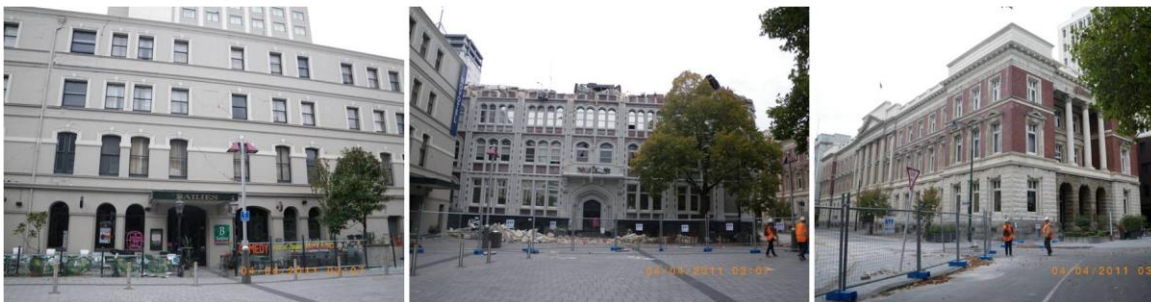
No liquefaction was observed in Cathedral Square. Severe structural damage of the church and nearby masonry buildings was observed. The last floor of the building (left side of Figure 3. 19) has collapsed at night during an aftershock. The building seen on the right side of Figure 3. 19 did not suffer any significant damage since it was successfully retrofitted before the shakings.

Figure 3. 19. Buildings in the Cathedral Square.

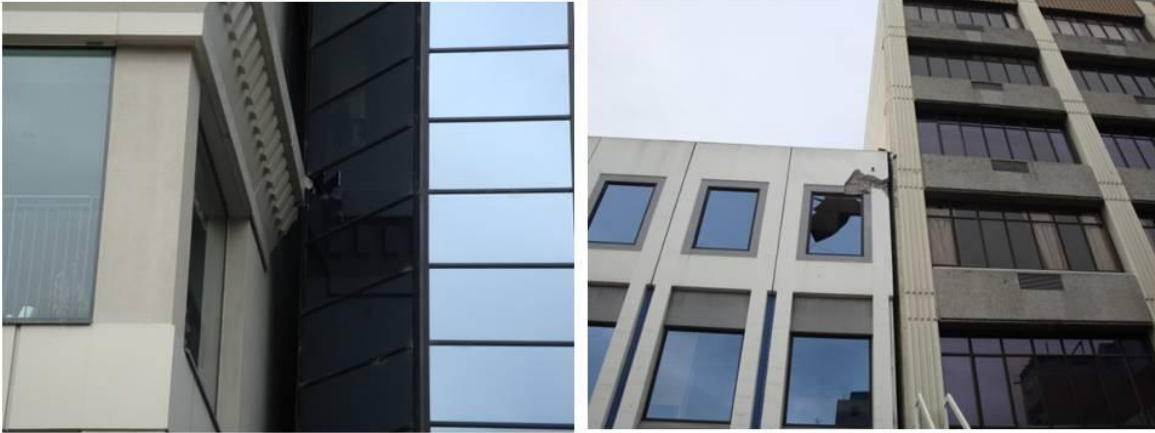
Pounding effect was also observed in CBD, among structures with varying height and stiffness. Large ground deformations might have also helped pounding of adjacent structures (Figure 3. 22).

Figure 3. 22. Observed pounding effect in CBD.

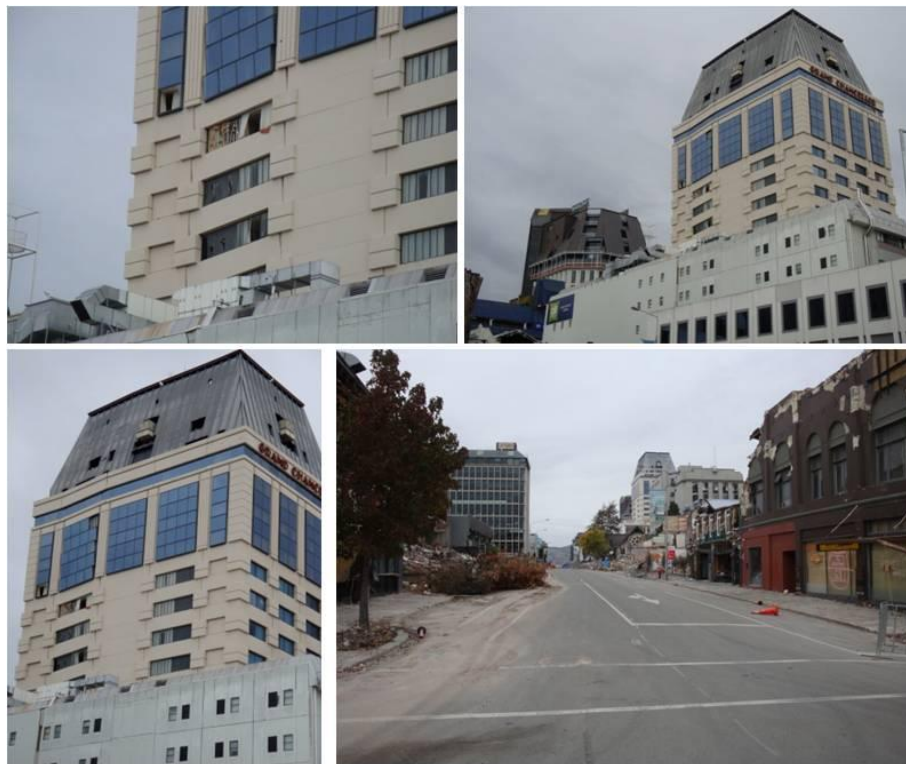
An emblematic building of the city, Grand Chancellor Hotel, had failure of one of the ground floor shear walls leading thus to progressive failure in the floors above. The building is the tallest in the city with 26 storeys and 85m height. Grand Chancellor exhibited severe damage and more than 1m residual top displacement, rendering it unusable. A safe region around the Grand Chancellor Hotel was close to any access even by the search and rescue teams, due to the high level of danger associated.

Figure 3. 23. Views of the Hotel Grand Chancellor.

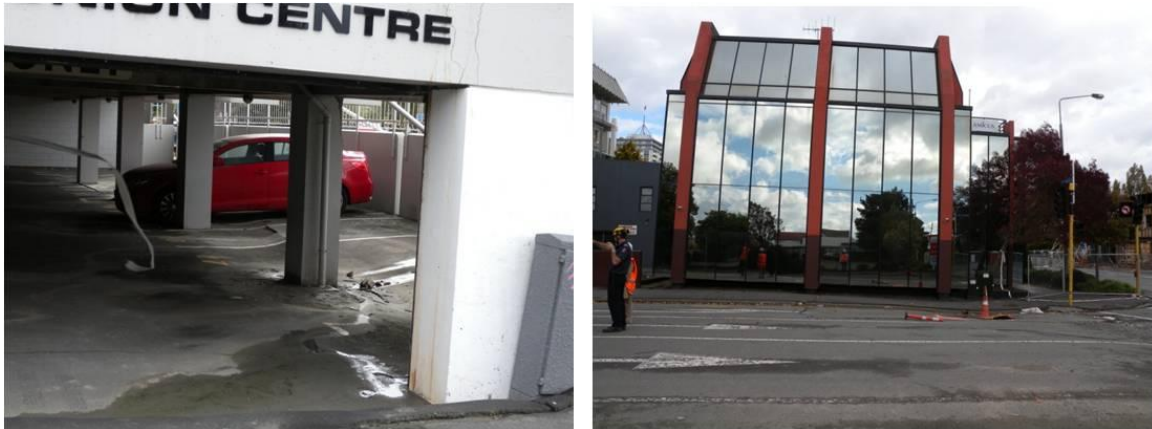
Figure 3. 24. Buildings (B20 left and B22 right) damaged due to differential settlements induced by liquefaction.

Traces of liquefactions were obvious along Madras Street. Severe damage was observed in EAST-WEST direction once more. A six storey building (see the left building in Figure 3. 24) was extensive liquefaction, shallow foundation comprised of isolated footings with tie beams and perimeter grade beam, differential settlements in the range of 26cm, structural deformations. The building shown on the right side of Figure 3. 24 suffered a substantial settlement of the front side resulting in tilt of ~ 2 degrees. Uniform lateral displacement of 15cm towards the area of significant liquefaction near the right front of the building was observed. Both these buildings were considered uneconomic to repair and were (will be) demolished in the months following the 22 February 2011 earthquake. Other multi-storey buildings also suffered this type of damage, which in many cases was exacerbated by the 13 June 2011 earthquakes (Cubrinovski and McCahon 2011).

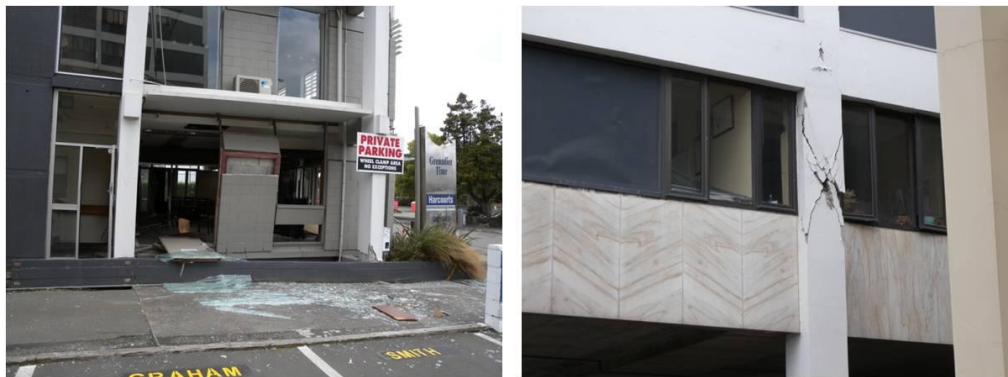
Figure 3. 25. Heavily damaged buildings at Madras Street.

Due to the architecture of the commercial buildings in CBD, characteristic short column shear failure as indicated in by the diagonal cracks are common (Figure 3. 25).

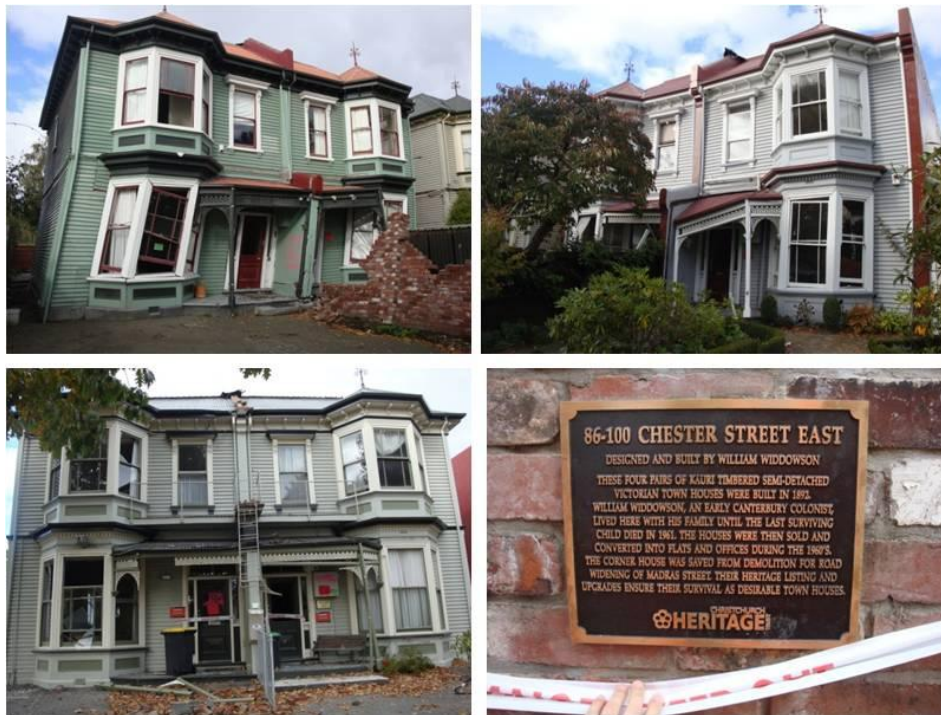
Figure 3. 27. Historical wooden structures at Chester Street.

Chester Street East has a series of historical timber houses sustained significant structural damage, plastic hinges to the columns of the ground floor, large deformations, liquefaction, large amount of sand covered the yards. Unfortunately, among the heavily damaged wooden

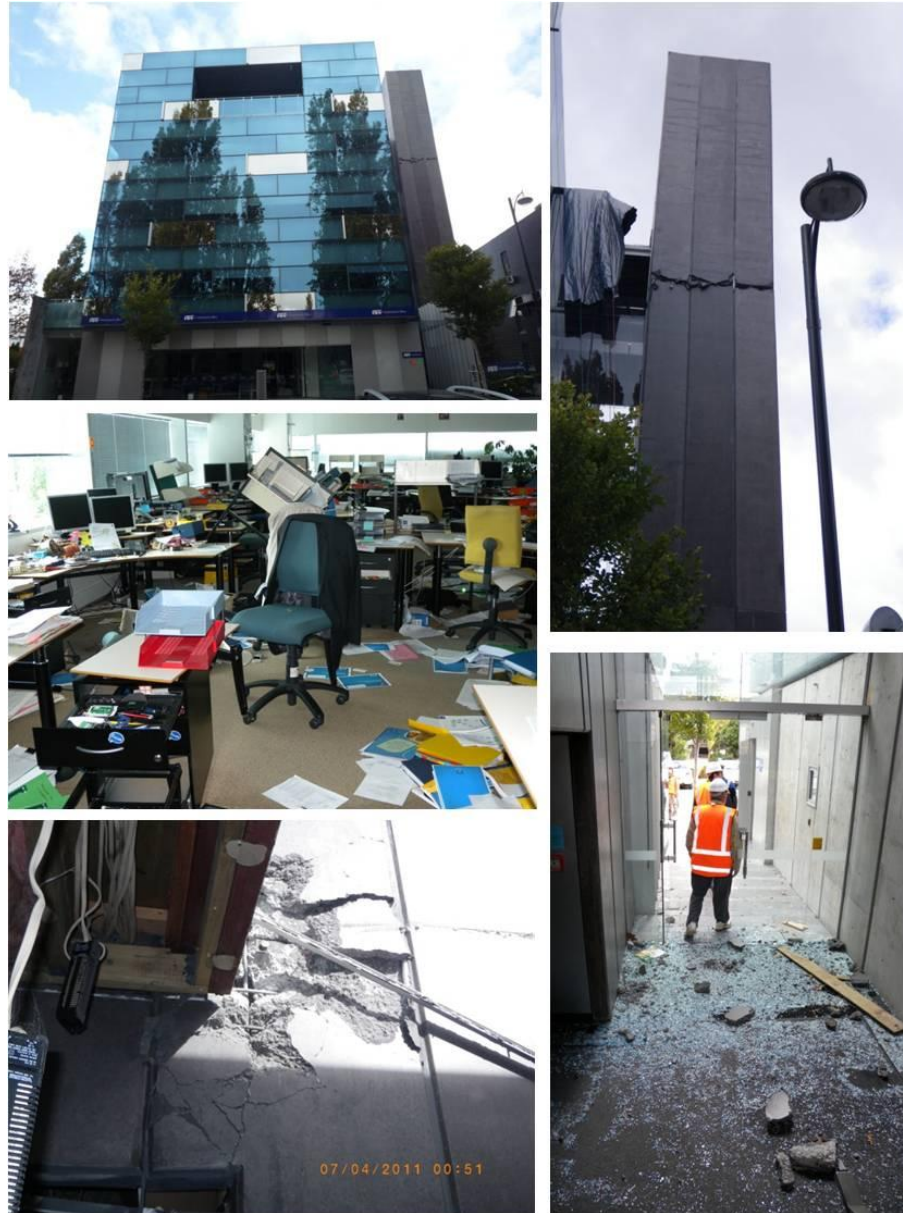
ACC Building on 262 Oxford Terrace across Avon river is very close to the river. The elevator tower suffered significant seismic load and was sheared horizontally creating a large crack. All things inside the building have fallen indicating high levels of accelerations.

Figure 3. 28. ACC building.

One reasonable explanation of the failure of the cantilever wall at the side of ACC building may be that the displacement profiles along the height of a frame and a cantilever wall structure considerably differ, however, in a frame-wall structure the diaphragms at floor levels, rigidly linking frames and walls, ensure common displacements. Due to the presence of frame the drifts of the cantilever wall, expected to be maximum at the top height, are limited. Nevertheless, in the case of ACC building the lack of a connecting link at the top is suspected to have been the reason for this displacement incompatibility between cantilever wall and frame, with the latter restraining the displacements of the former at all levels but for the one at the top, leading to wide crack at the immediately lower level.

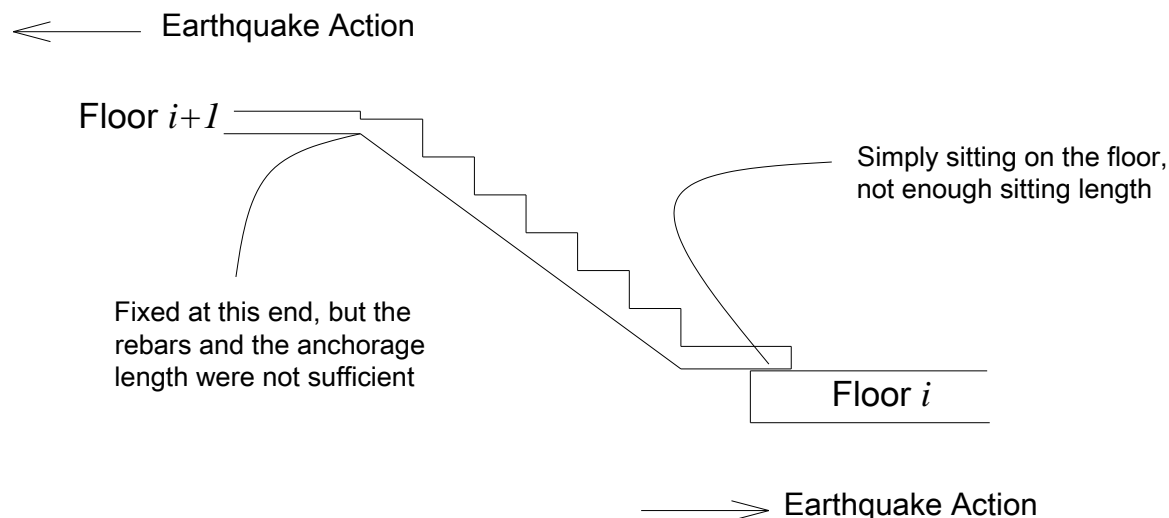
Forsyth Barr Building is one of the tall structures of the city. The stairs in the first three floors fell down during the earthquake trapping people upstairs since there was no other means of passage. The stairs were fixed on top and rebars were inserted inwards the floor slab. The other side of the stairs, the lower part, was simply sitting on the slab but obviously the sitting length was not sufficient (**Error! Unknown switch argument.** and Figure 3. 30).

Figure 3. 29. Collapsed stairs of the Forsyth Barr Building.

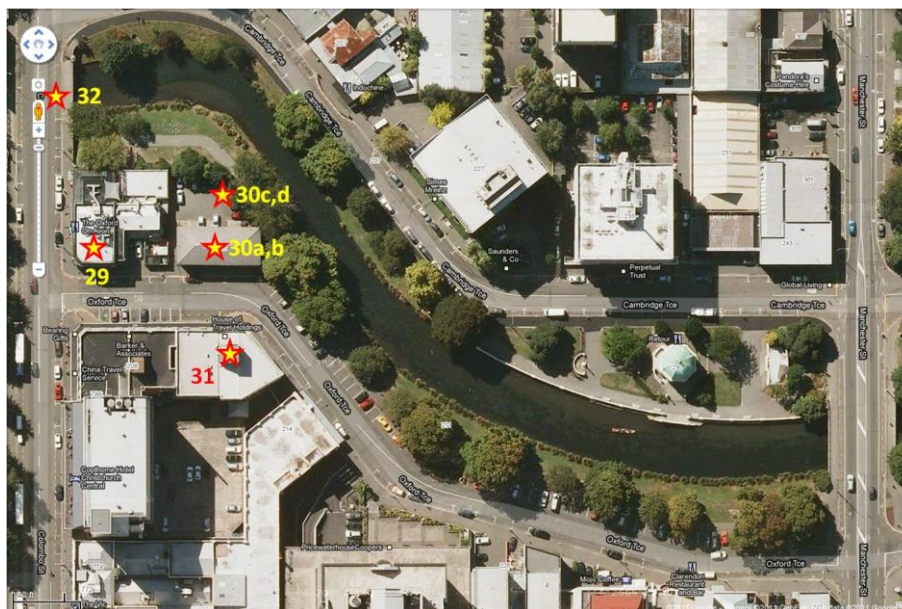
Colombo Street and Oxford Terrace are along Avon River where liquefaction is evident everywhere and large ground deformations due to liquefied soil and lateral spreading are common. Wide and deep cracks on the ground along the river bank were observed. There is a crust of clay 0.5 m thick on the surface. Usually the bottom of the river is covered with gravels but it is now filled with sand. The river is now more shallow (15 cm), which means that large amount of sand came up to the surface.

Figure 3. 31. Colombo Street and Oxford Terrace.

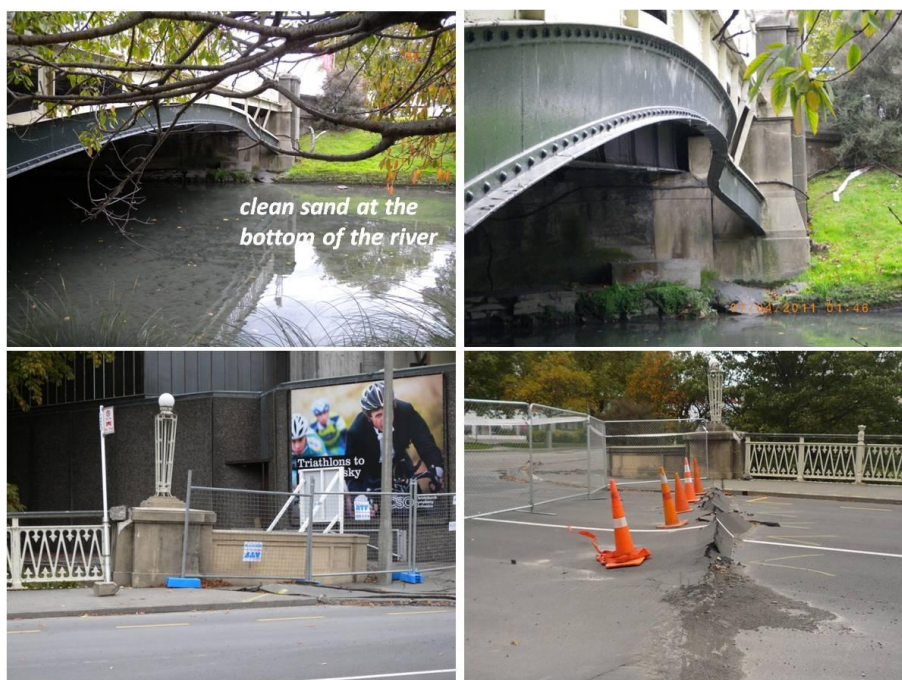
Lateral spreading of the river banks is restrained in the locations of bridges with rigid body. Spreading is limited by the abutments. The old bridge on Colombo Street, crossing Oxford Terrace, had significant buckling due to lateral spreading but the bridge is still operational (Figure 3. 32).

Figure 3. 32. The old bridge at Colombo St and Oxford Terrace.

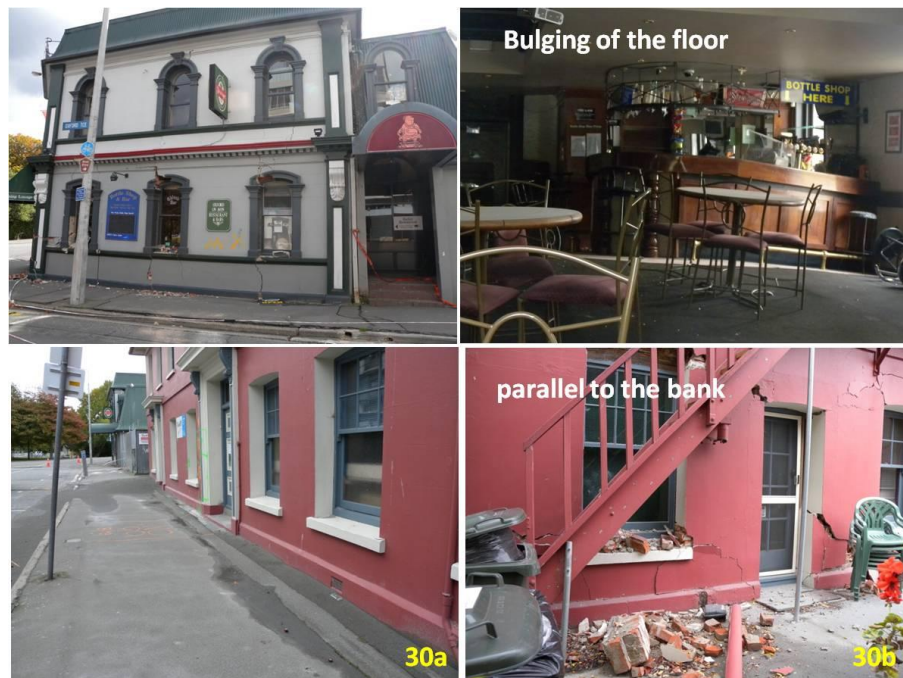
An old masonry building (B30) and a reinforced concrete building (B31) were subjected to large ground deformations that caused tilting of the structure and differential settlements (Figure 3. 33 and Figure 3. 34). As firemen reported, there was increase of cracks days after the earthquake causing further damage (B31). Wide cracks and opening of expansion joints are attributed to phenomenon of lateral spreading.

Figure 3.33. Building at Colombo St and Oxford Terrace (B30).

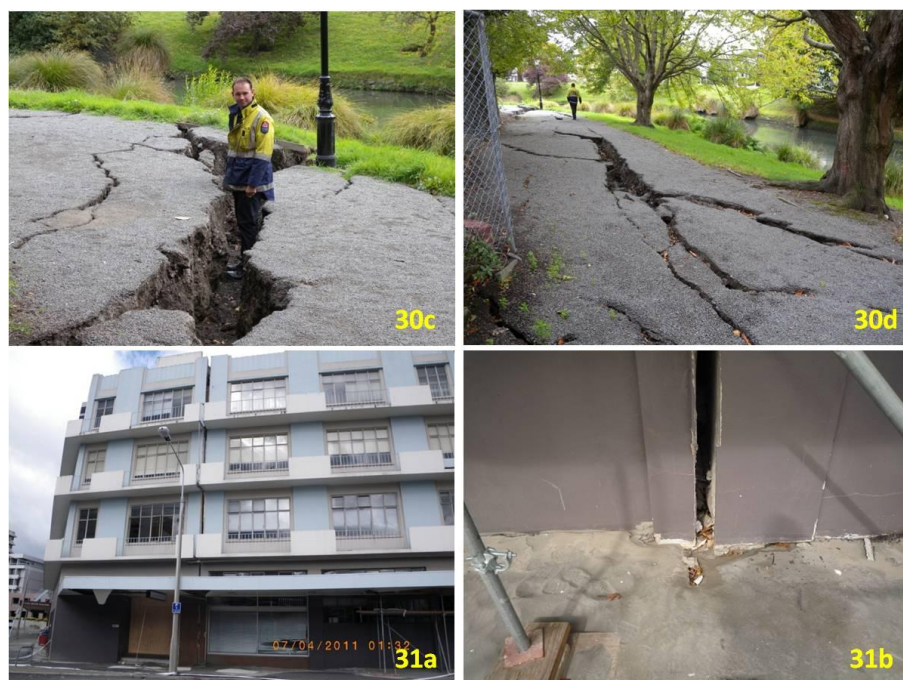
Figure 3.34. River bank at Oxford Terrace and the nearby building (B31).

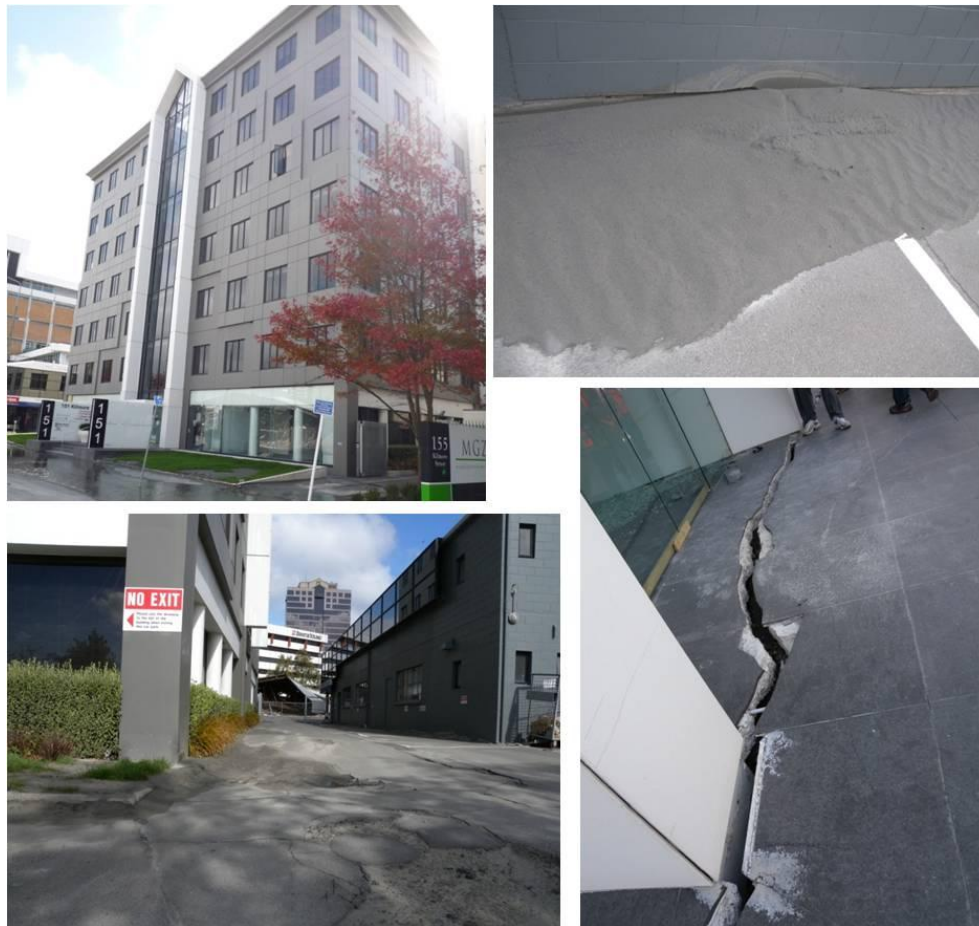
Another modern RC building at Kilmore Street, shown in Figure 3. 36, had no differential settlement though liquefaction was evident. Sand came up at the perimeter of the building but no bulging or sand-boil was observed inside the building. A large crack of ground and side walk was observed in front of the main entrance but no structural damage or shattered window glasses were witnessed.

Figure 3.36. A modern RC building at Kilmore Street with raft foundation.

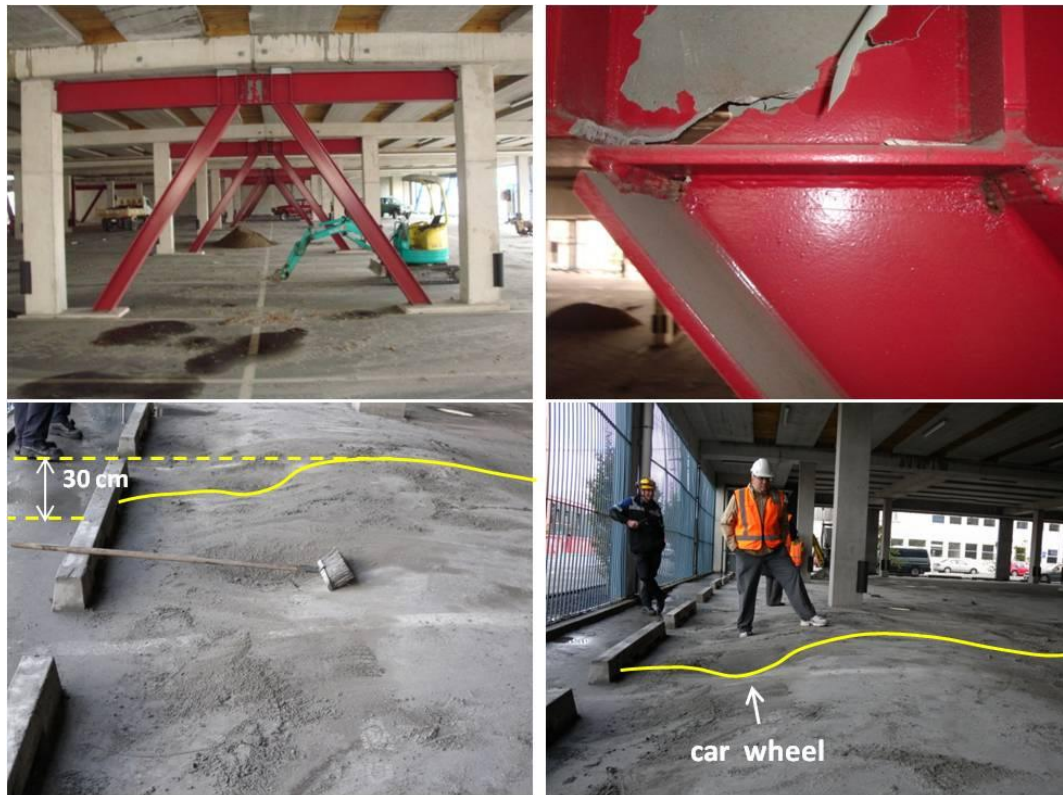
The building is 10-20m from the CHHC recorder across the street. It is known that the CHHC records exhibited some acceleration bulges caused by liquefaction. The liquefaction was also observed on site, especially inside the car park (Figure 3. 37). There was a bulging of ground, inside the building, due to liquefaction. Signs of sand-boils and bulges on the sidewalks are also evident. Formation of bulges in the car park was restrained by the wheels and bottoms of the cars parked during the earthquake as the traces of car wheels show.

Figure 3. 37. Hospital Staff Car Park (B34).

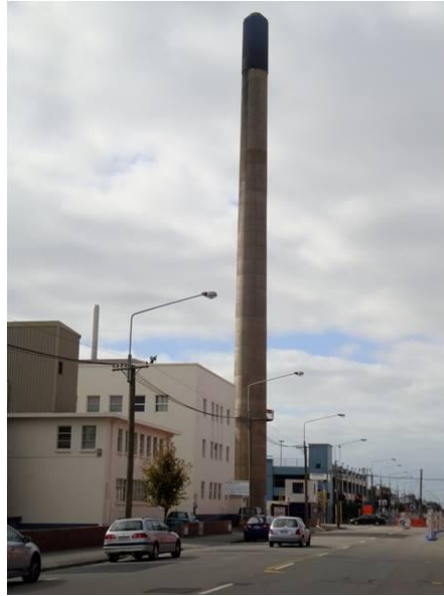
A tall RC chimney was found with no significant damage, next to the building where the acceleration recorder is installed (CHHC station). The integrity of the structure was checked after the first earthquake. The inspection showed no damage on the chimney. The utility buildings of the hospital did not suffer any significant damage as well.

Figure 3. 38. A tall RC chimney next to the CHHC recorder (B34).

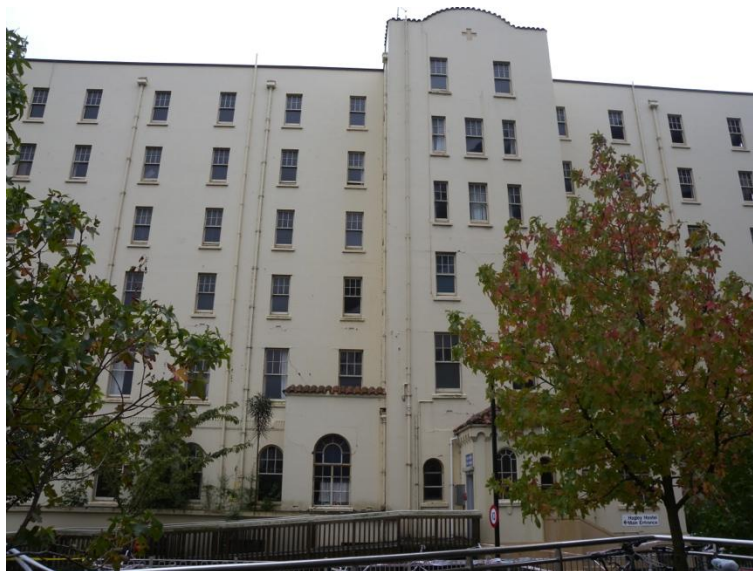
Figure 3. 41. The old unreinforced masonry block for nurses, that has moderately damaged during the earthquake.

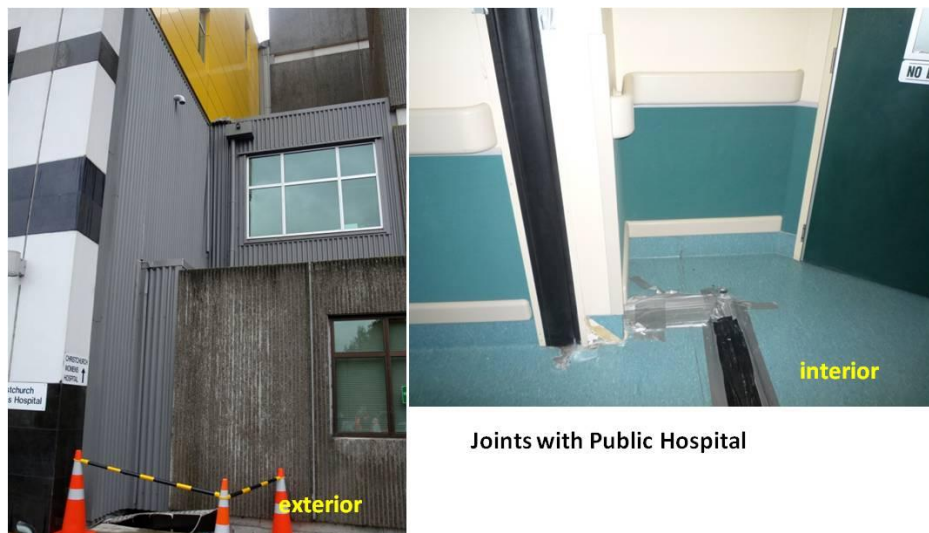
Figure 3. 46. Non-structural detailing in Women's Hospital to allow differential displacements due to the isolators.

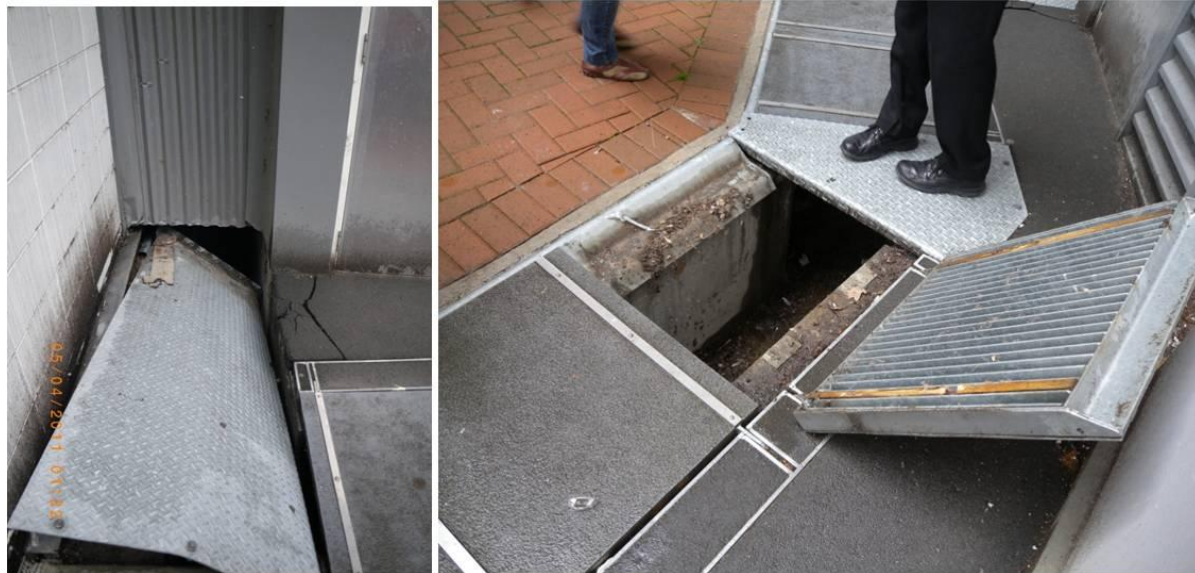
Figure 3.47. Gap allowance in the perimeter of Women's hospital.

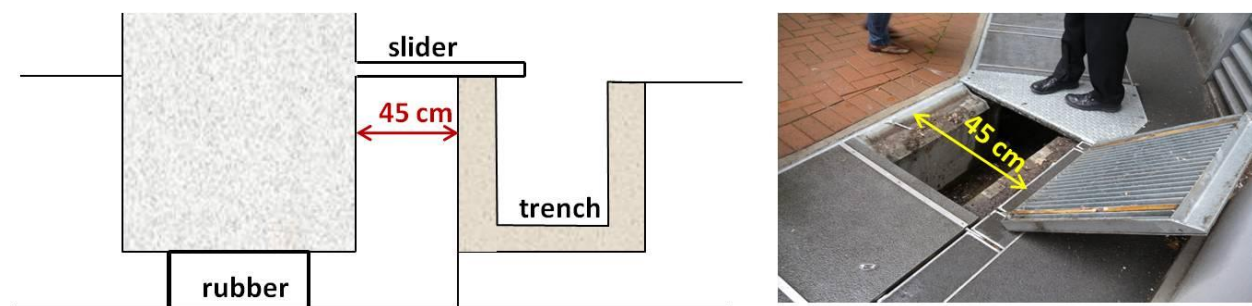
Figure 3.48. Gap allowance in the perimeter of Women's hospital.

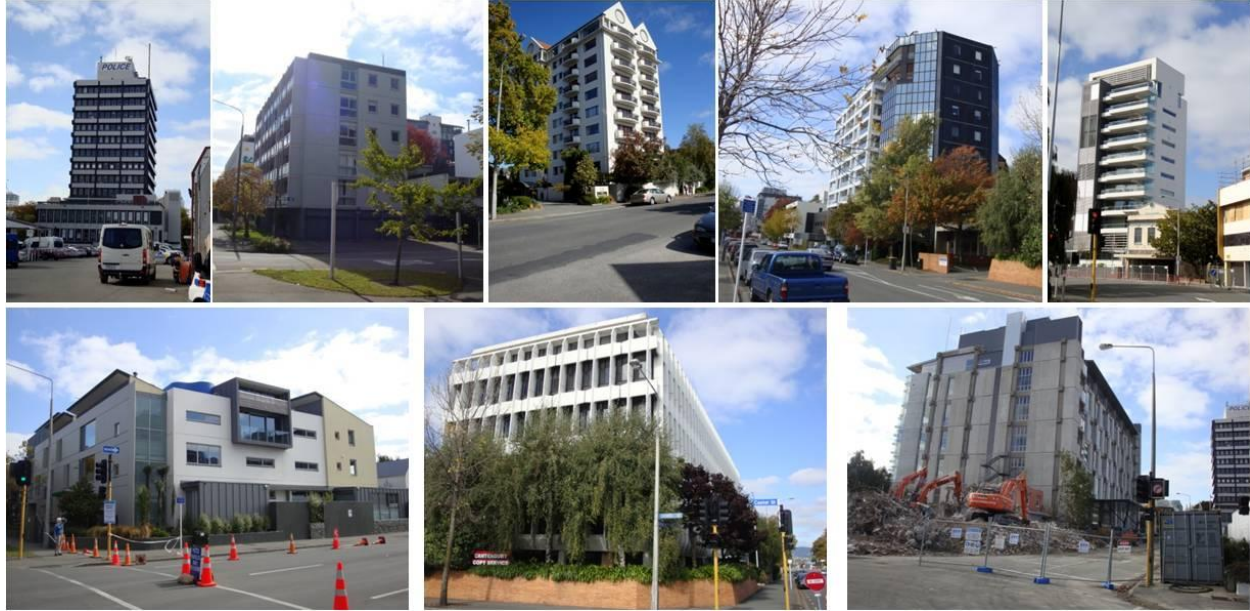
Most of the damage during the Darfield and Christchurch earthquakes of 2010 and 2011, respectively, were in CBD area. The buildings in the perimeter of CBD, some of which also multi-storey modern RC structures, did not suffer significant damage. Most of the multi-storey buildings outside CBD were intact, without any damage (Figure 3. 56).

Figure 3. 56. Modern RC buildings performing satisfactorily.

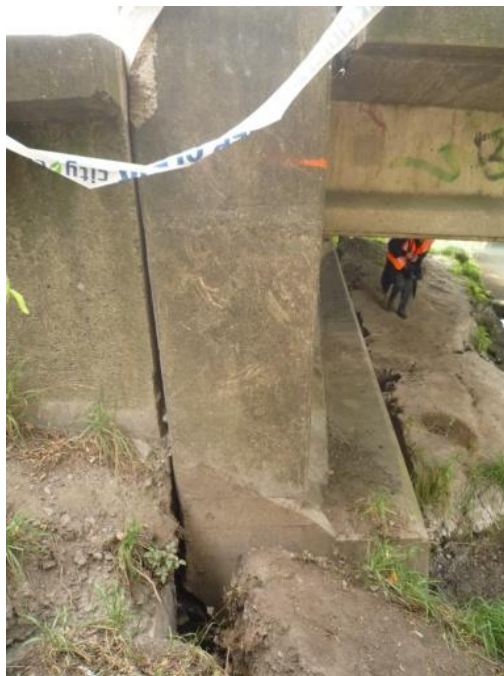
Figure 5.5. Fitzgerald Bridge (B1 on map of Figure 5.1). Performance of northern abutment after ChCh earthquake. Rotation of abutment is evident due to lateral spreading. The backfill has differentially subsided relative to the abutment.

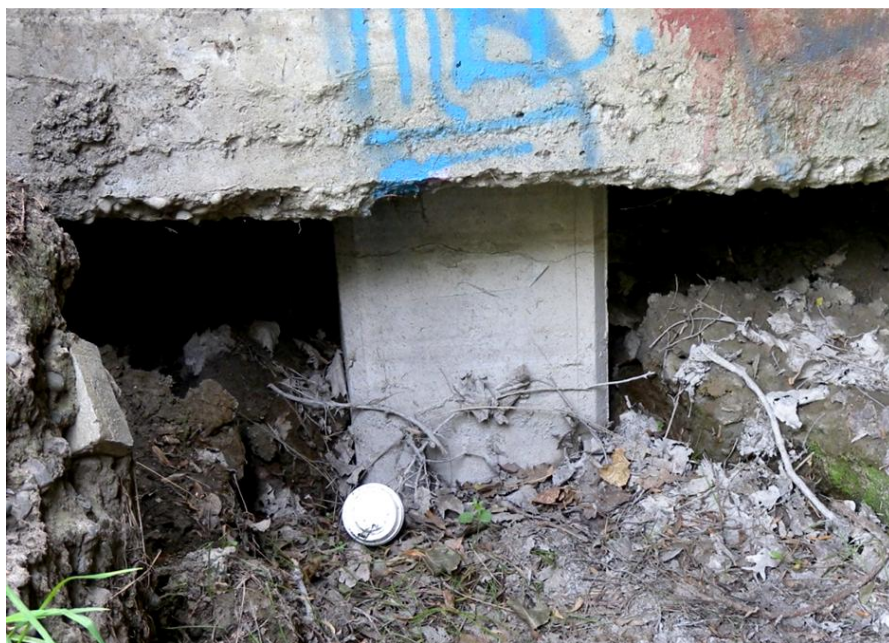
Figure 5.6. Fitzgerald Bridge (B1 on map of Figure 5.1). Rotation of northern abutment has caused tension cracks at the pile-tops.

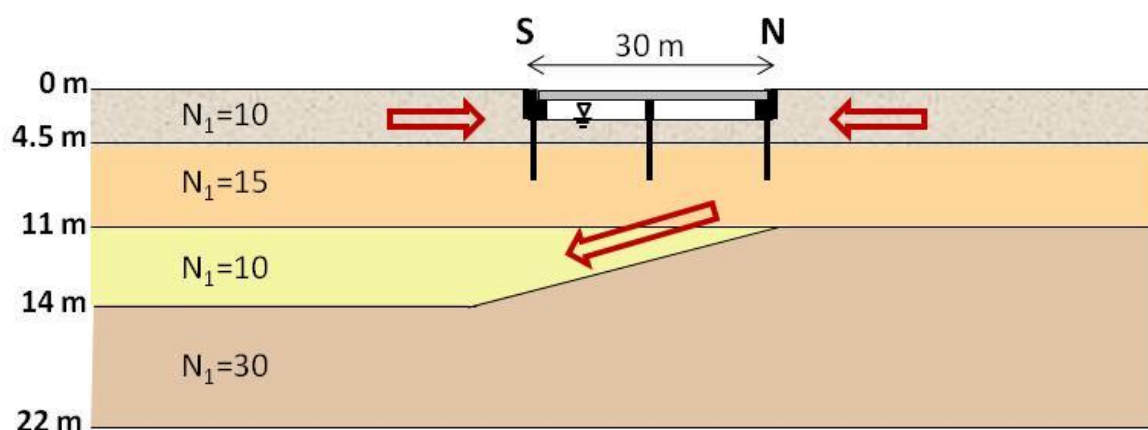
In the case of Fitzgerald Bridge the complete soil profile geometry profile (Figure 5.8) is available (Bradley et al., 2010). There is an inclination of the third soil layer towards the southern abutment, which tends to cause an additional lateral soil movement at the side of the northern abutment towards East, even below the pile foundation (8m deep), as indicated by the red arrows. This is also supported by the liquefaction potential analysis of the soil profile below the northern and southern abutment (Figure 5.9) which indicates that in the soil between 11 and 14m depth the liquefaction susceptibility is greater in the case of the northern abutment (Smyrou et al., 2011, conference paper). It should be noted that CSR was estimated using an average PGA value of the REHS and CCCC records which are the closest to the bridge site. The southern abutment, shown in Figure 5.3, after the Christchurch earthquake, suffered only some moderate cracks, with no significant horizontal displacement or rotation. Moreover, there were no signs of lateral spreading (cracks, gap between abutment and soil) in front of the toe of the abutment. On the other hand, the northern abutment (Figure 5.5 and 5.7) sustained substantial rotation, the backfill has settled and the ground in front of the toe has spread towards the river, exposing the top of the piles.

Figure 5.8. Soil profile geometry along Fitzgerald Bridge (B1 on map of Figure 5.1). The soil mainly consists of sandy gravel and sandy silt prone to liquefaction. The red arrows indicate the soil displacement due to lateral spreading.

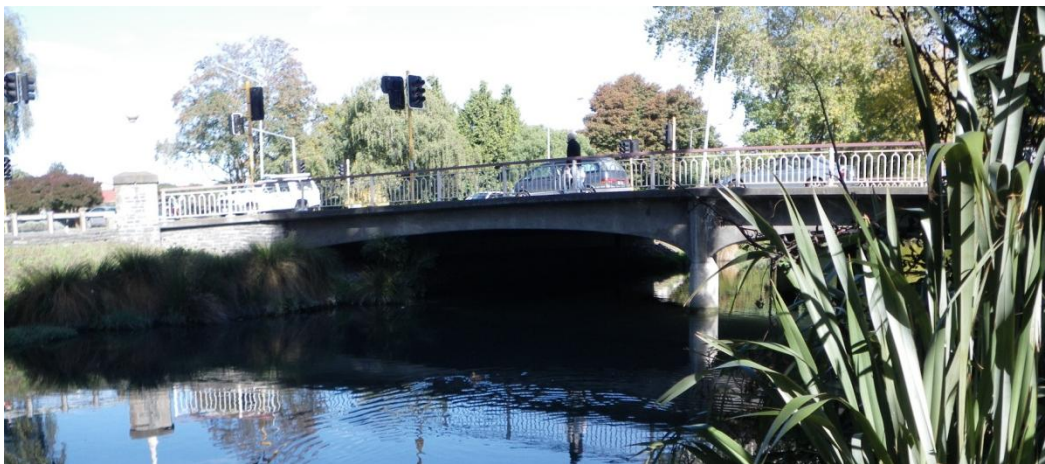
Figure 5.10. Stanmore Bridge (B2 on map of Figure 5.1).

Stanmore Road Bridge (Stanmore Rd & River Rd) is a concrete two span bridge which was completed in 1995 (B2 on map of Figure 5.1). The bridge sustained rotation of abutments and slump of the backfill due to lateral spreading, but overall its performance was satisfactory. Thus, it remained open to traffic after the Christchurch February earthquake.

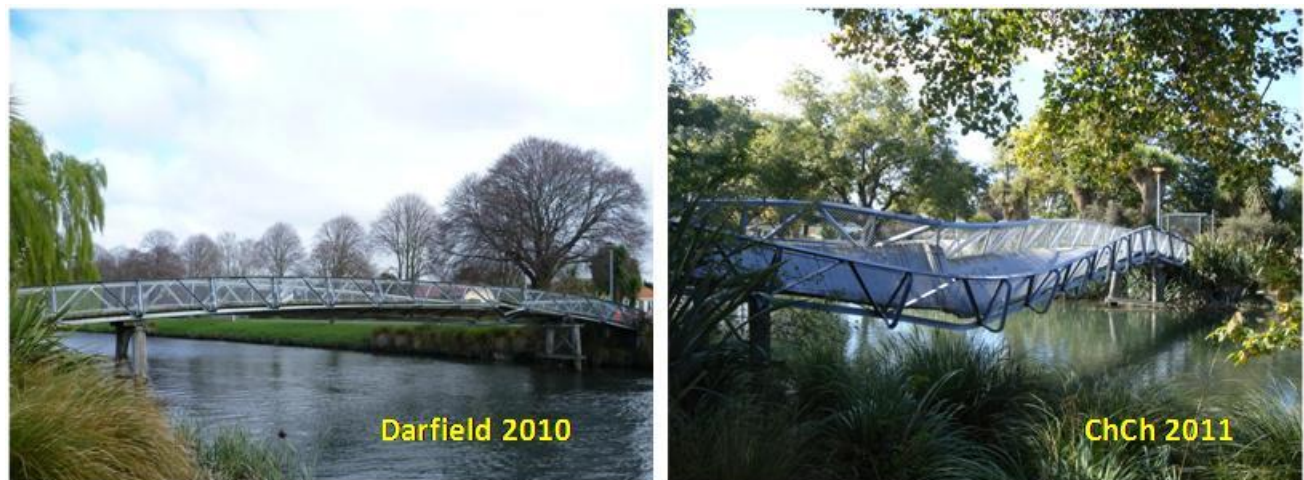
Medway Bridge (B2 on map of Figure 5.1) is a pedestrian steel truss bridge. The light superstructure buckled axially under the horizontal displacement of the abutments due to lateral spreading. The bridge had already developed large deformations after Darfield earthquake and remained closed. Buckling was even more severe after Christchurch earthquake.

Figure 5.14. Medway Pedestrian Bridge (B3 on map of Figure 5.1). Comparison of bridge damage between Darfield and Christchurch earthquakes. Source: NHP- Bridge Research Group.

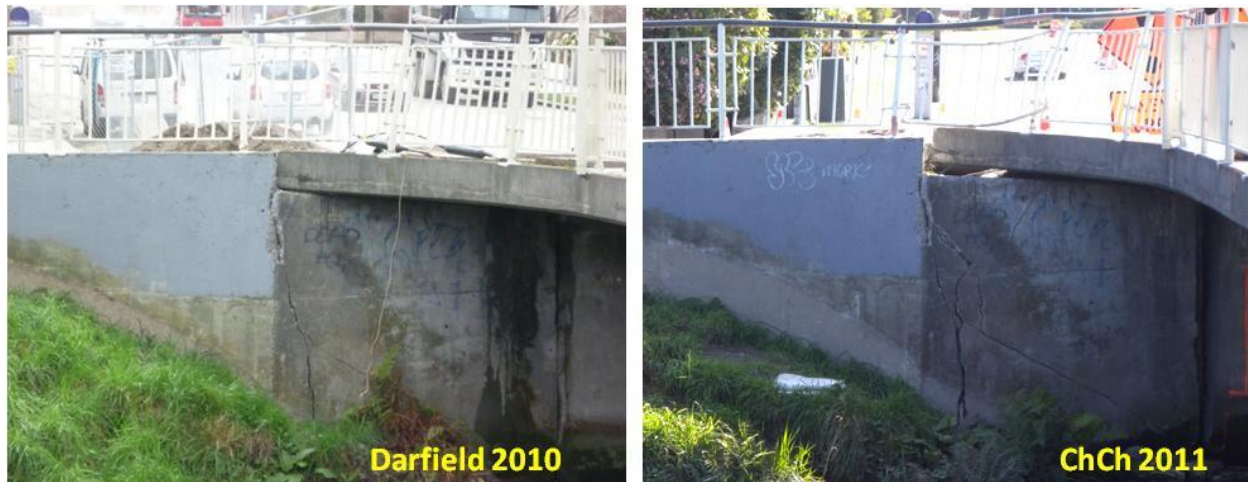
Figure 5.19. Western side of the northern abutment of Gayhurst Bridge (B4 on map of Figure 5.1). Comparison of damage between Darfield and Christchurch shaking events. The cracks have widened and extended, while the differential lateral riverward displacement of the abutment and wingwalls relative to the deck has increased after Christchurch earthquake Source: NHP-Bridge Research Group.

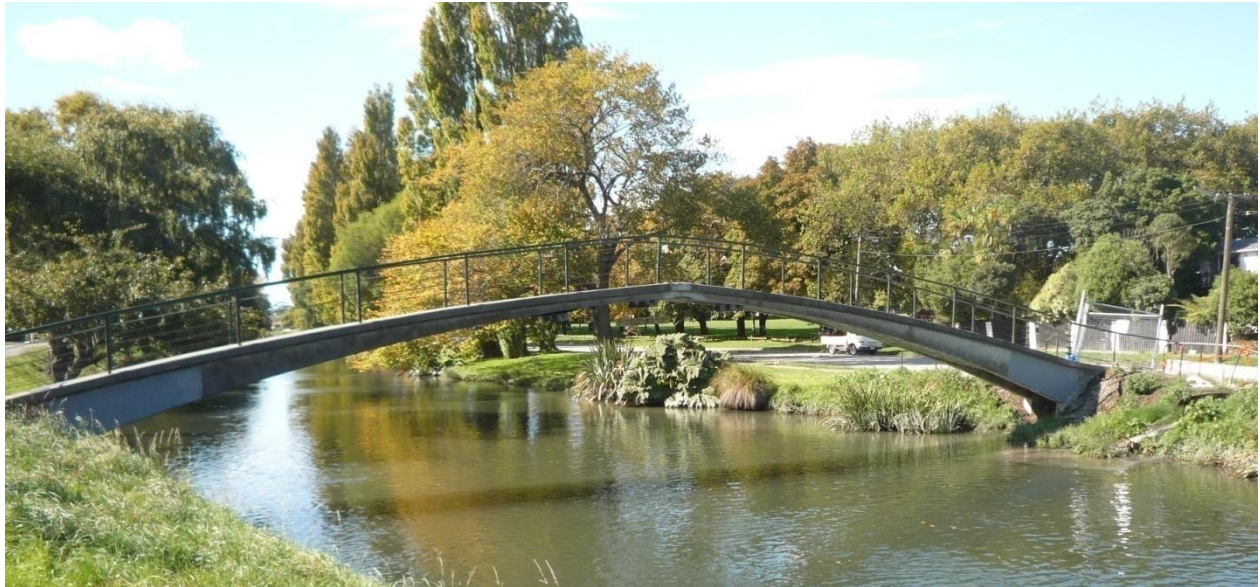
Figure 5.22. Snell Footbridge (B5 on map of Figure 5.1) after Christchurch earthquake.

Snell Footbridge is an arch-shaped overpass crossing Avon River in Dallington (B5 on map of Figure 5.1). The bridge damage was initiated in Darfield earthquake by cracking at the midpoint due to lateral spreading. In Christchurch earthquake, the cracks at the mid-point widened forming a plastic hinge. The abutments also sustained cracks, indicating that a 3-hing mechanism formed. The arch is still standing due to its arch geometry.

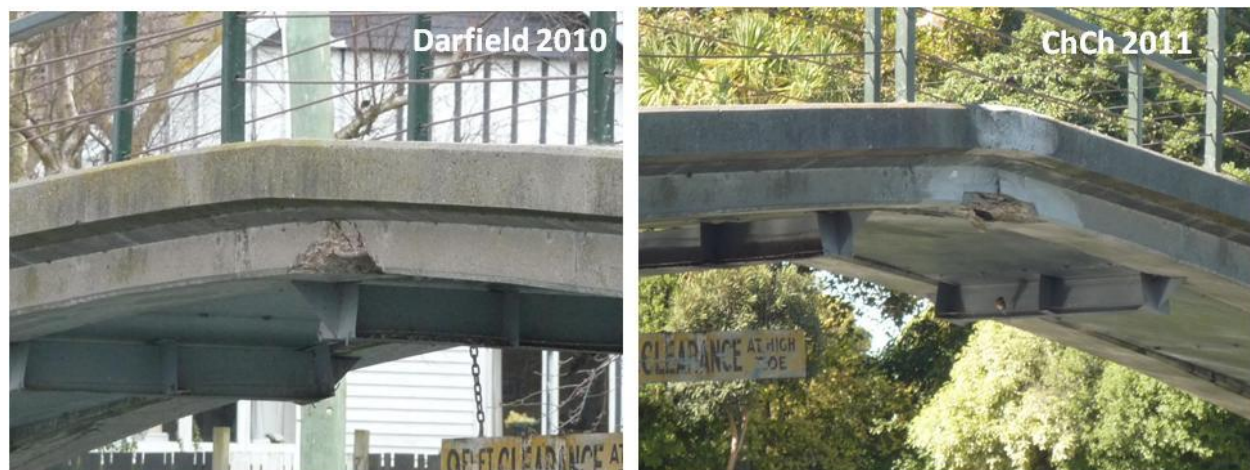
Figure 5.23. Snell Footbridge (B5 on map of Figure 5.1) after Christchurch earthquake. Comparison of damage between Darfield and Christchurch shaking events. The cracks have widened and extended at the mid-point. Source: NHP- Bridge Research Group.

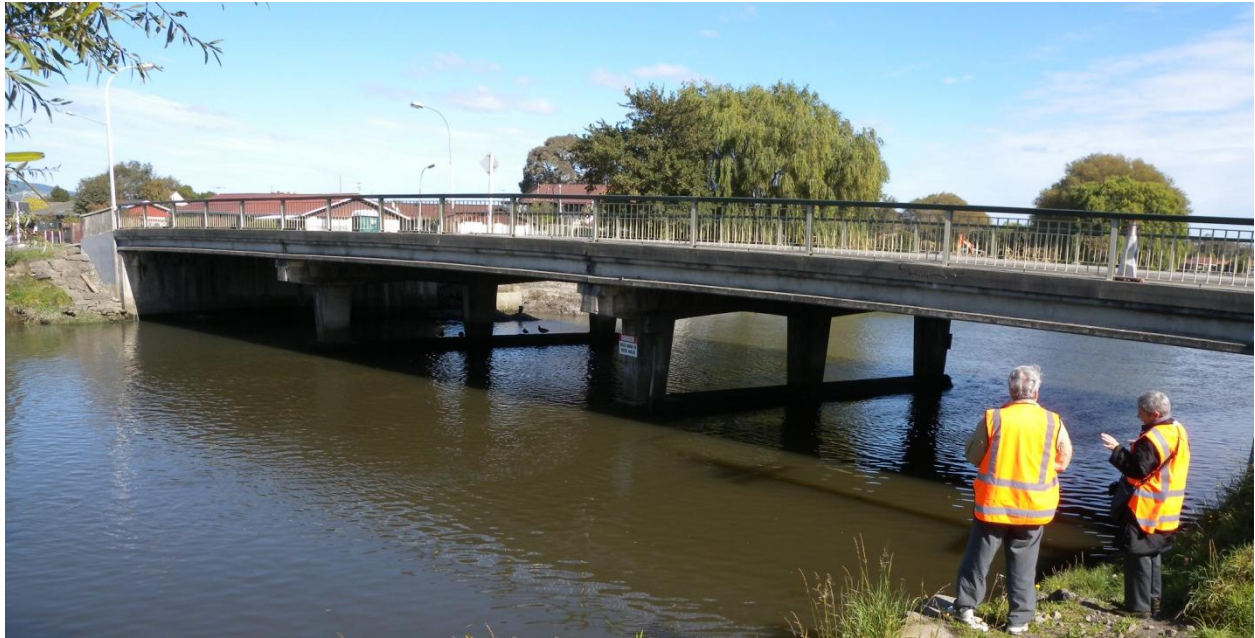
Figure 5.24. Avondale Bridge (B6 on map of Figure 5.1) after Christchurch earthquake.

The bridge sustained no damage in Darfield earthquake. In contrast, the bridge suffered rotation of abutments and moderate slump of the approach fills due to liquefaction-induced lateral spreading during Christchurch earthquake. Lateral spreading was more severe at the southern river coast. Thus, the rotation of the southern abutment (8 degrees) was larger than that of the northern abutment (4 degrees). The damage was not severe though, and the bridge was kept open to traffic.
