Geotechnical and Structural Field Observations from Christchurch, February 2011 Earthquake, in New Zealand

Research Report

September 2011

National Technical University of Athens, Greece

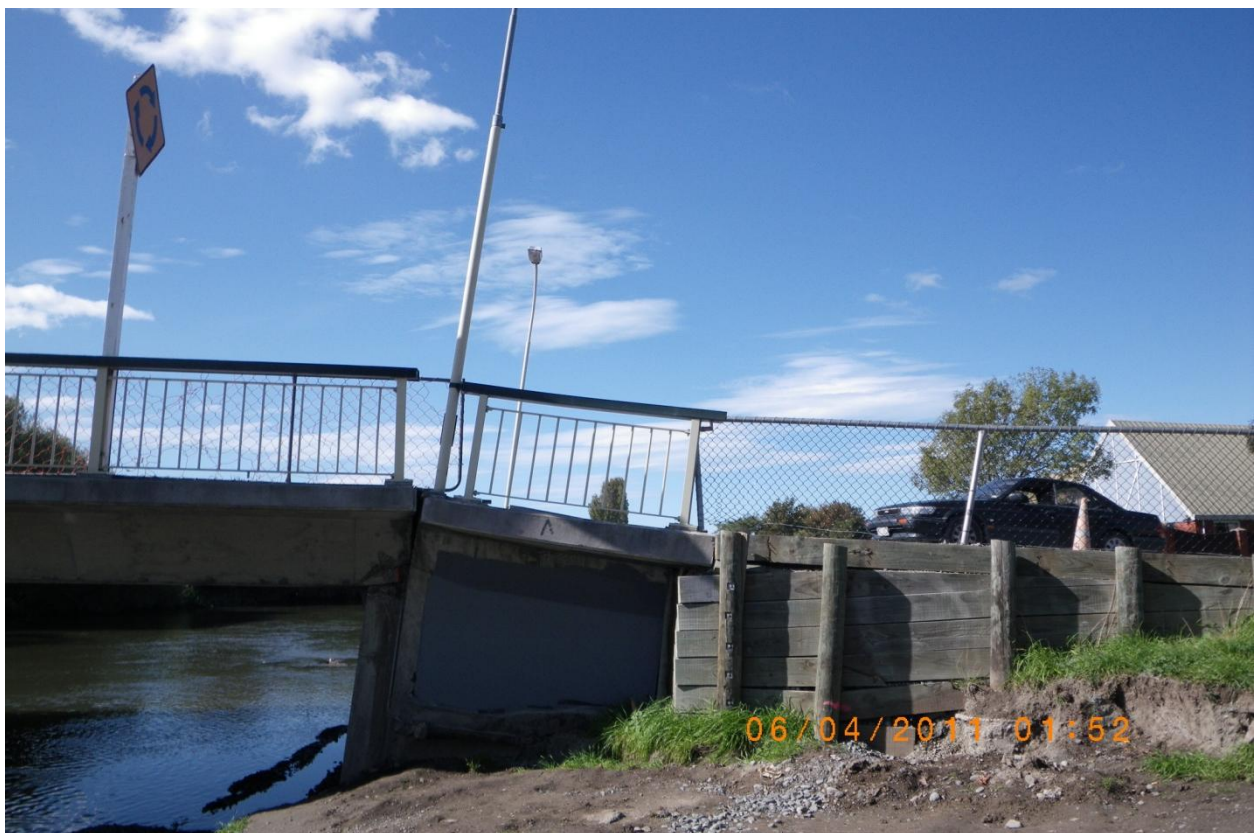
Figure 5.25. Southern abutment of Avondale Bridge (B6 on map of Figure 5.1) after Christchurch earthquake. Back rotation (8 degrees) and subsidence of the backfill.

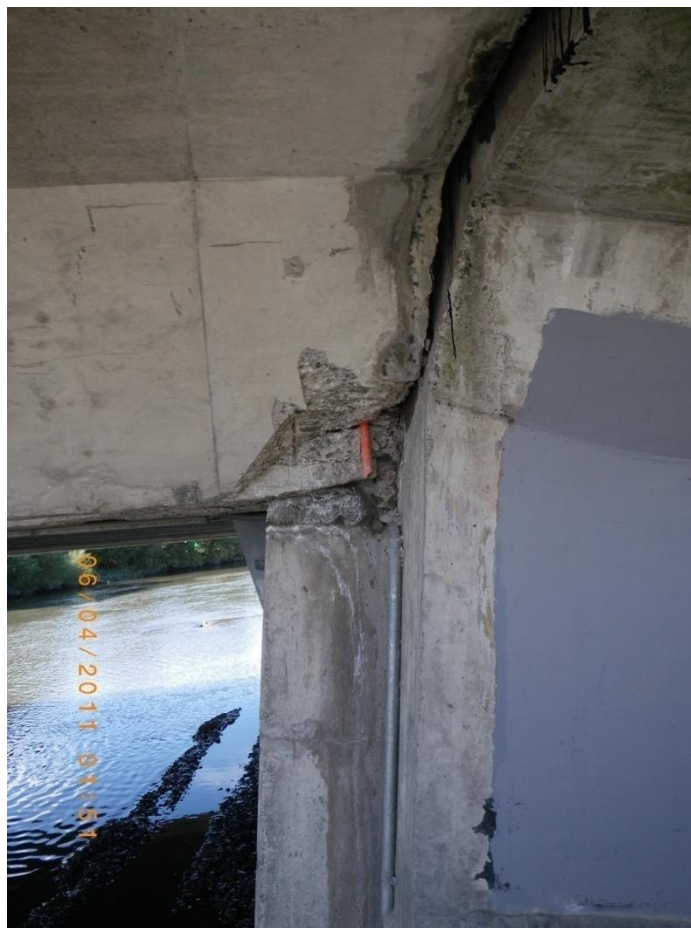
Figure 5.26. Southern abutment of Avondale Bridge (B6 on map of Figure 5.1) after Christchurch earthquake. Concrete spalling and gap opening at the joint of the deck with the abutment.

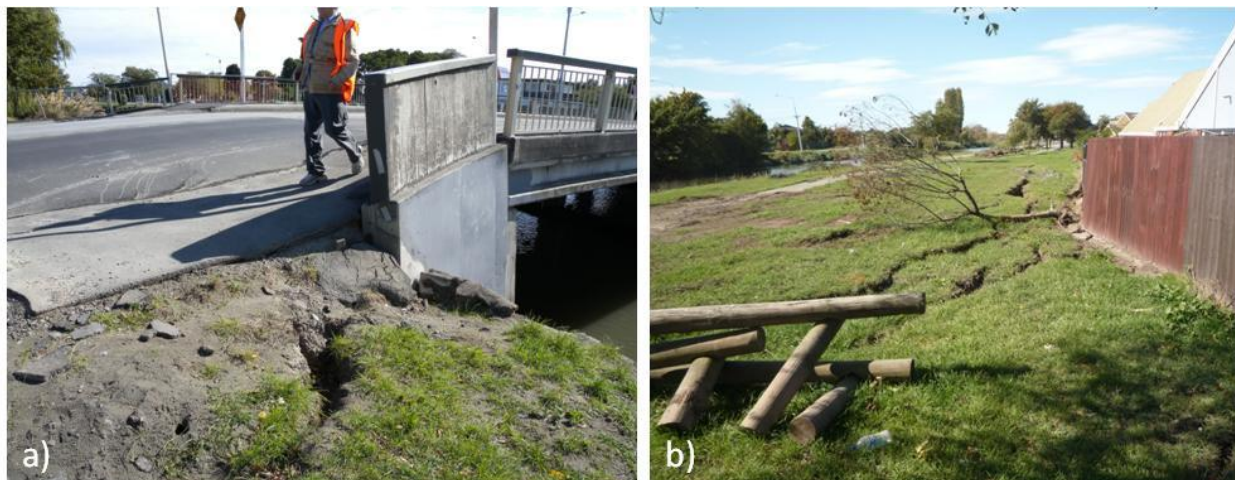
Figure 5.27. a) Back rotation of southern abutment of Avondale Bridge (B6 on map of Figure 5.1), cracks in the backfill, b) Large lateral spreading cracks in the south coast parallel to the river extending in a great distance at both sides of the southern abutment.

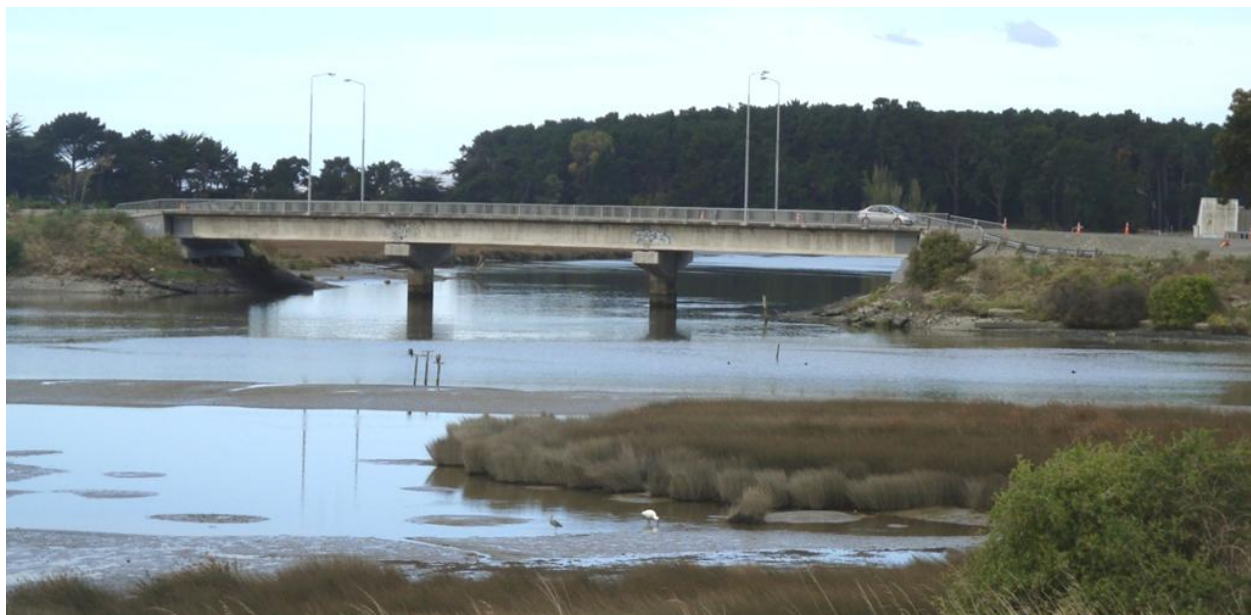
The bridge suffered significant damage during Darfield earthquake due to lateral spreading. The soil in the wetland is very prone to liquefaction. Thus, the ground deformation induced by liquefaction caused back rotation of the abutments (around 6° vertically and 8° horizontally as measured on site), slumping of the approach fills and exposure of the pile foundation due to large soil "flow" and settlement underneath the abutments. During Christchurch earthquake, lateral spreading was even more severe, forming cracks in the ground which expanded several meters inland. The initiated damage from Darfield earthquake was extended with evidence of plastic hinging at the top of piles, cracks and concrete spalling in the abutments, as well as even greater subsidence of the backfill. Overall, the rotation and horizontal displacement of the abutments only slightly increased compared to how much large was the soil movement in Christchurch earthquake. This is due to deck restraining and pile bending resistance. Thus, the main damage of the bridge is attributed to the first earthquake.

Figure 5.31. South Bridge Road Bridge (B8 on map of Figure 5.1) after Christchurch earthquake.

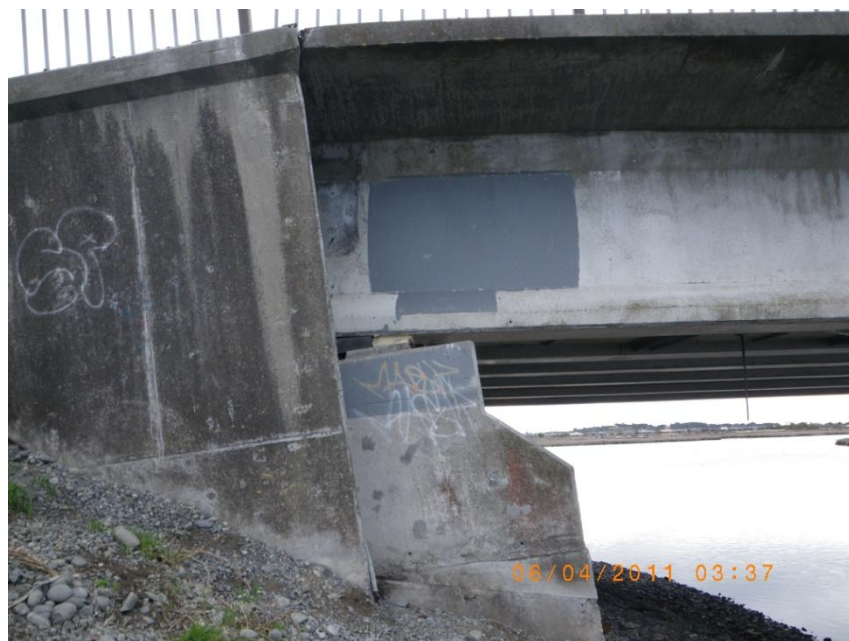
Figure 5.33. Western abutment of South Bridge Road Bridge (B8 on map of Figure 5.1) after Christchurch earthquake. Back rotation of the abutment around the deck and slump of the approach fill.

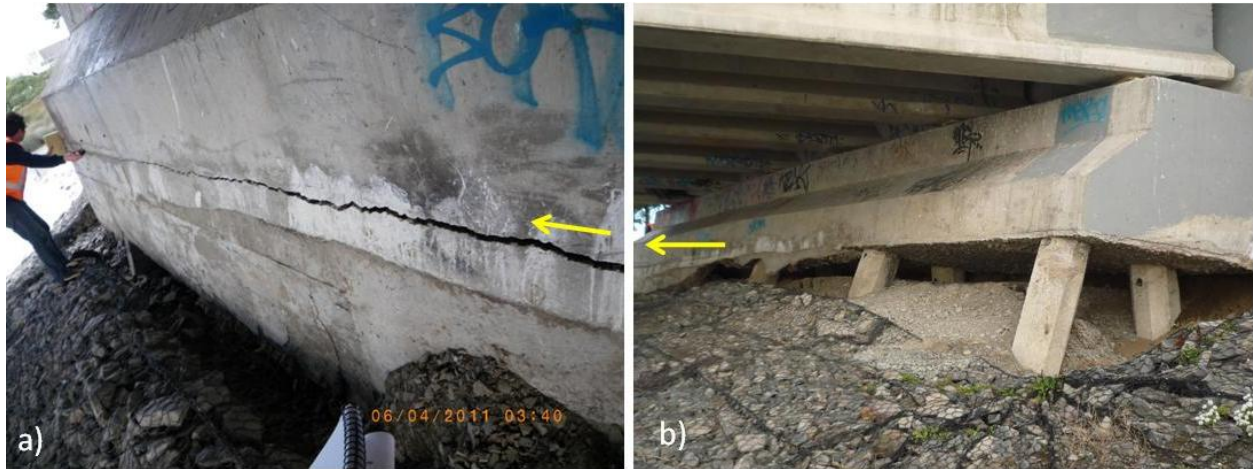
Figure 5.34. Western abutment of South Bridge Road Bridge (B8 on map of Figure 5.1) after Christchurch earthquake. a) Large tension horizontal crack at the base of the abutment, b) The gabion mat used for erosion protection in front of the abutment has laterally and vertically moved so that a great part of the pile heads has been exposed.

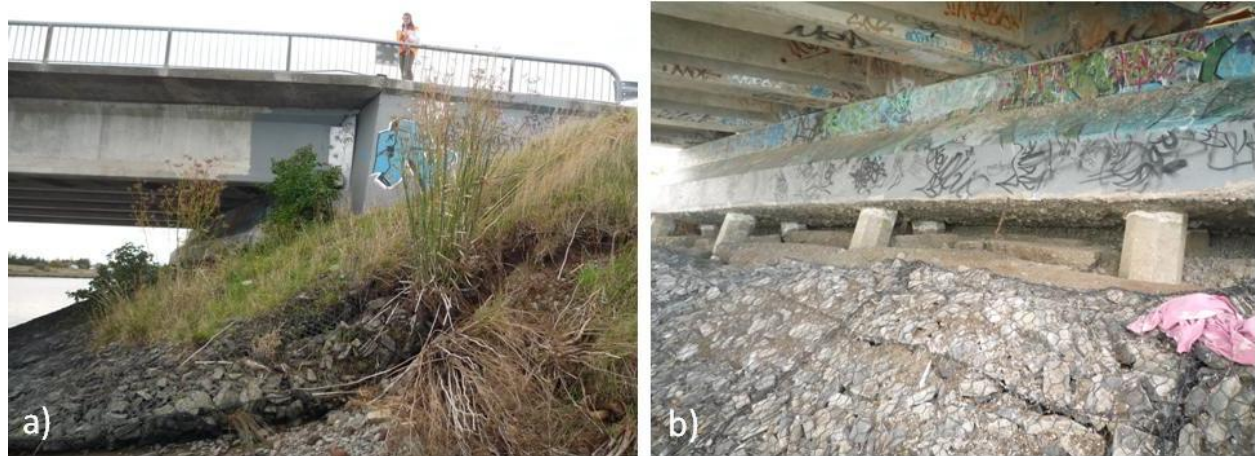
Figure 5.36. Eastern abutment of South Bridge Road Bridge (B8 on map of Figure 5.1) after Christchurch earthquake. a) Back rotation of the abutment around the deck and slump of the approach fill, b) the soil underneath the abutments has moved riverwards exposing both rows of piles.

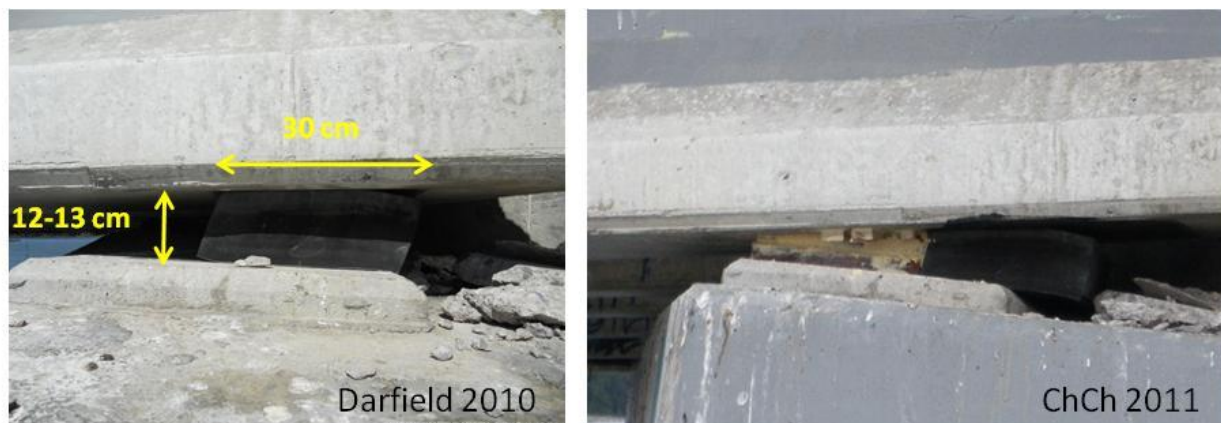
Figure 5.38. Western abutment of South Bridge Road Bridge (B8 on map of Figure 5.1). Differences between Darfield and Christchurch shaking events. The rubber bearing pad had sheared and slid laterally in Darfield earthquake. After Christchurch earthquake the rubber pad has deformed and displaced even more. The timber pad, used as a stop probably has been placed after Darfield earthquake, because it seems to have sustained certain deformation. Source: NHP- Bridge Research Group..

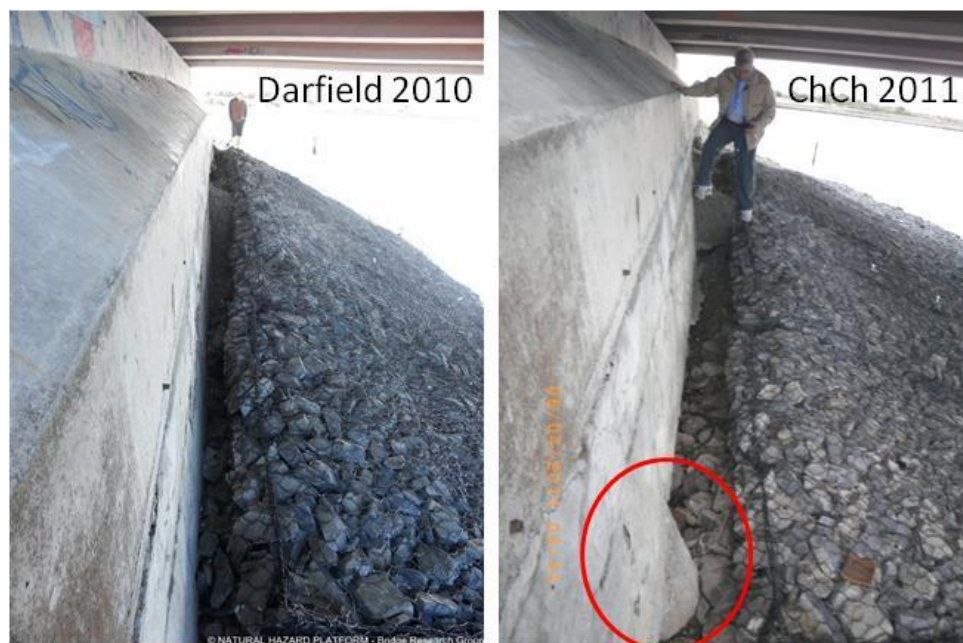
Figure 5.41 Western abutment of South Bridge Road Bridge (B8 on map of Figure 5.1). Differences between Darfield and Christchurch shaking events. After Christchurch earthquake,

the lateral soil movement has at least twice as much as in Darfield earthquake. Thus the piles are more exposed. Source: NHP- Bridge Research Group.

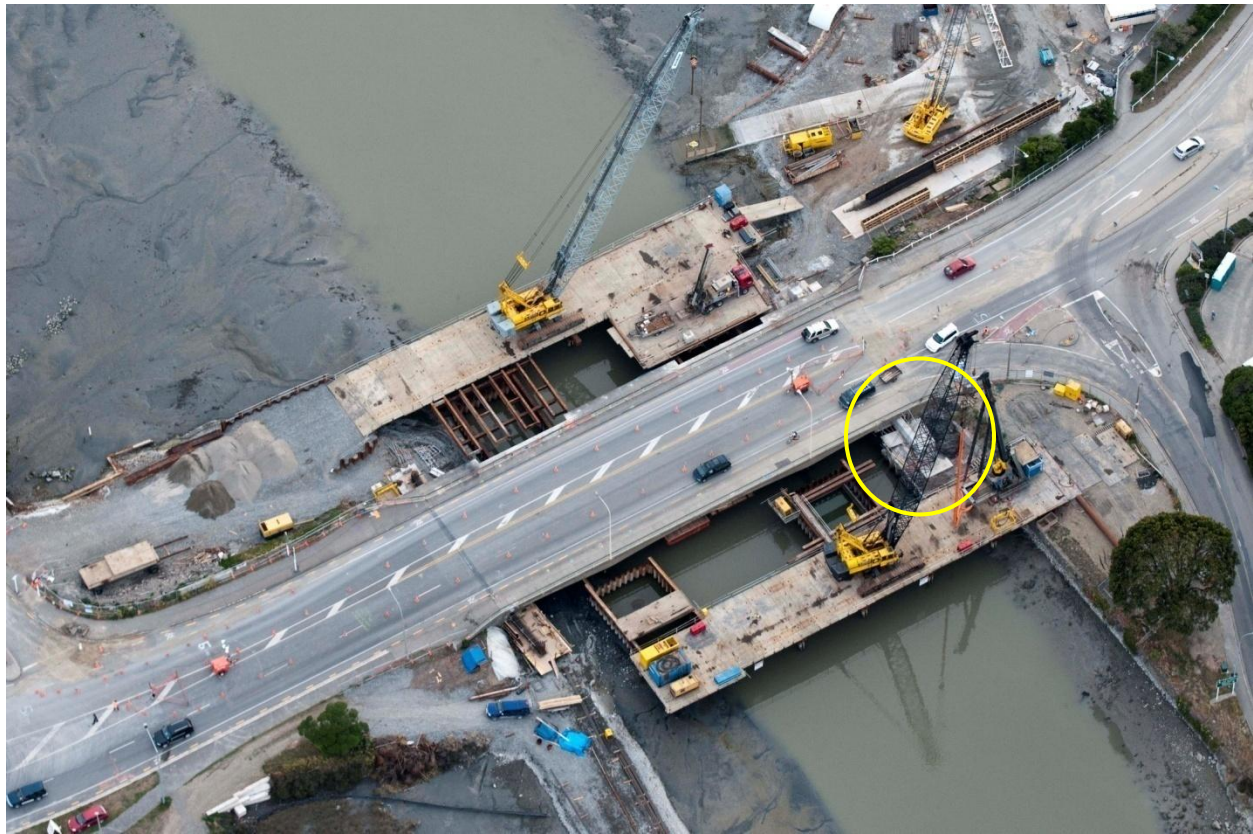
constructed in the east coast adjacent to the old one. The new abutment was founded on piles driven half a meter in the bedrock and was not yet attached to deck (yellow circle in Figure 5.43).

Figure 5.43. Ferrymead Bridge (B8 on map of Figure 5.1). Construction site in the process of strengthening and widening of the bridge. Photo taken after Christchurch earthquake. The new east abutment, in the yellow circle, was built one month before the shaking event.

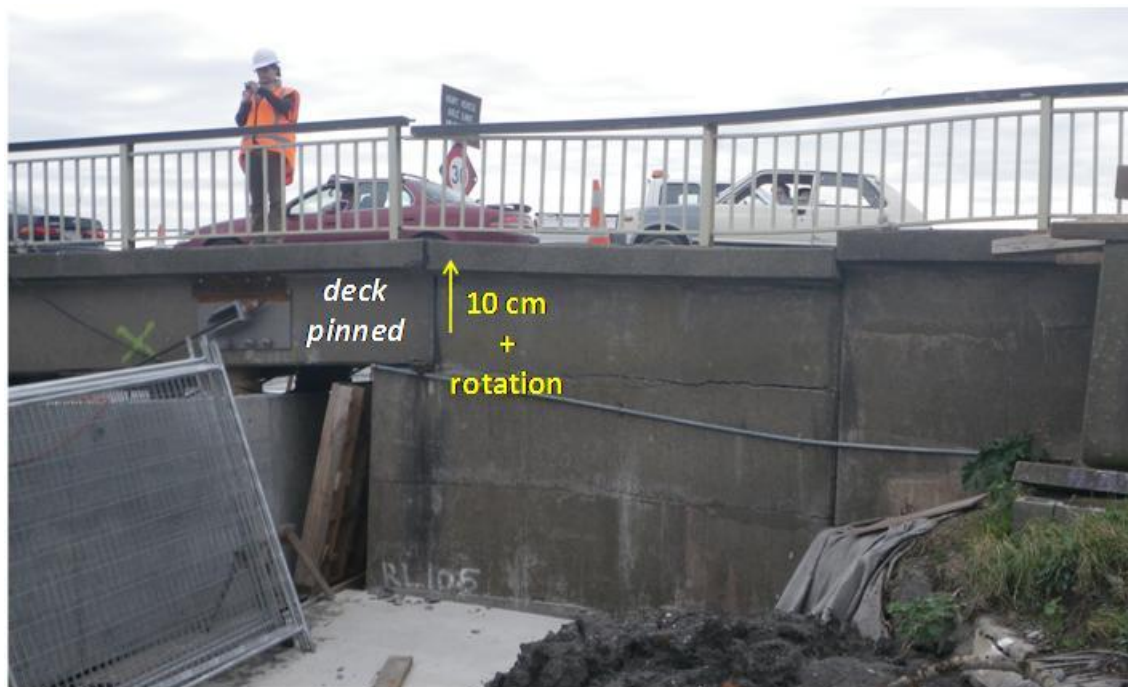
Figure 5.45. East abutment of Ferrymead Bridge after Christchurch earthquake (B8 on map of Figure 5.1). The front section of the abutment has back rotated and moved upwards by 10 cm. The rear section of the abutment has been displaced in a similar trend.

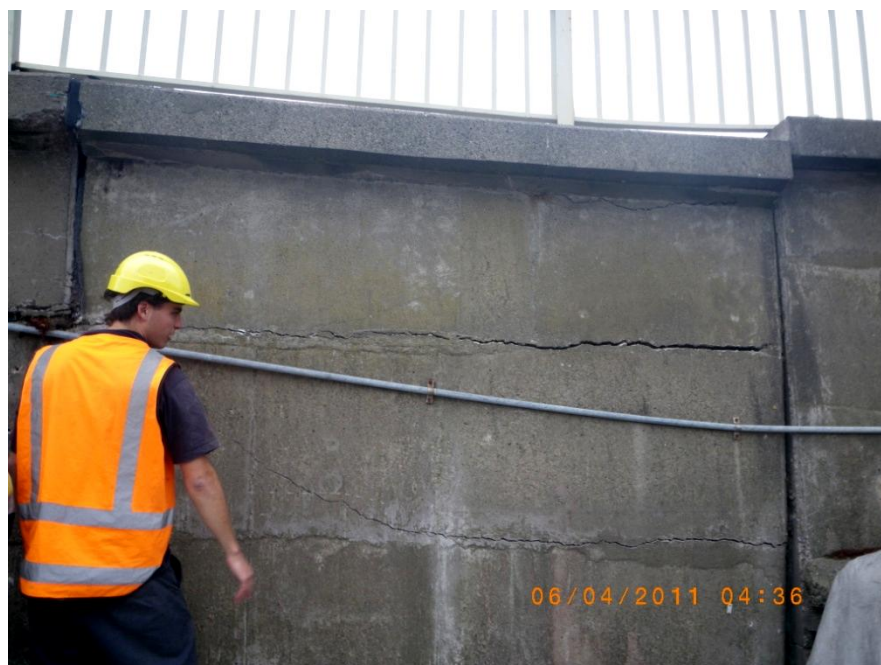
Figure 5.46. East abutment of Ferrymead Bridge after Christchurch earthquake (B8 on map of Figure 5.1). Horizontal cracks in the abutment wall have developed. The major crack is located at the height of the lower part of the deck.

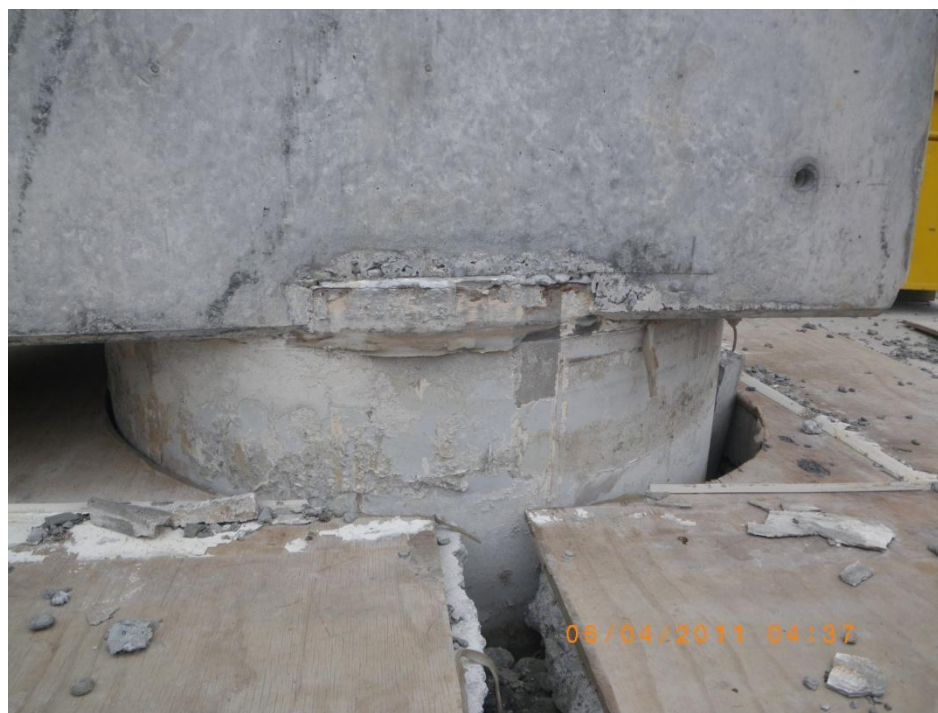
Figure 5.48. New east abutment of Ferrymead Bridge after Christchurch earthquake (B8 on map of Figure 5.1). The abutment have moved towards the center of the bridge. The gap opening at the back side of the pile is a result of this movement.

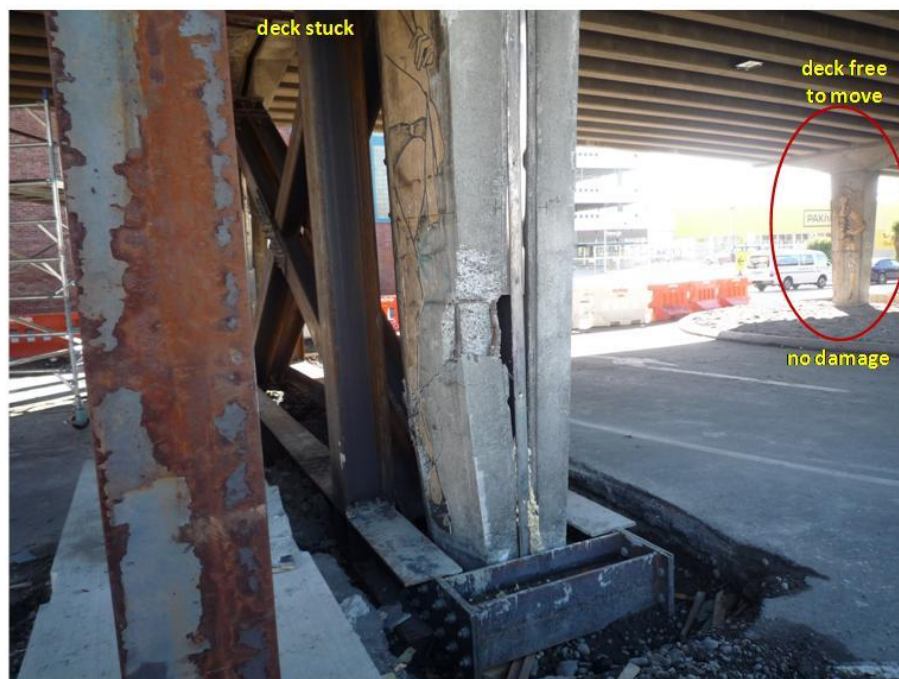
movement on the other side, leading thus increased forces on the columns at the separation joint.

Figure 5.52. Failure of the pier due to shear and then buckling of the rebar under axial loads.

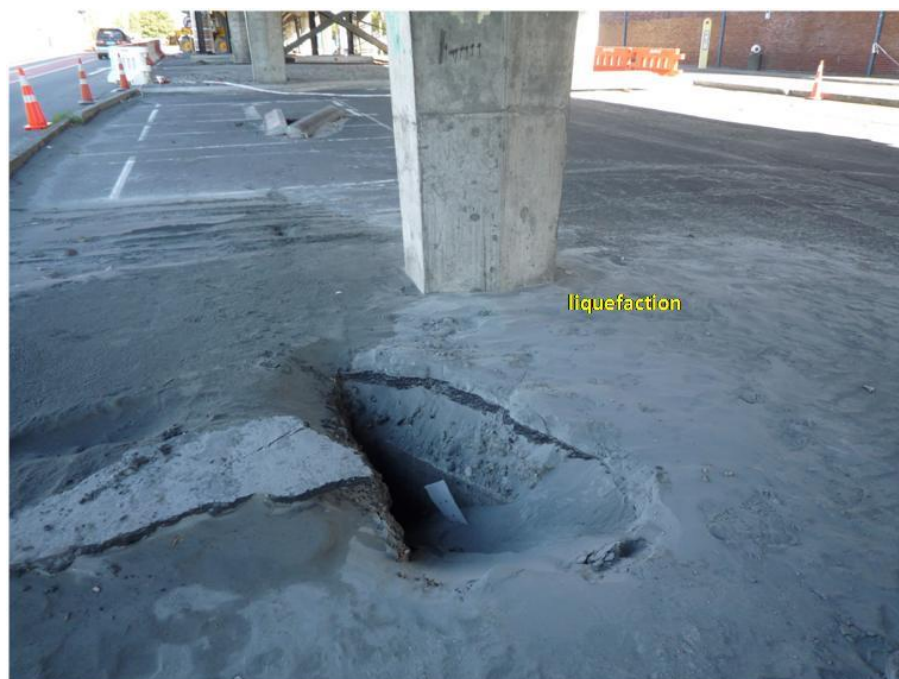
Figure 5.53. Sand-boils indicating liquefaction.

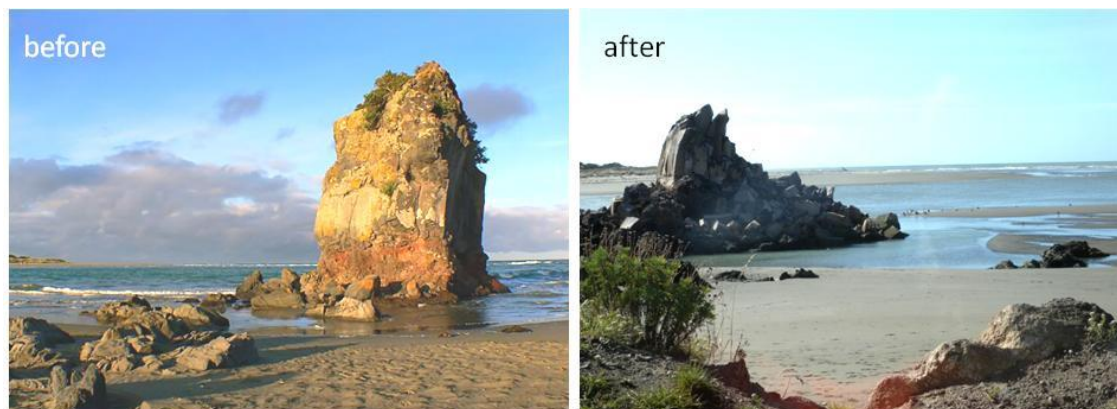
Figure 5.4. The "Shag Rock" has reduced to half its height (site S3 in the map of Figure 5.1).

Christchurch New Zealand's local landmark, known as "The Shag Rock" or "Rapanui", is a prominent sea stack stands close to the southern shore on Main Road leading to Sumner. The rock had a height of 11m depending on the tide level, until it crumbled during the February 2011 Christchurch earthquake. Now, the Shag Rock is reduced to half its height and the remains are still easily seen from the road.

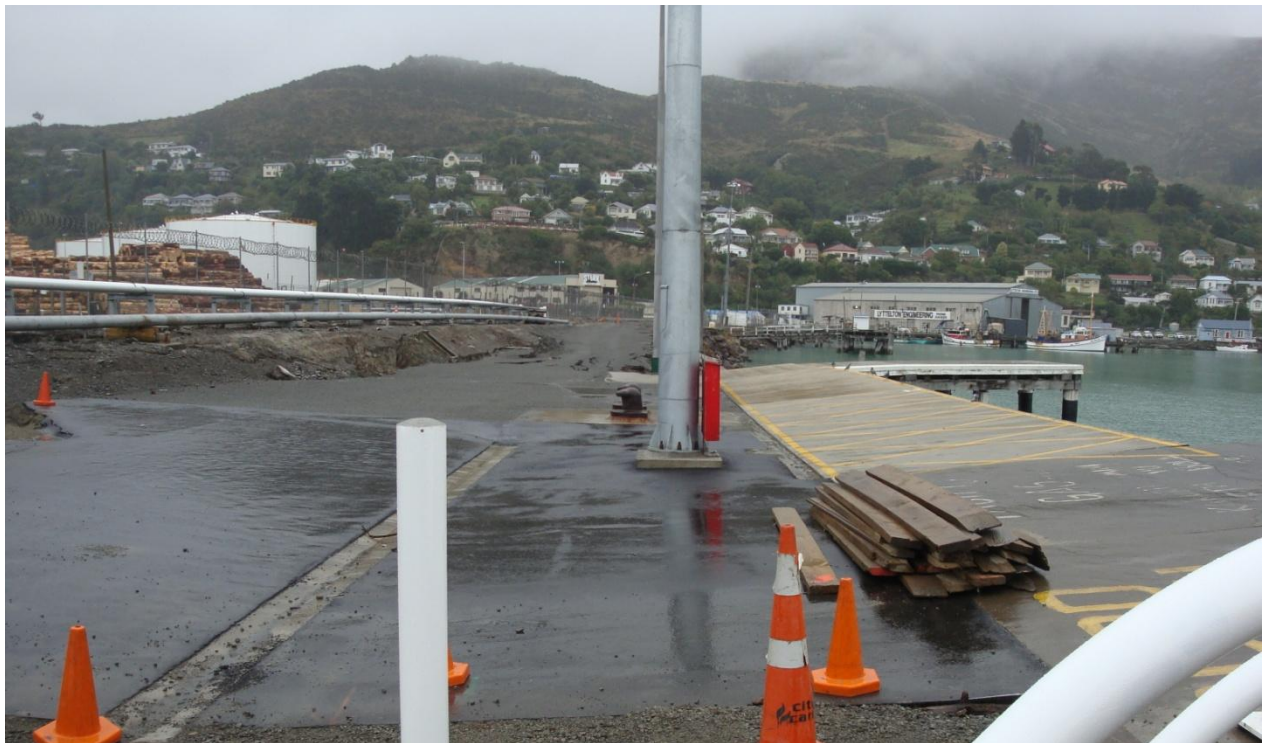
Figure 5.23. Large settlement of the backfill (site W3 in the map of Figure 5.6).

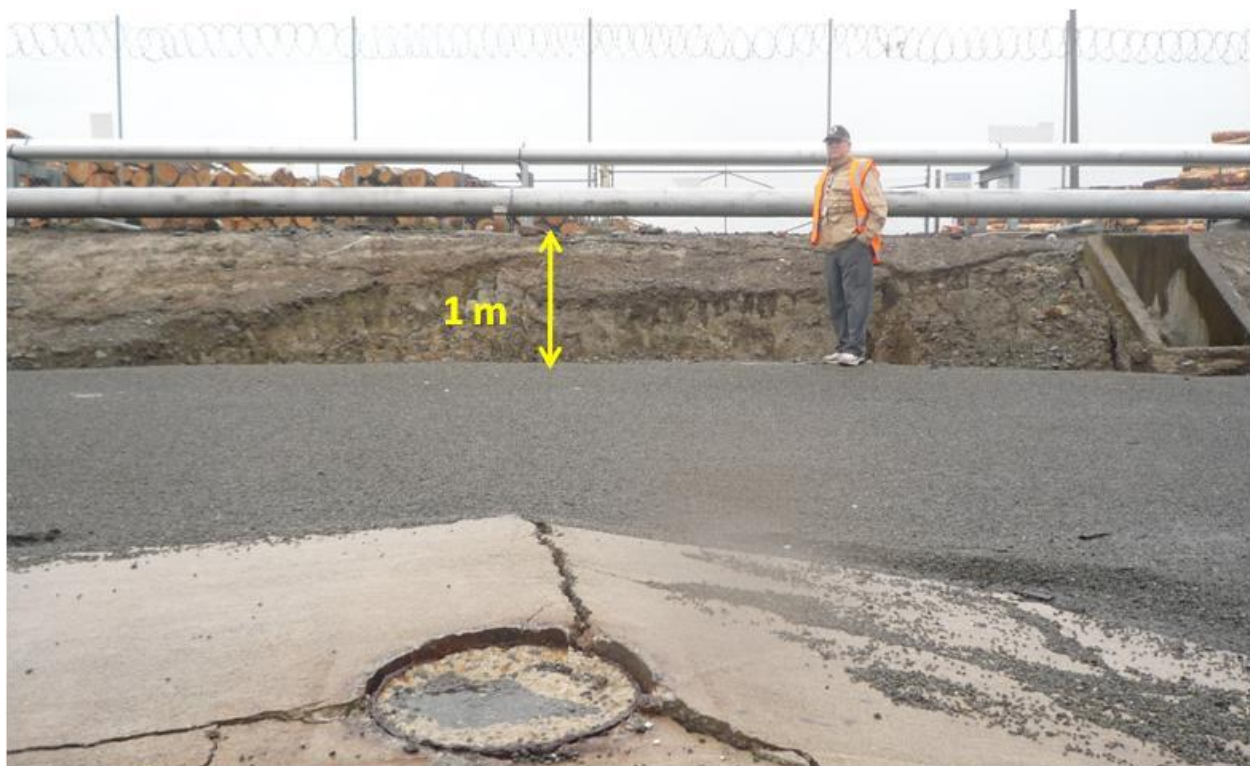
Figure 5.24. Settlement of the backfill in the order of 1 m (site W3 in the map of Figure 5.6).

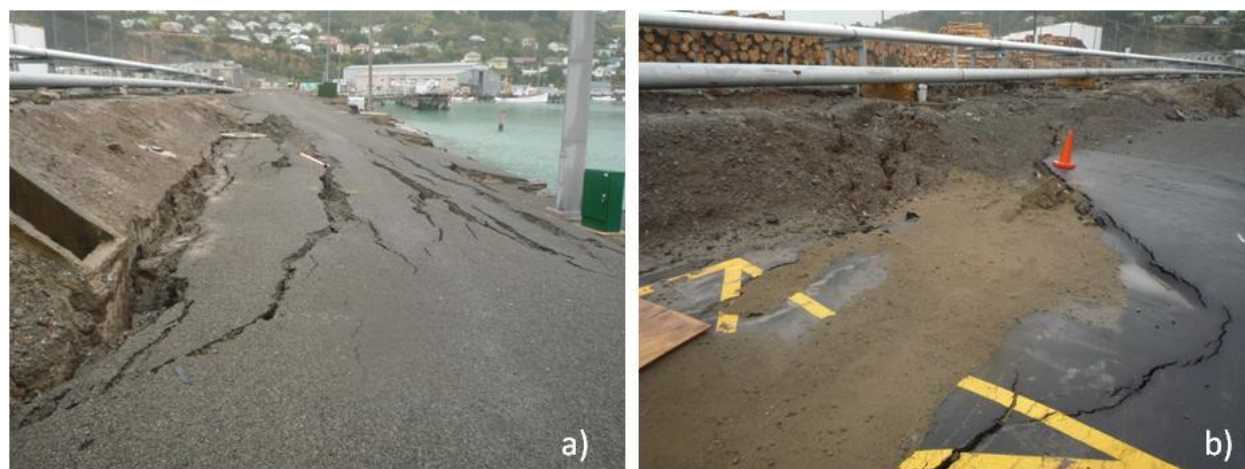
Figure 5.25. a) Cracks in the inclined asphalt due to lateral spreading, b) Ejected sand appeared on the surface indicating that liquefaction has occurred (site W3 in the map of Figure 5.6).

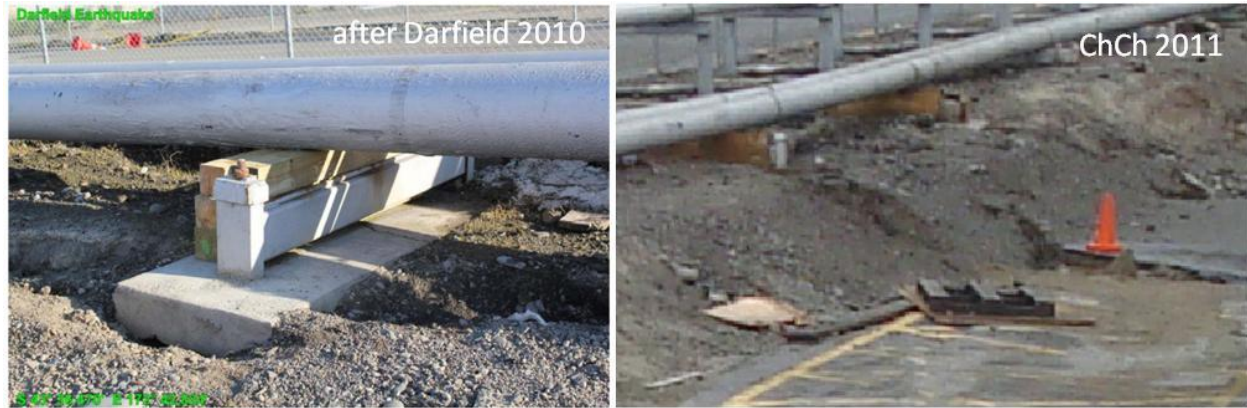
Figure 5.27. Comparison of the fuel pipe line deformation (site W3 in the map of Figure 5.6) between Darfield and Christchurch earthquakes. After Darfield earthquake, temporary wooden support was used to accommodate settlement under fuel line (Cubrinovsky et al., 2010). After Christchurch earthquake, the supports are still there and they have settled together with the fuel line.
