Foundation–structure systems over a rupturing normal fault: Part I. Observations after the Kocaeli 1999 earthquake

Ioannis Anastasopoulos · George Gazetas

3 The “natural experiment” of Denizevler: Overview

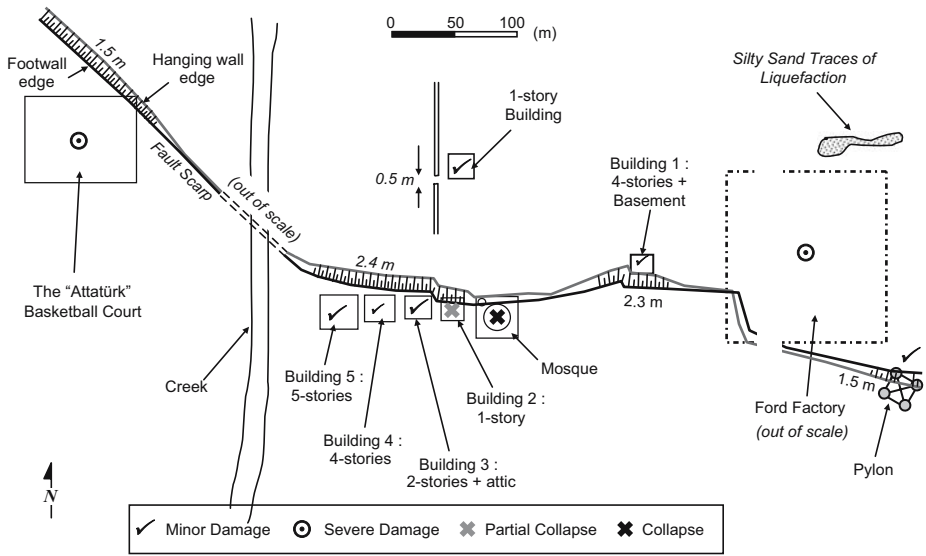
Figure 2 illustrates a plan sketch of the investigated area along with the surface trace of the dislocation. As depicted in the figure, the rupture emerged at the surface creating fault scarps of up to 2.4 m. In contrast, in some cases the dislocation could not be easily identified seeming to disappear, converted to widespread differential settlement of the ground surface rather than a distinct scarp. From east to west, a first

Fig. 2 Sketch of the region of Denizevler (east of Gölcük) under study : the normal fault trace passed through a number of buildings, a mosque, the Ford factory, a high-voltage pylon, and a basketball court. The extent of damage ranged from minor to full collapse (the limits of the factory are out of scale). Values indicate the vertical component of the fault offset at the ground surface.

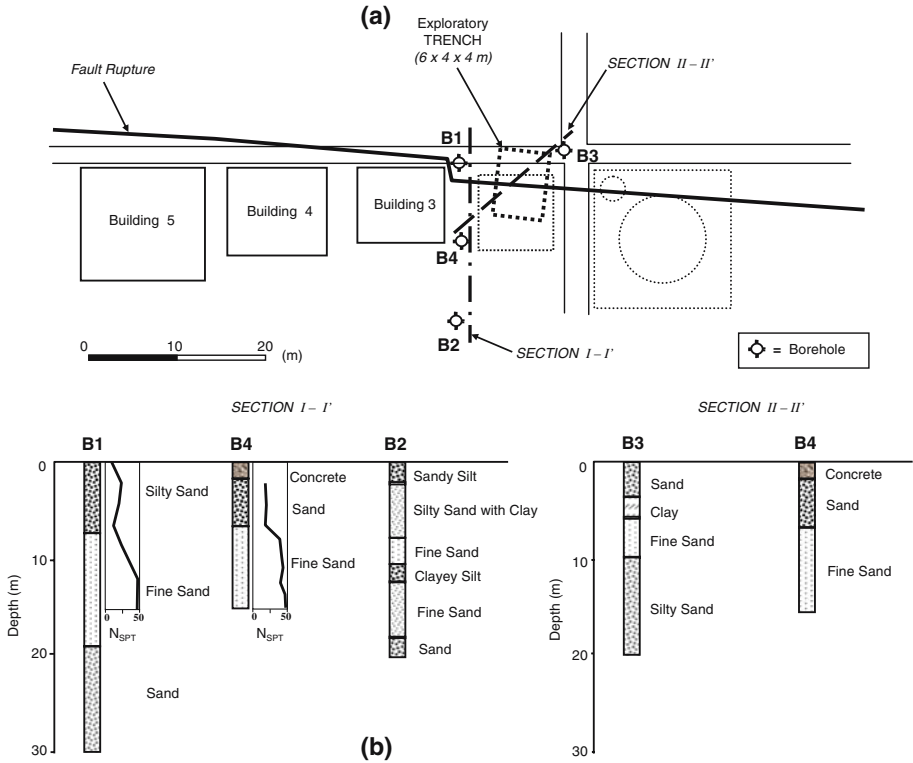
In the area of study we conducted an (admittedly limited) soil investigation, comprising four boreholes and an approximately $6\text{ m} \times 4\text{ m} \times 4\text{ m}$ (length \times width \times depth) trench. The soil exploration took place right beside Building 3, where a vertical displacement of 2.1 m was observed. Fig. 12a shows the locations of the boreholes and the trench. The exploration was performed about 18 months after the earthquake. Regrettably, the fault scarp had been covered with fill; only in the area around Building 1 was the scarp still visible. Boreholes B1 and B3 were located within the hanging wall, while B2 and B5 within the footwall. Figure 12b summarises the key results of this exploration, in the form of soil layer characterisation and number of blows N_{SPT} of the Standard Penetration Test (SPT). As revealed by the N_{SPT} graphs the first 6–8 m consist of relatively loose, to medium soil layers with N_{SPT} ranging from 17 to 33, while deeper the soil becomes much stiffer, with N_{SPT} reaching 50 at a $\sim 15\text{ m}$ depth. The soil profile comprises alternating layers of silty to fine sand, and sand. The presence of clayey materials is only limited to some thin layers of clayey silt to silty sand with clay. The water table was found to be very close to the surface, at approximately -2 m . We found it very difficult to excavate the trench at depths $>3\text{ m}$: due to the high water table trench walls destabilised easily.

Fig. 12 Geotechnical exploration conducted near Building 3: **(a)** plan view of the area, showing the approximate position of the boreholes and of the exploratory trench, and **(b)** geotechnical cross-sections I-I' and II-II'. [Note that typical N_{SPT} values correspond to about $1.25 N_{SPT,60}$, since the delivered energy ratio has been measured at about 48%.]

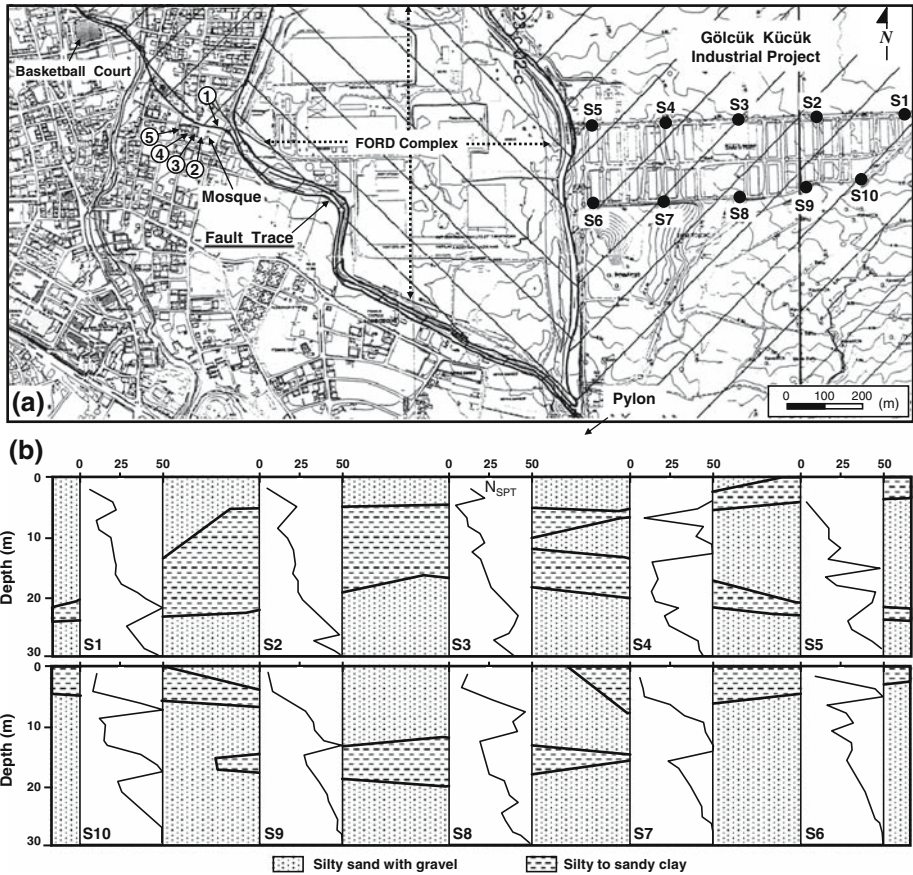
Now, it is interesting to follow the fault trace along the map of Fig. 13a from east to west. Interestingly, the fault trace follows the southern border of the FORD complex almost precisely. We believe that this is a significant observation and cannot be attributed to a mere coincidence. Observe also that the border of the FORD complex coincides with a regional road. It is reasonable to assume that the road pre-existed, and that the setting of the plant border was based on the alignment of the road. Since most roads tend to adapt to local topography, it may be argued that there must have been some topographic feature that caused the road to be formed this way. The most likely such feature is a pre-existing fault scarp at the same exact location. If such hypothesis is true, then the observed normal faulting must indeed be *tectonic and not co-seismic*. Its creation lasts several minutes and is of a quasi-static nature, as the cushioned movement of a block supported with elastic springs on a downward displacing base [Ambraseys 2002 personal communication]. The results of the trenching will shed more light to this hypothesis. Figure 13b summarizes the results of soil investigation at the Gölcük Küçük site. A total of 10 boreholes, S1–S10, indicate similar soil layering with our exploration. Again, the soil profile comprises layers of silty to fine

Fig. 13 (a) Map of the greater area of Denizevler showing the position of the Gölçük Küçük Industrial Project relative to the points of interest of our study, and (b) Longitudinal geotechnical cross-sections along lines S1-S5 and S10-S6, and super-imposed N_{SPT} variation at each of the 10 locations (Geotechnical Report GEOS, 2000)

sand, alternating with silty to sandy clay. The soil is moderately dense for depths up to 20 m. In most boreholes the water table was also found at -2 to -3 m. The obvious similarity with the findings of our soil exploration confirms that soil conditions do not differ significantly from one point of interest to another.

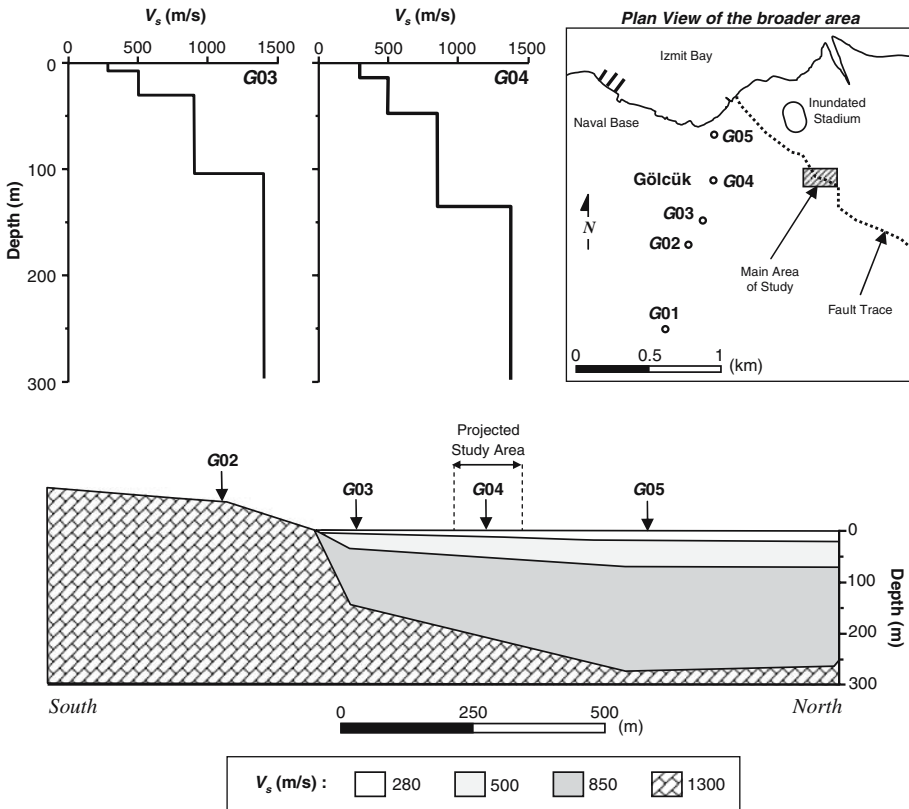
Figure 14 depicts the shear wave velocity, V_s , profile based on microtremor measurements that were conducted in close proximity to our study area by Arai et al. 2000. The measurements were performed at five sites (G01 to G05), extending from the southern hills to the shore of Izmit bay. The two-dimensional V_s profile was estimated by inverse analysis, applying the improved H/V (horizontal-to-vertical) spectrum method (Arai and Tokimatsu 1998). As shown in the figure, the bedrock outcrops to the south with $V_s \approx 1300$ m/s. Then, it dips steeply for about 100 m and continues dipping northwards. At site G04, which is the closest to our study area, the first (near-surface) soil layer with $V_s \approx 280$ m/s extends to -20 m depth. This first layer is the one encountered in both our and the Gölçük Küçük soil exploration. It

Fig. 14 Shear wave velocity V_s profile based on microtremor measurements (after Arai et al. 2000)

is followed by a stiffer layer of $V_s \approx 500$ m/s ending at -45 m depth, and a third one with $V_s \approx 850$ m/s extending down to the bedrock at -130 m depth.

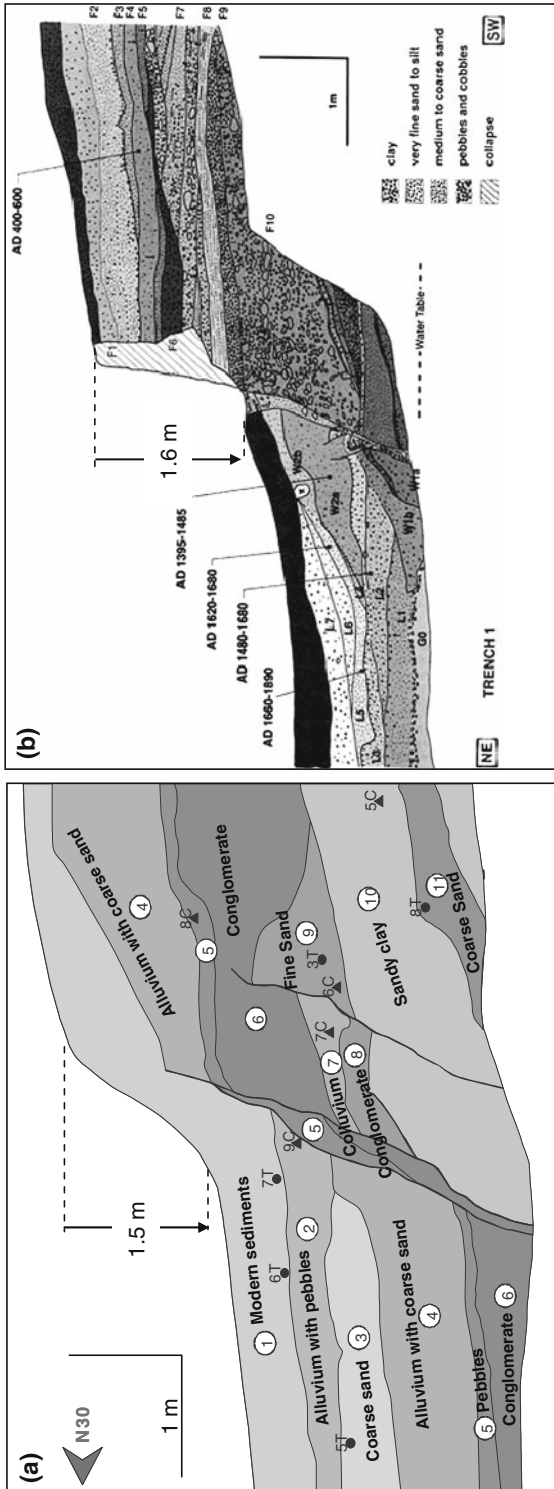
The geological cross-section produced by the excavated trench at the area of Denizevler is shown in Fig. 15a. As foresaid, the sidewalls of the trench we excavated right beside Building 3 could not be stabilised. Therefore, the results shown herein refer to a nearby location, where the water table was a little deeper. In any case, the aim of trenching was not to determine soil composition with exactness, but to conclude on the tectonic origin of the outcropped rupture. As shown in the geological cross-section, besides the current 1.5 m dislocation, a second one also exists. This second rupture does not reach the ground surface, stopping within layer 6 (conglomerate). This older rupture is apparently the result of older seismic events [Pavlidis 2003] confirming the tectonic nature of the observed dislocation. In fact, the trenching showed that the investigated normal fault had been activated at least 3 times in the past. The measured offset (observe layer 6) is almost twice the height of the 1999 dislocation (≈ 2.8 m) compared with 1.5 m. This offset is cumulative, incorporating the effect of the 1999 dislocation and that of the aforementioned older seismic episodes.

Fig. 15 Geological cross-sections trenched in the area of Denizevler: (a) the exploration by Pavides et al. (2003), compared to (b) the detailed study of Klinger et al. (2003)

detailed paleoseismic study conclude that their trenching reveals 3 distinct seismic episodes, with the 1999 earthquake being of course the latest. They explain that the oldest earthquake is responsible for the formation of wedge W1, while the penultimate one for wedge W2. These wedges are formed after each earthquake from the unavoidable erosion of the fault scarp. After a seismic event nature smoothens the scarp (erosion). Soil material is eroded from the upper half (footwall) and deposited downslope (hanging-wall). This implies that the material of each wedge was originally on top of the footwall. The height of each wedge is practically equal to the height of the eroded material (assuming that the volume of the wedge is equal to the soil volume that was detached from the top half), and hence the height of each wedge is roughly equal to half of the fault offset that triggered it. Thus, measuring the height of wedges W1 and W2, it was concluded that they must have been formed by two seismic offsets, 1.6 m and 1.4 m, respectively. From radio carbon dating, it was estimated that the oldest event took place around 1509, followed by the penultimate at about 1,719, and the latest earthquake in 1999. The three offsets and their approximate periodicity persuasively confirm the tectonic origin of the 1999 episode.

Comparing the results of our exploration (Fig. 14a) with the detailed study of Klinger et al. (Fig. 14b) we confirm our findings and conclude on the tectonic origin of the observed normal fault. The periodicity shows that almost the same magnitude events (offsets of ~ 1.5 m at this particular location) occur almost every 200–300 years. Deeper trenches might reveal additional data for the existence of seismic episodes that preceded.
