Fault rupture–foundation interaction: selected case histories

E. Faccioli · I. Anastasopoulos · G. Gazetas ·
A. Callerio · R. Paolucci

Keywords Fault rupture propagation · Soil–structure interaction · Kocaeli · Düzce-Bolu · Chi–Chi · Mount Etna

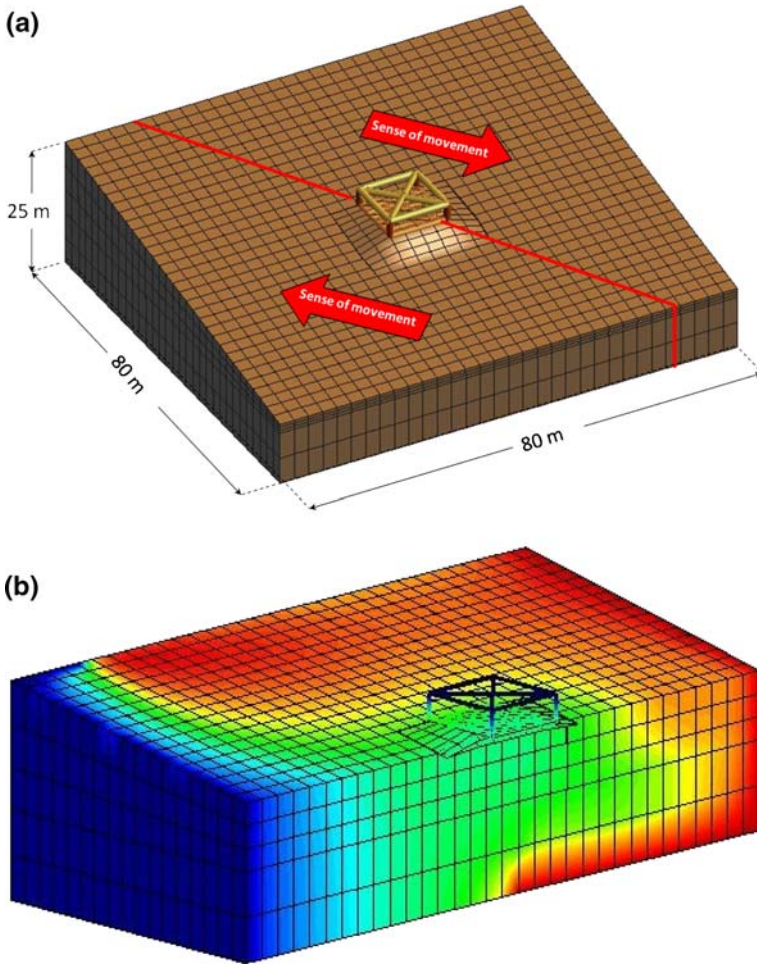
clockwise rigid-body torsion around its vertical axis (Fig. 6). Both the simulation results and the field observations are in qualitative agreement with the work of [Berrill \(1983\)](#), who studied analytically the behaviour of buildings on continuous-rigid shallow foundations, subjected to strike-slip faulting.

Fig. 6 Mt. Etna—Pernicana strike-slip fault—3-D finite element analysis of the 1-story building of Fig. 4: **a** 3-D mesh layout, and **b** horizontal displacement contours. Due to the rigidity of the foundation, the fault rupture is diverted, with the structure being subjected to rigid-body rotation. Analysis results can be seen to be in qualitative agreement with field observations

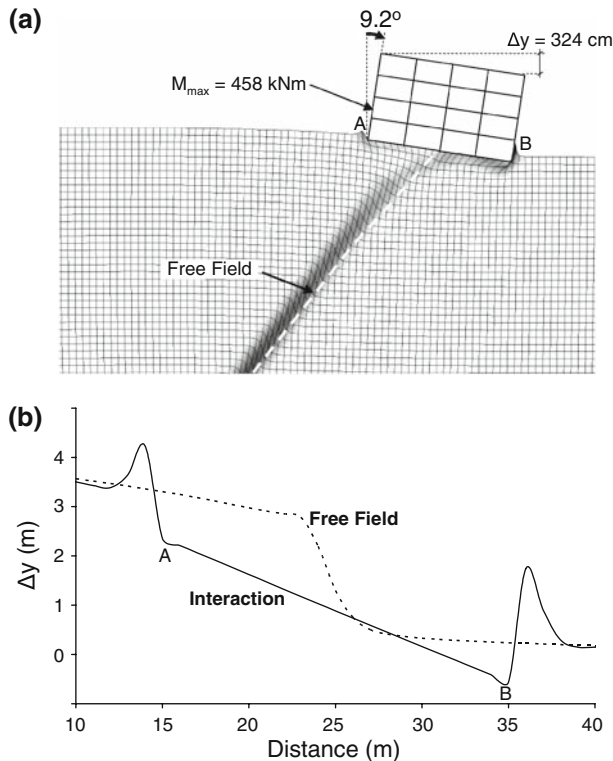
of seismic refraction measurements (Dong et al. 2003). While the idealised superstructure was simulated with beam elements, the soil–foundation interface was modelled with special gap elements, allowing for detachment and slippage. As illustrated in Fig. 8, the 4-story model experienced a rigid-body rotation of 9.2° (compared to the 10° observed in reality), without excessive stressing: the maximum bending moment M_{max} in the superstructure did not exceed 458 kNm. The vertical displacement Δy of the ground surface clearly indicates that the building rotates as a rigid body (tilting without significant distortion): region AB in Fig. 8 is of constant inclination. The numerical results are in good agreement with field observations.

Fig. 8 Chelungpu thrust fault, Chi-Chi, Taiwan 1999 earthquake—Chung-Cheng Park, Fung-Yan City—s2-D finite element analysis of the 4-story building of Fig. 6 ($h = 4 \text{ m}$): **a** Deformed mesh and plastic strain, **b** Vertical displacement Δy at the ground surface. The structure is subjected to rigid-body rotation, without excessive stressing. Analysis results can be seen to be in qualitative agreement with field observations

This discrepancy may stem from the plane strain simplification of our analysis: the actual fault rupture crossed the corner of the building.

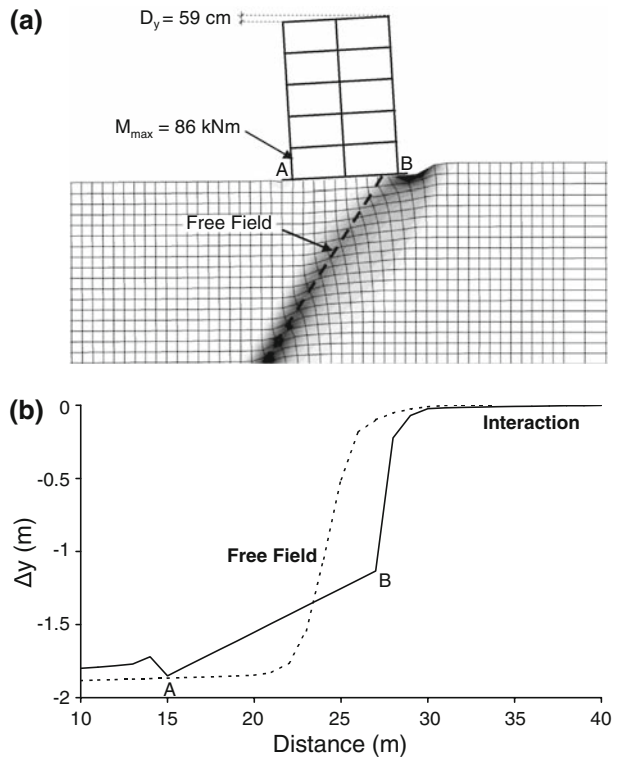
The same method was applied to analyse this case-history: a bedrock offset of vertical amplitude $h = 2$ m was imposed on an idealised soil deposit of thickness $H = 40$ m. As described in ([Anastasopoulos and Gazetas 2007b](#), the thickness of the soil deposit was estimated based on microtremor measurements by [Arai et al. \(2000\)](#). As illustrated in Fig. 10, the rupture path is clearly diverted towards the footwall as it approaches the ground surface. The building is subjected to some rigid-body rotation resulting in a differential settlement $Dy = 59$ cm, without being distressed: $M_{max} = 86$ kN m. As in the two previous cases, the rigid and continuous foundation is responsible for this favorable response. The analysis compares well with field observations, except that in reality the rotation was less conspicuous.

Fig. 10 Normal fault east of Gölcük, Kocaeli, Turkey 1999 earthquake—Denizevler—2-D finite element analysis of the 5-story building of Fig. 9 ($h = 2$ m): **a** Deformed mesh and plastic strain, **b** Vertical displacement Δy at the ground surface. Due to the rigidity and continuity of the box-type foundation, the fault rupture is diverted towards the footwall; the structure is only subjected to limited rigid-body rotation, without significant stressing. Analysis results are in qualitative agreement with field observations

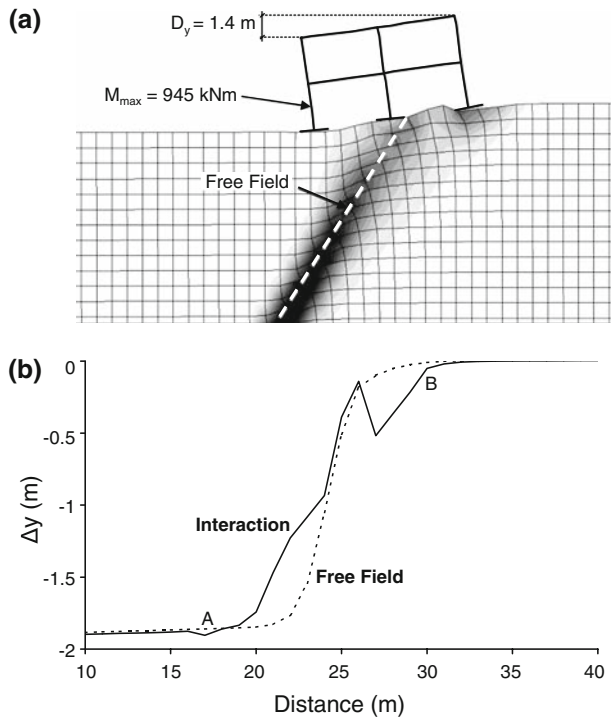
The previously discussed method was applied for the analysis of the Mosque. A bedrock offset of vertical amplitude $h = 2$ m was imposed at the base of a soil deposit of thickness $H = 40$ m. As illustrated in Fig. 16, the rupture path was not substantially affected by the structure. Most of the deformation is found to occur between the isolated footings of

the Mosque, in the form of a diffuse failure zone, causing the structure to tilt towards the hanging wall with a differential settlement $D_y = 1.4$ m. However, not all of the imposed deformation is converted to rigid-body rotation, and the Mosque was substantially distressed (computed $M_{max} = 945$ kN m). In general, the results of this analysis are in agreement with the observed performance.

Fig. 16 Normal fault east of Gölcük, Kocaeli, Turkey 1999 earthquake—Denizevler—2-D finite element analysis of the Mosque, Fig. 14a ($h = 2$ m): **a** Deformed mesh and plastic strain, **b** Vertical displacement Δy at the ground surface. Due to the discontinuity and flexibility of its foundation, the superstructure of is subjected to excessive stressing, in accord with the observed performance
