STRUCTURAL DAMAGE OF A 5-STOREY BUILDING: DIFFERENTIAL SETTLEMENT DUE TO CONSTRUCTION OF AN ADJACENT BUILDING OR BECAUSE OF CONSTRUCTION DEFECTS ?

Ioannis Anastasopoulos

National Technical University of Athens
Zografou, 15780, Athens, Greece

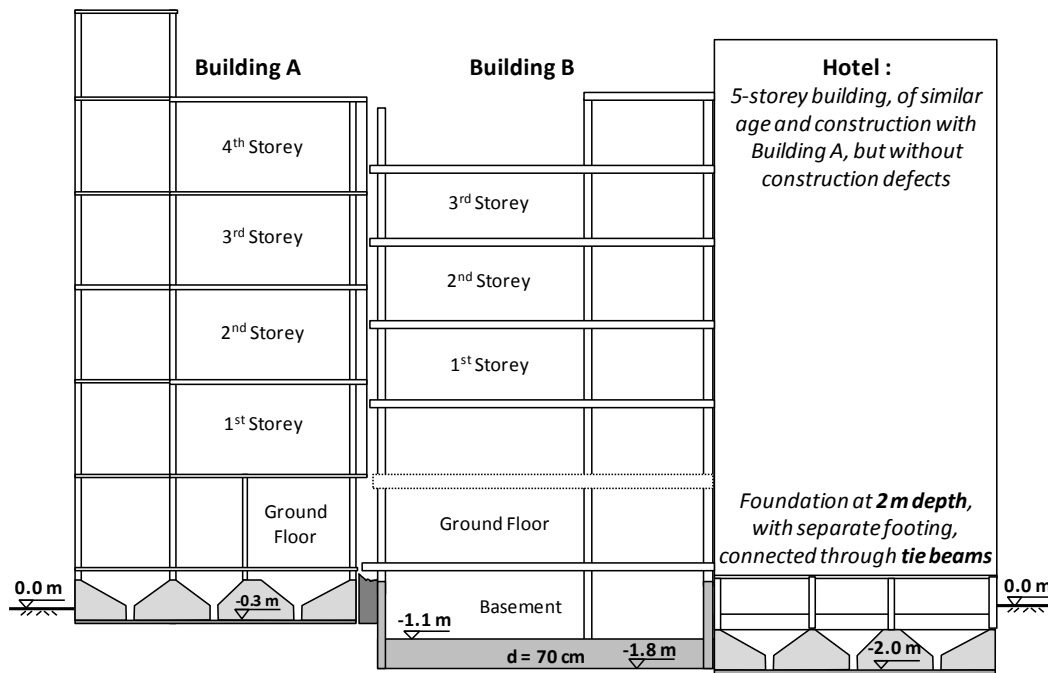
Fig. 1. Sketch showing the damaged Building A, the under-construction Building B, and the neighboring Hotel Building.

The damage to Building A first appeared in July 1999, just before completion of the erection of the RC frame of Building B, and consequently about 3 months after completion of the basement excavation. Therefore, it would not be reasonable to associate the damage with inadequate retaining during excavation, since in such a case the damage should have appeared much earlier. The damage is mainly in the form of shear cracks on infill walls in the transverse direction and distortions of internal door frames. An example of the observed cracks is shown in **Fig. 4a** (see **Fig. 2** for the exact location). Inclined at approximately 45° , the observed shear cracks are indicative of differential settlement of the first column row (closest to Building B) with respect to the second one (see also **Figs. 1** and **2**).

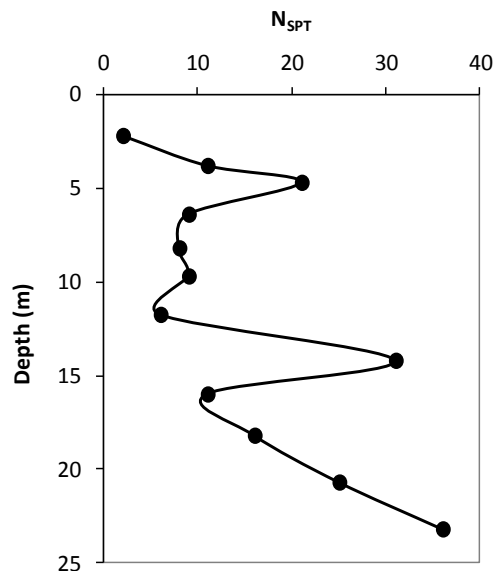
On November 2004, the owners of Building B hired another geotechnical consultancy to undertake a geotechnical investigation. A 30 m deep borehole was conducted in front of Building B, revealing that the first 15 m consist of soft clayey silt, reaching stiff sandstone at 26 m depth. The depth of the water table was found at 1.2 m depth, i.e. 1.5 to 2 m from the ground surface. On February 2005, the owners of Building A hired another consultant to reevaluate the damage and propose corrective measures. The observed damage was once more attributed to the settlement due to the additional loads of Building B, and to inadequate retaining of the 1.5 m deep excavation for the basement of the latter.

Photo of the borehole in front of building B
[Triton, 2004]

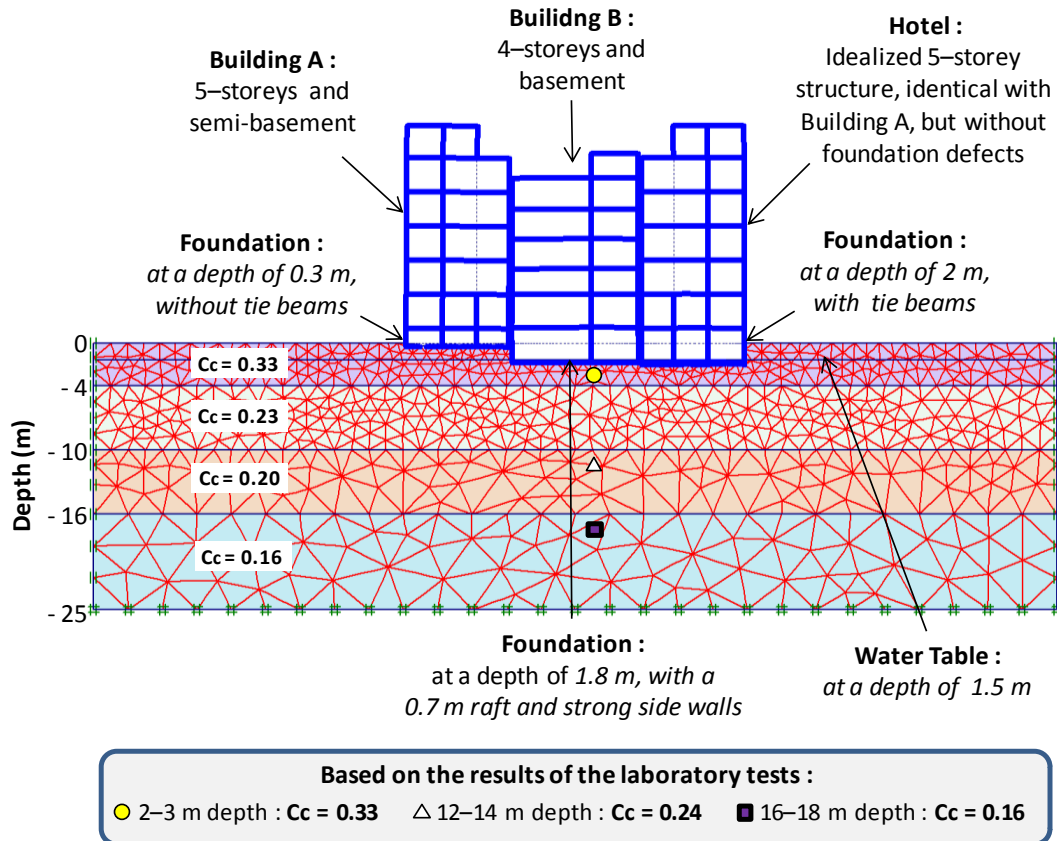
entire construction sequence is simulated, from the construction of Building A (in 1968), to the construction of the RC frame of Building B (in 1999). As shown in **Fig. 6**, the entire soil–foundation–structure system is analyzed, including the three neighboring buildings: Building A, Building B, and the Hotel. The latter is a 5-storey RC building of similar age, construction typology, and total height (and therefore of similar total dead load) with Building A, but having two very significant differences: (a) its separate footings are founded at 2 m depth (i.e., where the foundations of Building A should also lie), and (b) the footings are connected with RC tie beams (as the footings of Building A should also be).

Fig. 6. Finite element modeling of the three neighboring buildings.

The soil–foundation–structure system is analyzed numerically employing the FE code PLAXIS. The analysis is performed in 2D, assuming plane-strain conditions, and considering a representative slice (in the transverse direction) of the three neighboring buildings. The soil is simulated through 15-node plane-strain triangular elements, while the foundation and the superstructure of the three buildings with beam elements. The behavior of both the foundation and the superstructure is reasonably assumed elastic (since the RC frames have no damage), considering a Young's modulus $E = 25 \text{ GPa}$ for the reinforced concrete. The nonlinear response of the soil is modeled with a Cam-clay model [Butterfield, 1979; Borja & Lee, 1990; Muir Wood, 1990] incorporated in PLAXIS ("soft soil" model). Model parameters are calibrated based on the basis of the aforementioned geotechnical investigation [Triton, 2004], taking into account the stratigraphy of the soil, the depth of water table, the *SPT* results, and of course the laboratory tests, with particular emphasis on compressibility–consolidation tests. Based on the above, the geotechnical profile of **Fig. 6** is considered representative of the soil conditions in the vicinity of the three buildings.
