STRUCTURAL AND GEOTECHNICAL ASPECTS OF THE CHRISTCHURCH (2011) AND DARFIELD (2010) EARTHQUAKES IN N.ZEALAND

Eleni Smyrou¹, Panagiota Tasiopoulou², İhsan E. Bal³,
George Gazetas⁴ and Elizabeth Vintzileou⁵

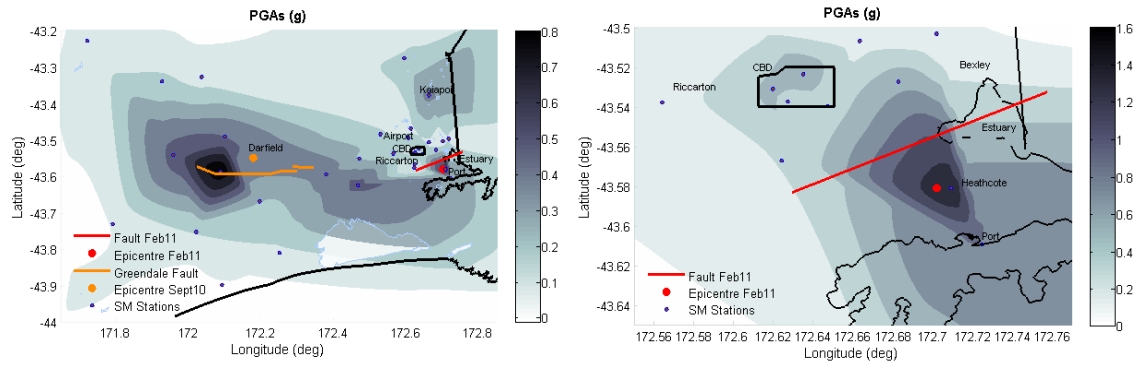
Thanks to a dense network of strong ground motion stations, a large number of records have been obtained, offering valuable information on the two events. Figure 2 presents the spatial distribution of the peak ground acceleration (PGA) values as characteristic indicator of the intensity of the Darfield and Christchurch earthquakes.

Figure 2. Approximate spatial distribution of the peak ground accelerations from the Darfield (left) and Christchurch (right) earthquakes.

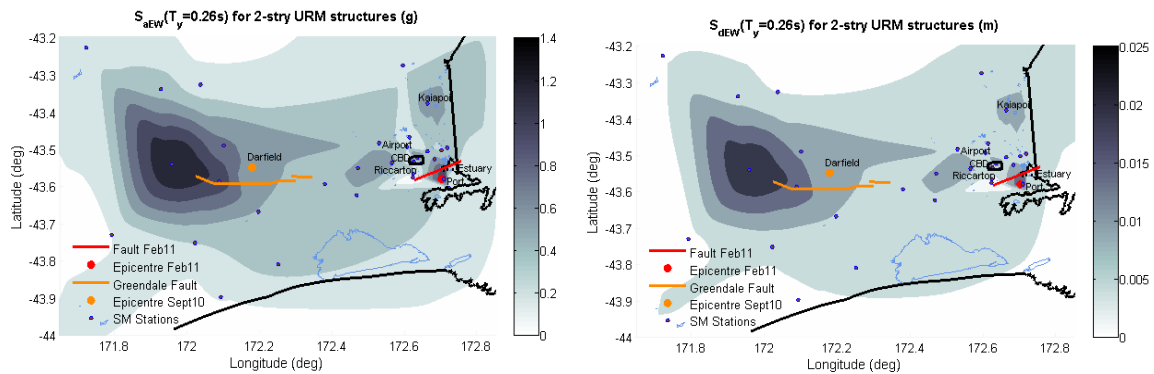
Spectral acceleration and spectral displacement plots given in Figure 9 indicate that for the short period range where the low-rise timber and URM buildings fall into, the concentration of spectral amplifications occurs near the western end of the fault. This is somehow interesting since Figure 2 reveals a concentration of PGAs along the fault rupture line, implying that the motion right along the fault may contain mostly long period components. Another observation derived from Figure 9 is the displacement demand for the SDOF systems. Uma et al. (2008) claims that the drift limit state for URM buildings for the moderate damage is 0.4%, which is translated to a

0.012m displacement demand for an equivalent SDOF system, explaining thus the damage concentration of such structures in the Darfield area after the September'10 earthquake.

Figure 9. Spatial distribution of spectral accelerations (left) and displacements (right) for Darfield earthquake for yield period of 0.26sec (2-storey typical URM houses-EW direction).

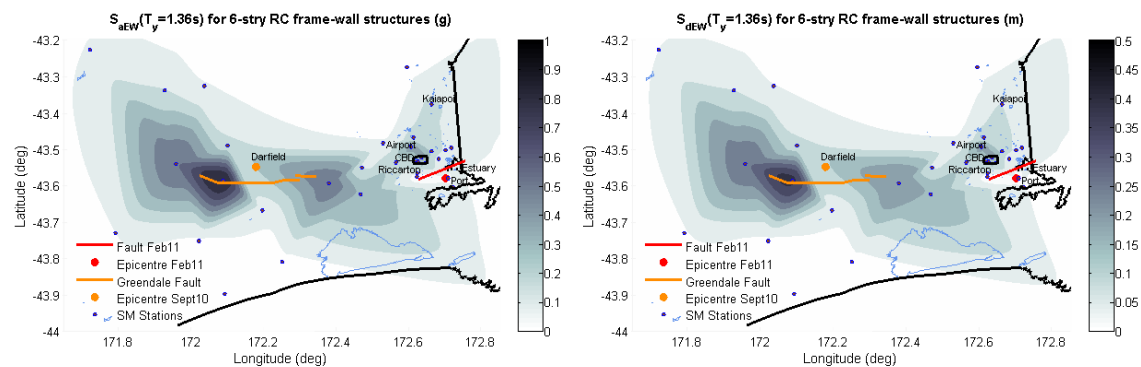
An interesting feature in Figure 10, in relation to the comments given above on Figure 9, is that the long period spectral amplifications appear more pronounced on the western end fault, a probable outcome of forward rupture directivity effects that affect the frequency content of the strong motion records with respect to the position and the site distance from the fault (Somerville, 2003). The spectral acceleration values in Figure 10 highlight the very high acceleration demands imposed (in the range of one g), but, as the building exposure in that region is mostly low-rise residential, extensive damage of mid-rise RC structures was not observed after the September'10 earthquake.

Figure 10. Spatial distribution of spectral accelerations (left) and displacements (right) for Darfield earthquake for yield period of 1.36sec (6-storey typical RC frame-wall structures - EW direction).

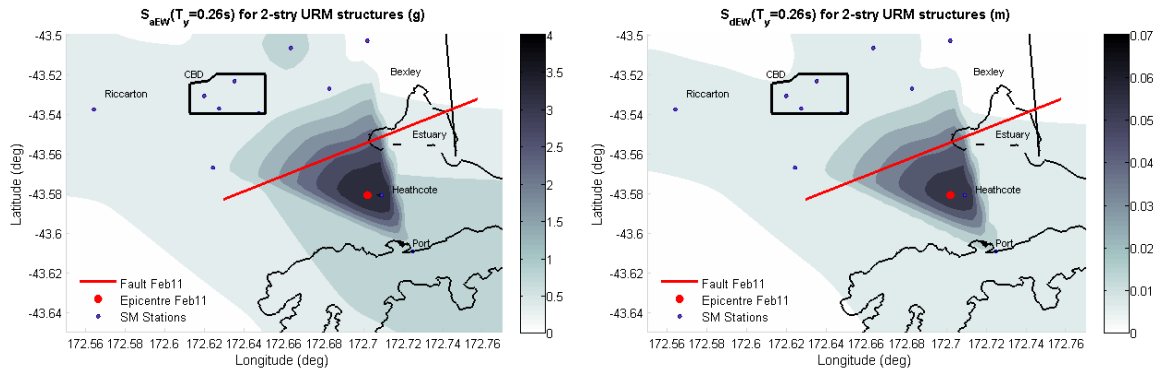
The spatial distribution of PGAs and long-period spectral values exhibit a gradual reduction of values with increasing distance from the source, as readily shown by the contour lines, referring to a point-source for the February'11 earthquake rather than a line source as happened in the September'10 earthquake. The seismological definitions concerning the Christchurch earthquake are yet not settled, due to the fact that there was no surface rupture, and even the debate on whether the February'11 earthquake belonged to the aftershock sequence of the Darfield earthquake or not is still open. Nevertheless, from an engineering point of view it is rather interesting noticing in Figure 11 that the short-period components are concentrated in Heathcote Valley, where the epicentre of the earthquake was, while Figure 12 suggests that the long period components are stronger close to CBD, 7km away from the epicentre. This finding can correlate the damage expected to certain structural types in specific areas to the damage really observed.

Figure 11. Spatial distribution of spectral accelerations (left) and displacements (right) from Christchurch earthquake for the yield period of 0.26sec (2-storey typical URM houses - EW direction).

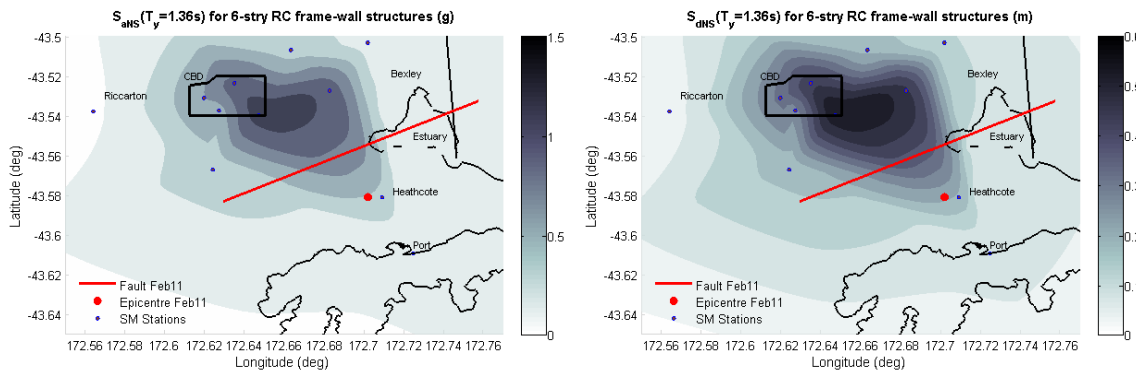
Figure 12. Spatial distribution of spectral accelerations (left) and displacements (right) for Christchurch earthquake for the yield period of 1.36sec (6-storey typical RC frame-wall structures - NS direction).

As mentioned, the life losses from the second earthquake were primarily due to the heavy damage or collapse (mostly partial) of mid-rise and relatively tall RC structures in the CBD. Indicatively, the case of Grand Chancellor Hotel, which is a 26-storey structure with severe damages and more than one meter residual top displacement, is mentioned as an example of a tall RC building with substantial structural damage that rendered it unusable. Figure 12 presents this issue quite clearly showing that the spectral amplification around CBD is much higher than the one close to the fault epicentre. Nevertheless, the effects of the Christchurch earthquake on tall structures in CBD needs to be investigated in detail with respect to the soil-structure interaction and the soil plastification recorded in several parts of the centre.

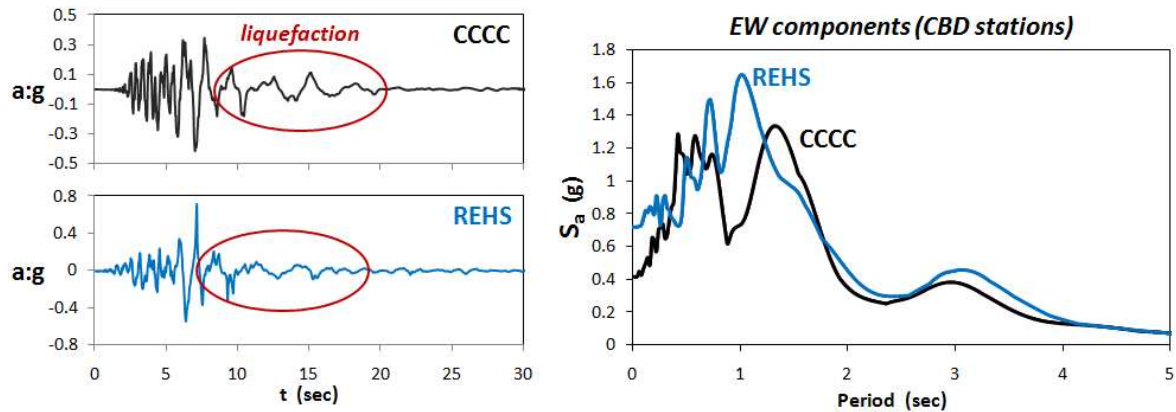
Finally, it is worth noticing the different composition of the spectral values for short and long periods in different regions in respect to the fault (Figure 9 to Figure 12), which could be partly attributed to potential source effects. However, another plausible explanation is the soil softening due in particular to soil liquefaction that occurred in large scale in both earthquakes. Response spectra obtained in liquefied areas are often characterised by bulges in the long-period range, signifying substantial amplification of the spectral values, much further than the constant acceleration plateau (Figure 12). Such a change in the frequency content, evident also in the spatial plots, has a significant impact on the seismic demand imposed and thus on the response of mid-rise and tall structures.

Figure 12. Recorded acceleration time-histories (left) and response spectra from REHS and CCCC stations (right) indicative of liquefaction.
