NORMAL AND REVERSE FAULT RUPTURE INTERACTION WITH CAISSON FOUNDATIONS: CENTRIFUGE MODELLING AND NUMERICAL SIMULATION

Paper No. NRFLO

5th International Conference on Earthquake Geotechnical Engineering January 2011, 10-13

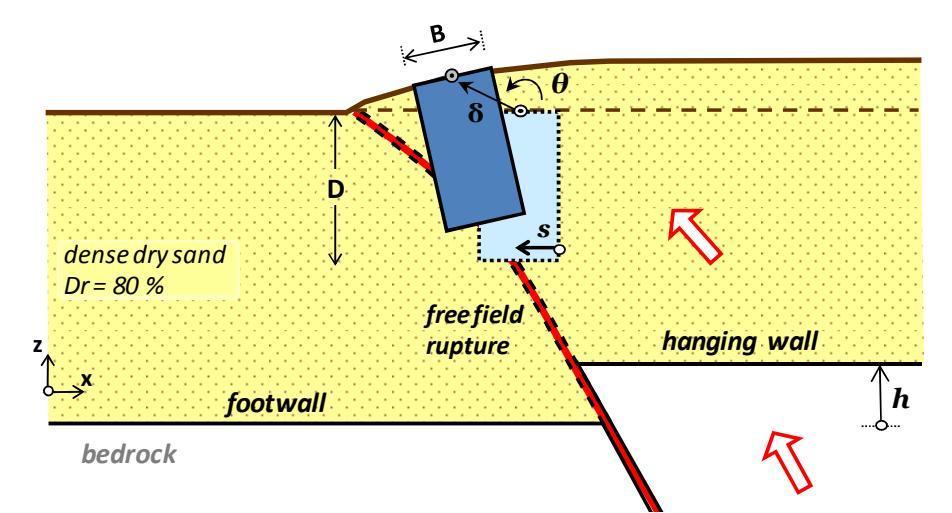
Figure 1 illustrates schematically the main features of the studied problem (indicatively for the case of reverse fault rupture) and defines the Cartesian coordinate system adopted. A 5 x 5 x 10 (m) square in plan caisson foundation is considered, supported on a 15 m thick layer of dense ($D_r \approx 80\%$) dry sand. It carries a total vertical load of approximately 20 MN, which represents the weight of a superstructure of significant size (e.g., a medium span bridge). Reverse and normal (upwards and downwards) fault displacement of vertical amplitude h (throw) is applied at the bedrock. The displaced block of soil (i.e. the hanging wall) moves upwards with a dip angle of 60°, whereas the footwall remains stationary. The fault deformation forces the caisson to move as a rigid body, experiencing both translational δ and rotational θ displacements.

Figure 1. Schematic illustration of the studied problem for the case of reverse fault rupture.

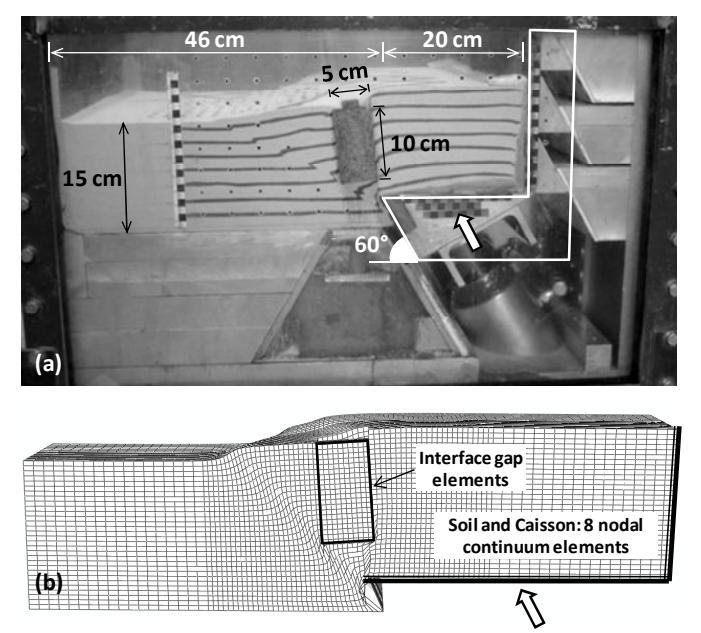
A photograph of the centrifuge model inside the strongbox is shown in Figure 2a, as deformed after completion of test ML-05, where the caisson was placed at a position s/B = 0.22. The 150 mm deep (i.e. 15 m at prototype scale) soil layer was prepared by dry air pluviation of Fontainebleau sand [Gaudin, 2002]. The sand was pluviated from a specific height with a fixed sieve aperture to control the mass flow rate, giving a uniform density $D_r \approx 80\%$ ($\gamma = 16.11 \text{ kN/m}^3$). Direct shear tests were conducted to investigate the soil stress–strain and volumetric behaviour. For a mean value of relative soil density $D_r = 80\%$, the peak and residual friction angles of the soil were measured as $\varphi_{peak} = 37^\circ$ and $\varphi_{res} = 31^\circ$ at a normal effective stress representative of the middle of the soil depth (i.e. $\sigma'_v = 120$ kPa for depth z = -7.5 m). The dilation angle ψ was measured as approximately 10° for the same representative normal stress.

Figure 2. Combined experimental and numerical study : (a) photo of the faulting apparatus and the centrifuge model (for reverse fault rupturing) ; (b) snapshot of deformed FE mesh.

Figure 2b shows the deformed FE mesh for s/B = 0.22, for comparison with the physical model (Figure 2a). It is noted that only half of the model was simulated, taking advantage of symmetry along the centreline of the foundation (which corresponds to the location of the Perspex front face in the centrifuge models).

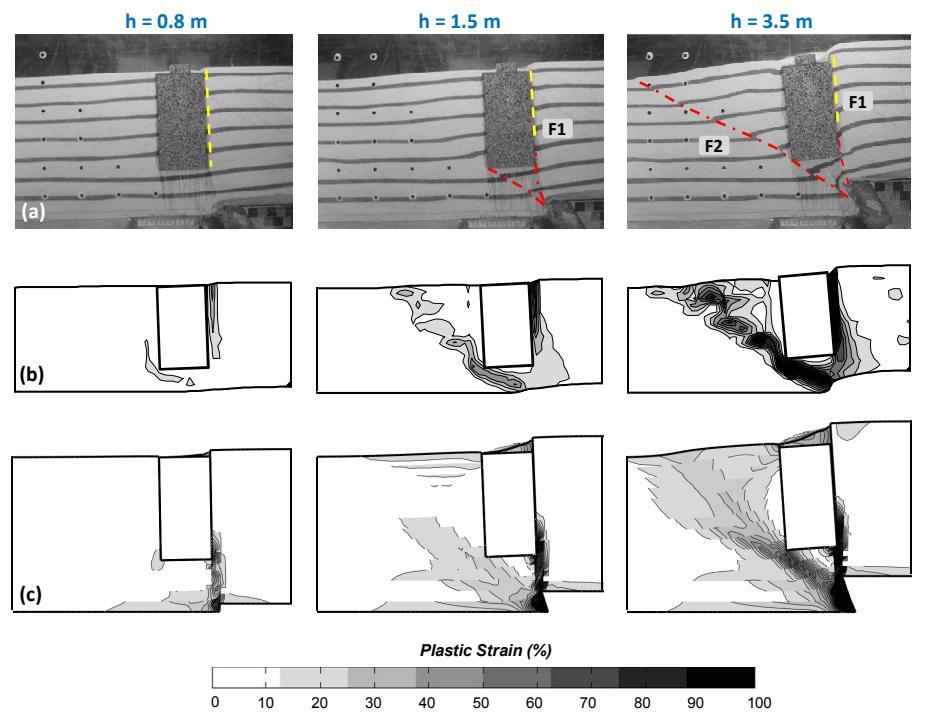
Figure 3a shows a set of images captured at different – characteristic time points during faulting. Significant soil deformation can be observed for h = 0.8 m propagating vertically towards the soil surface on the right (hanging wall) side of the caisson and causing significant sliding to take place along the right caisson sidewall (indicated by the dotted line), yet without evident fault plane formation (see also corresponding shear strain contours in Figure 3b, as deduced through image analysis of the test results). However, after 0.7 m of additional fault displacement (h = 1.5 m) a localization plane (F1) has clearly formed and propagated from the base dislocation point to the right corner of the foundation and all along its right sidewall.

Figure 3. *Reverse* Fault rupture-caisson interaction at different stages of faulting for s/B = 0.22 (Test ML_05): (a) centrifuge test model images; (b) contours of shear strains developed within the soil in the centrifuge test compared to (c) the corresponding numerical analysis.

In this test, the caisson was positioned so that the free field rupture would cross the caisson base 1.1 m to the left of its right corner (s = 0.28 B). As expected the rigid caisson mass interacts with the rupturing fault modifying significantly the failure pattern in comparison to the free field path. The mechanisms of fault–caisson interaction are highlighted in Figure 3.

At the same time, a secondary localization (F2) appears. Initiating from the bedrock dislocation, F2 intersects with the left (footwall) caisson base corner propagating with a much shallower dip angle. Thereafter, on additional fault displacement, the rupture bifurcates and fault deformation localizes upon

these two distinct strands, one at each foundation side. Observe the soil heave formation next to the top right caisson corner due to F1 and the scarp formed at the soil surface due to the emergence of F2 for h = 3.5 m.

Comparison between the analytically computed and the experimentally deduced shear strain contour plots (Figure 3b and 3c) demonstrates the effectiveness of the numerical method in successfully predicting the generation and evolution of the different fault mechanisms for the whole studied range of fault displacements.

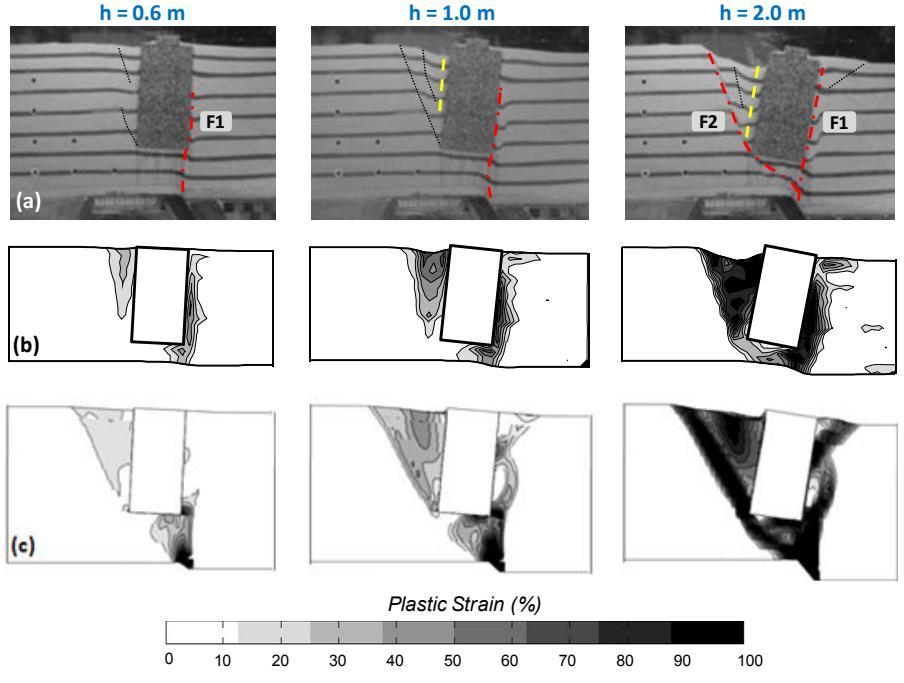
Figure 4a displays a set of the centrifuge model test images, captured at different levels of fault displacement, and demonstrates a progressive type of failure associated with the interplay between different failure mechanisms. First, for h = 0.6 m, the caisson acting as a kinematic constraint forces the rupture to deviate significantly from its free field path, actually changing orientation, and to propagate towards the hanging-wall (right) caisson edge. Interestingly, *F1* propagates at a dip angle greater than 90° (about 98°) contradicting the orientation of rupture in the bedrock.

Figure 4. *Normal* Fault rupture-caisson interaction at different stages of faulting for s/B = 0.28 (Test ML_08): (a) centrifuge test model images; (b) contours of shear strains developed within the soil in the centrifuge test compared to (c) the corresponding numerical analysis.

active failure wedge forms on the footwall side of the foundation for h = 1.0 m, clearly indicated by the respective shear strain contours in Figure 4b. Soil failure on this side, as well as the soil distress underneath the foundation base due to its significant rotation, "facilitate" the diversion of the rupture to the left of the caisson and a secondary rupture plane (F2) is mobilized. Thereafter, a rather subtle interaction mechanism is observed, involving the formation of active and passive failure wedges on the left(footwall) and right (hanging-wall) side of the caisson respectively, and fault propagation on both sides concurrently (see image for h = 2.0 m and the equivalent shear strain contours). Moreover, a sliding plane evidently forms along the left sidewall (highlighted in Figure 4a) and a large gap appears at the top left caisson side.

The numerically computed shear strain contours shown in Figure 4c indicate that the numerical analysis captures the previously described fault rupture–caisson interaction mechanisms closely, demonstrating excellent agreement with the experiment.

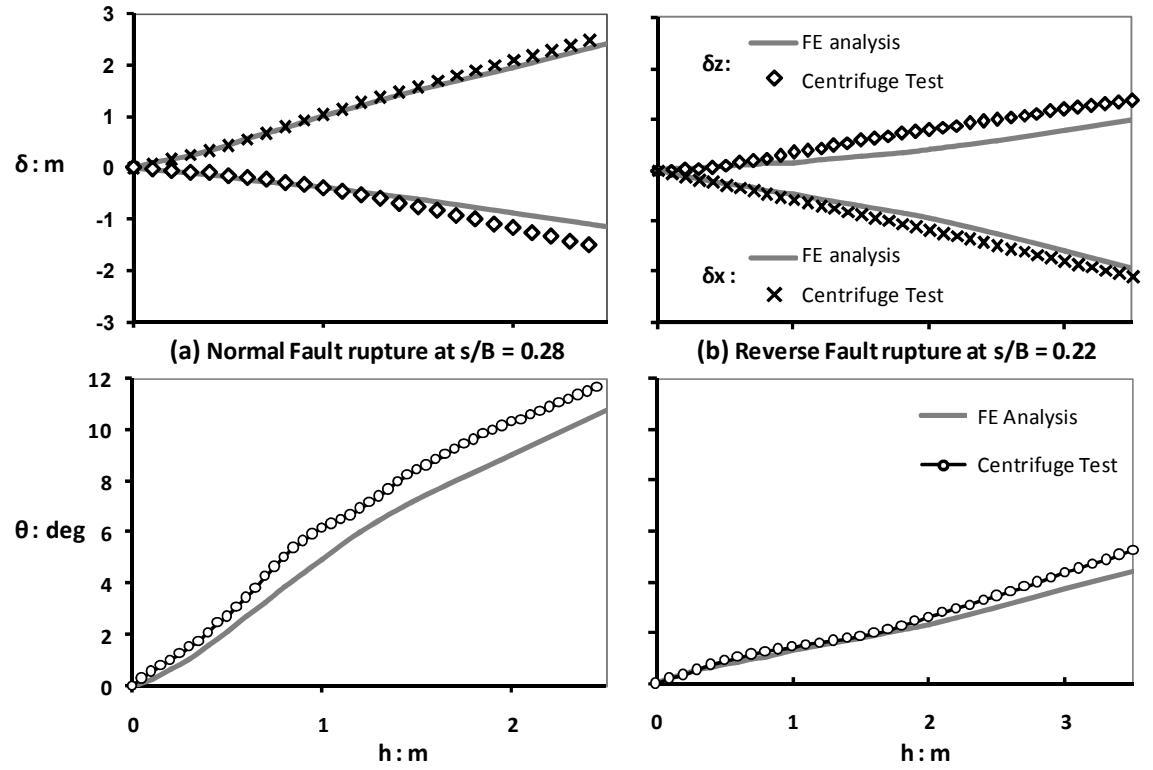
Regarding the caisson response, the extensive soil failure around the caisson, owing to the fault deformation spreading on both sides, provoked significant displacements in both the presented tests (Figure 5). The figure indicates the very satisfactory agreement between analysis and experiment throughout the whole range of the examined fault displacements and for both types of tectonic movement. In the particularly destructive case of normal faulting at s/B = 0.28 (Test ML-08), the rotation of the caisson , reaching about 12° for h = 2.5, exceeded by a factor of more than two the rotation experienced in the other two normal fault tests. This indicated the determinative role of the exact caisson position on the prevailing fault–caisson interaction mechanisms and the subsequent caisson response and motivated the following parametric investigation of the effect of the parameter s.

Figure 5. Comparison between experimental and analytical results in terms of the caisson translational (δ) and rotational (θ) response with respect to the applied fault throw (h).

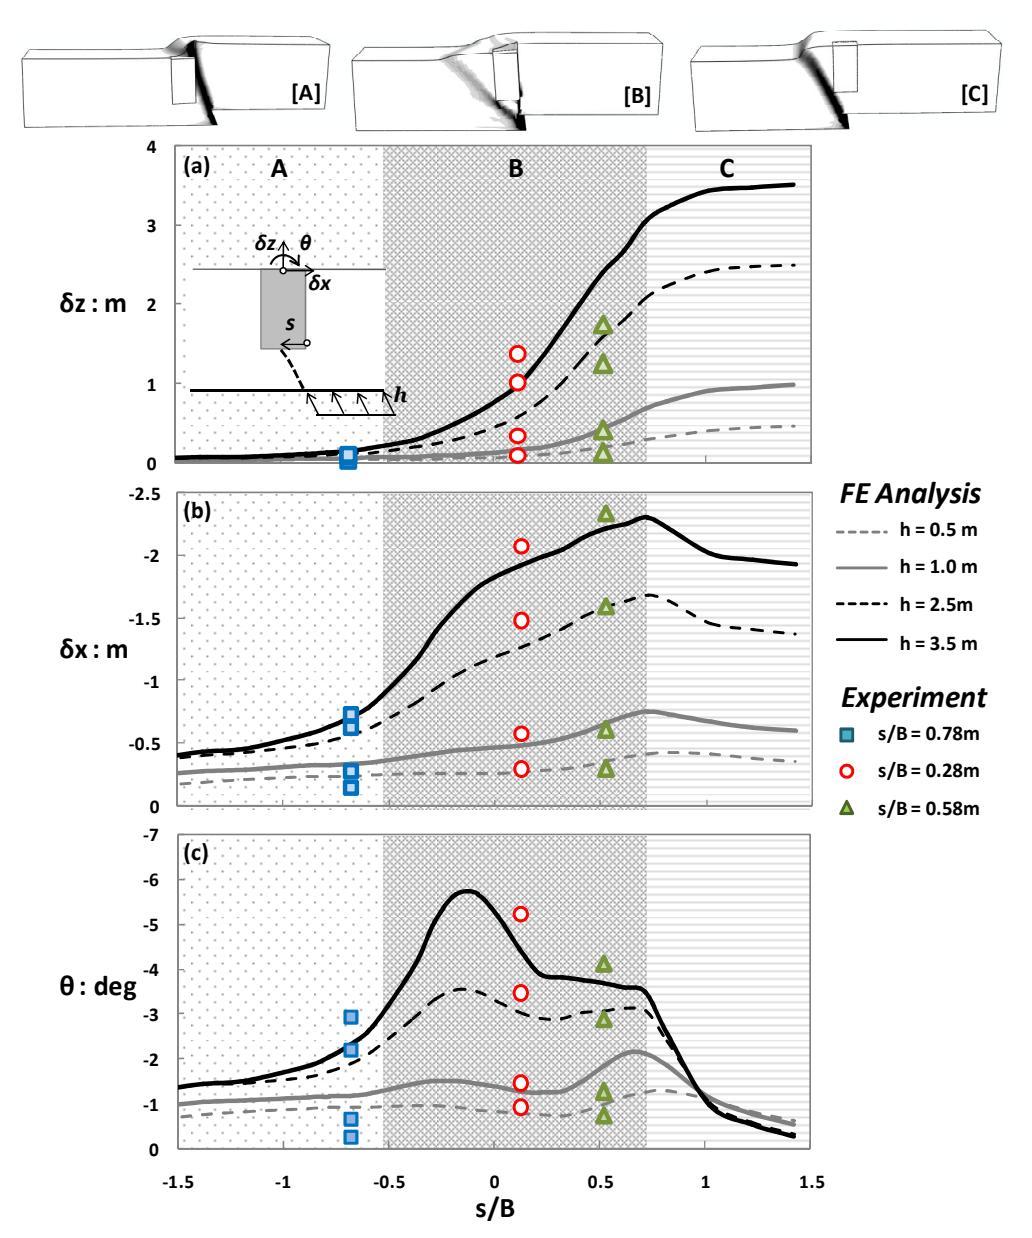
Three different interaction mechanisms can be identified, dividing the graphs of Figure 6 in three zones : (a) Mechanism A, for s/B < -0.5; (b) Mechanism B, for $-0.5 \le s/B < 0.7$; and (c) Mechanism C, for s/B ≥ 0.7 . More specifically:

Figure 6. The effect of the exact caisson location (s) on the mechanisms of fault rupture–caisson interaction and the consequent caisson response for the case of *reverse* tectonic movement: (a) vertical displacements, (b) horizontal displacements, and (c) rotation for different levels of throw.

Gaining enough confidence in the effectiveness of the numerical method in modelling the mechanisms of fault-caisson interaction allowed the conduction of a thorough parametric investigation of the exact caisson position effect on the caisson response. Figures 6 and 7 summarize the results for reverse and normal faults respectively in terms of the caisson displacements (δ_x , δ_z , θ) experienced at different relative fault-caisson positions *s/B* for different levels of fault throw h. The different failure mechanisms taking place are also indicated by the shear strain finite element contours that correspond to different points (positions) in the graph.

For both types of tectonic movement the plane of caisson response with respect to relative position can be divided into three zones of response A,B, and C, broadly representing three different patterns of fault– caisson interaction mechanism and hence three different modes of foundation response. These are illuminated in the following. To allow comparison with the experiments and show the generally good agreement between analytical and experimental results, centrifuge test results are also indicated (with marker points) for the same throws values.

Mechanism A ($-0.5 \le s/B < 0.7$; i.e. s < -2.5 m since B = 5 m) is observed when the fault rupture interacts with the upper half of the caisson right sidewall. The rupture is diverted towards the hanging wall and the caisson remains on the footwall. As a result, it experiences limited distress, being subjected to relatively small rotational and horizontal displacement, and practically zero uplift. This zone of s/B is clearly the most favourable for the performance of the supported structure.

Mechanism B ($-0.5 \le s/B < 0.7$; i.e. $-2.5 \text{ m} \le s < 3.5 \text{ m}$) occurs when the free field rupture crosses the caisson near its right base corner, as in the case of the previously discussed test ML-05 (s/B = 0.22). Fault

bifurcation is observed and deformation occurs simultaneously upon two fault strands, one on each side of the caisson. Increased rotations, and hence horizontal displacements, are associated with this zone of response primarily due to the fault deformation spreading within a wider soil area on both sides of the foundation.

Mechanism C (s/B \ge 0.7; i.e. s > 3.5 m) the fault rupture diverts towards the caisson footwall side, intersecting at its left base corner. This leads to an abrupt decrease of θ , which is virtually eliminated for s/B > 1.0 (i.e. when there is practically no interaction of the fault rupture with the caisson). The caisson experiences pure translational displacement, moving along with the hanging wall.

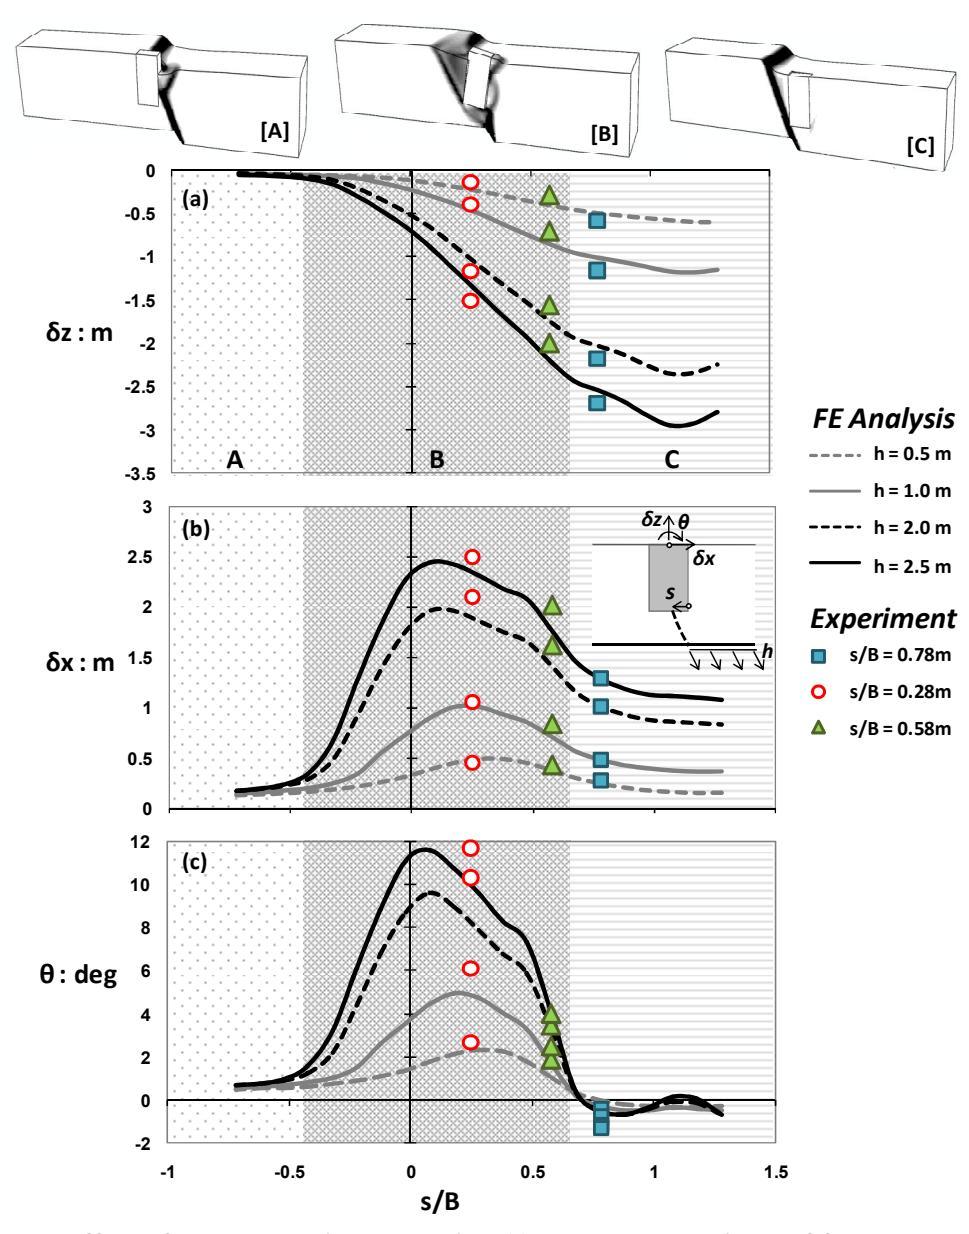
In the same way as with reverse faults, three modes of response can be identified (Figure 7):

Figure 7. The effect of the exact caisson location (s) on the mechanisms of fault rupture–caisson interaction and the consequent caisson response for the case of *reverse* tectonic movement: (a) vertical displacements, (b) horizontal displacements, and (c) rotation for different levels of throw.

Mechanism A (s/B < -0.4; i.e. s < -2 m) takes place when the fault rupture "grazes" the hanging-wall (right) sidewall of the caisson, missing its base by 2 m or more. The rupture path is refracted on the rigid sidewall and deviated towards the hanging-wall (to the right). The caisson remains on the footwall side of the fault, and experiences limited distress for all levels of fault throw *h*. This is presumably the most favourable area of possible caisson positions.

Mechanism B ($-0.4 \le s/B < 0.6$; i.e. $-2 m \le s < 3 m$) is prevalent when the fault rupture crosses the caisson body near its right base corner. As discussed previously for test ML-08 (s/B = 0.28), the interaction of the caisson with the fault rupture is in this case quite complex, involving : (i) bifurcation of the shear zone along both sides of the caisson, (ii) formation of an active failure wedge at the footwall (left) side of the caisson due to its substantial rotation, and (iii) formation of a passive-type failure wedge at the hanging-wall (right) side of the caisson (also due to the rotation). This area of possible interaction positions, is probably the most detrimental for the system response.

Mechanism C (s/B \ge 0.6; i.e. s > 3 m) prevails when the fault rupture crosses the caisson close to its footwall (left) corner, or misses it completely on the footwall (left) side. The rupture is diverted towards the footwall and the caisson translates downwards, following the hanging wall, with only minor rotation
